2007 District Wide Facility Evaluations
Building Assessment Report

Canterbury Elementary School

2530 Canterbury Rd, Cleveland Heights, Ohio

July 20, 2007

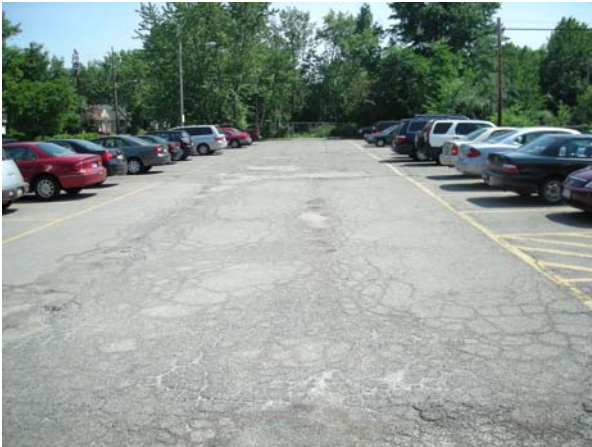
Deteriorated Asphalt in Parking Lot

- Concrete pavements (walks) are in fair condition, with many areas requiring replacement.
- Concrete curbs are generally in fair-to-good condition. Spot cracked curbs replacement is required.
- Existing asphalt parking lot areas are in fair-to-poor condition. Many areas of asphalt have failed and require replacement. All parking lot areas should be resurfaced and restriped after asphalt repairs have been made.

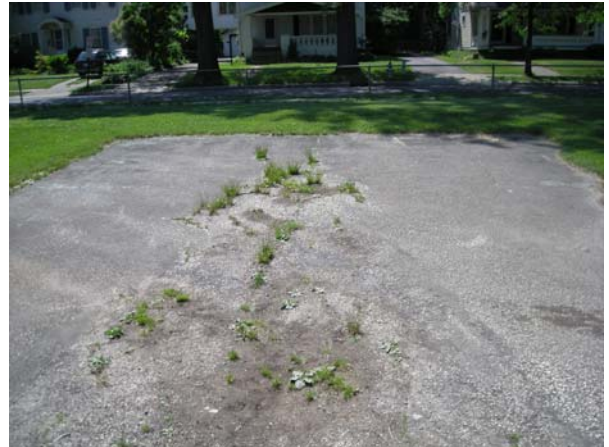
Deteriorated Playground Asphalt

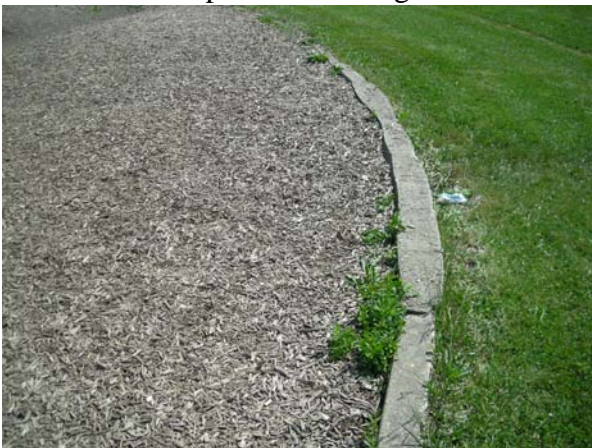
Concrete Playground Curb

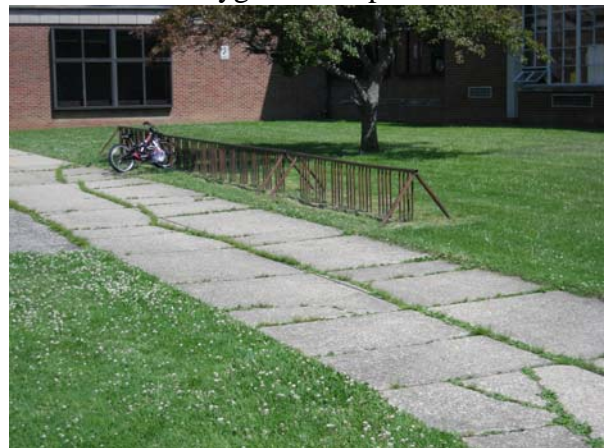
Bike Rack

- Bike racks to the north of the school are old, rusted and in need of replacement.
- Wood benches and tables are worn and should be replaced.
- Some areas of the existing chain link fence post, rail and gate have been damaged and should be replaced. These areas generally occur at or near the parking lots. In other areas, the existing chain link mesh is rusted or bent, while posts and rails appear sound – mesh should be replaced, and existing posts and rails painted.

Replace bench/ table	ea	3	\$ 800.00	\$ 2,400.00
Replace bike rack	ea	4	\$ 500.00	\$ 2,000.00
Subtotal Priority 3:				\$29,400

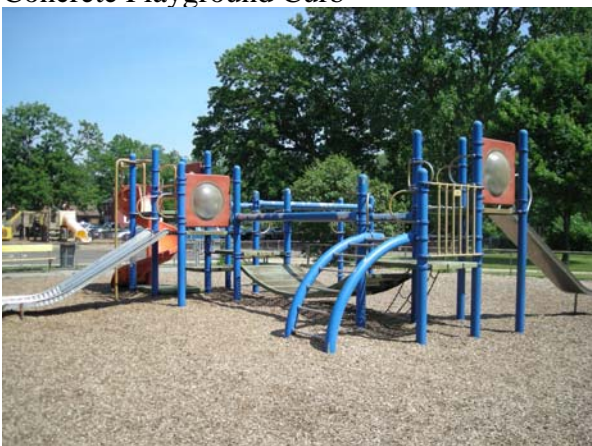
Playground Equipment

- The playground equipment at Canterbury Elementary School varies in type and condition at different site locations. Swings to the north of the school are in need of repair or replacement. The modular playground to the southeast of the school is worn but appears solid. This play area is in need of some repair and repainting of peeling elements. The swings in this area are likewise in need of painting.

<i>Item</i>	<i>Unit</i>	<i>Qty.</i>	<i>Unit Cost</i>	<i>Assessed Cost</i>	<i>Comments</i>
Playground repair/repaint	lump	1	\$ 25,000.00	\$ 25,000.00

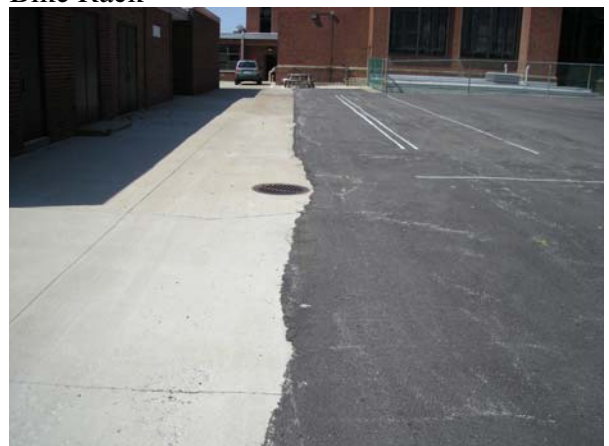
Mismatched Paving

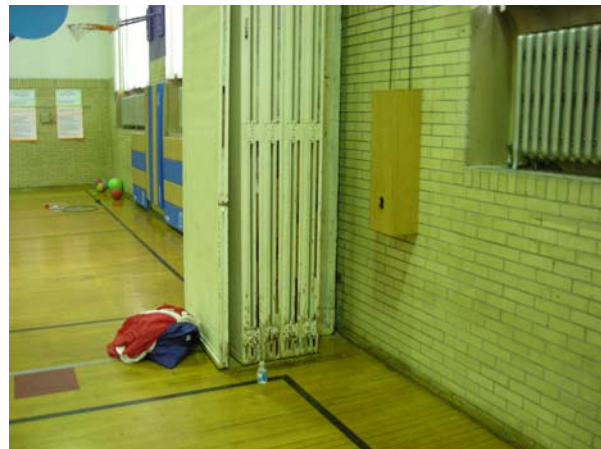
Gymnasium Partition

- The stage curtains are old and stained, and should be replaced.
- The operable partition in the gymnasium is functional, but in poor condition and nearing the end of its useful life.
- The wood floor of the gymnasium and stage is worn and should be refinished and restriped as required.
- Gymnasium equipment (backboards, ropes, etc.) appears to be in fair condition.

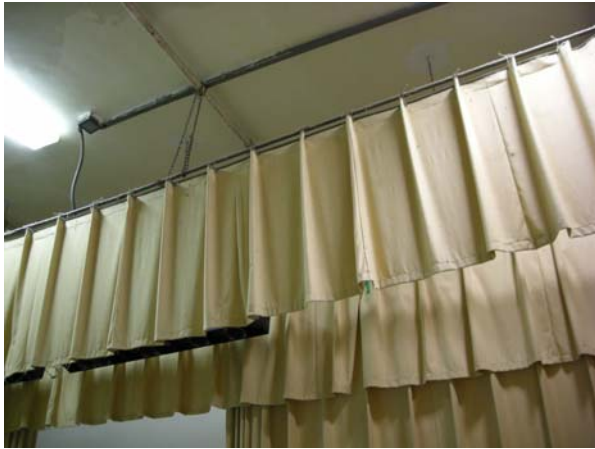
Stage Curtains

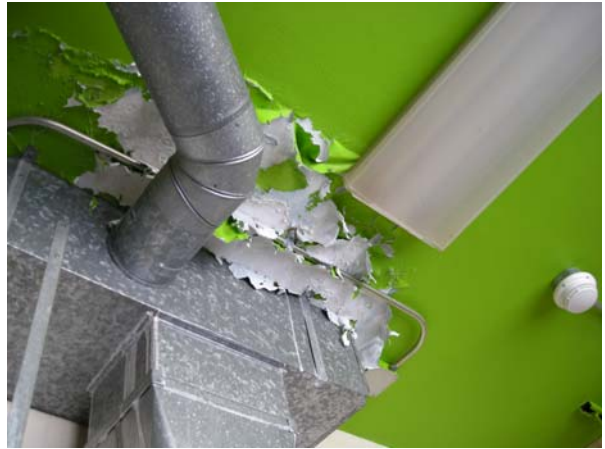
Ceiling Deterioration

- Plaster ceilings are typically in good condition. Some areas were observed to have water damage, and these should be patched.
- Acoustical tile ceilings are generally in good-to-fair condition. Selective tile and grid replacement is required. The “east” ceiling of the 1973 media center addition had numerous areas of tile damage and should be replaced. Many ceiling areas, while level and sound, had yellowed/discolored grid - an aesthetic concern which does not require immediate replacement.

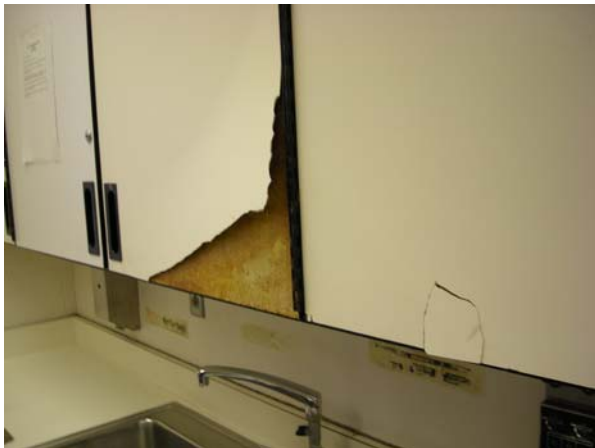
Deteriorating Casework

- The condition of built-in casework (base/wall/tall cabinets) varies by location. Some casework replacement is required, mostly at wet locations - sink base cabinets, base/wall cabinets at the kitchen, etc.
- The condition of modular tan-colored casework also varies by location, but is generally in the fair-to-good range.

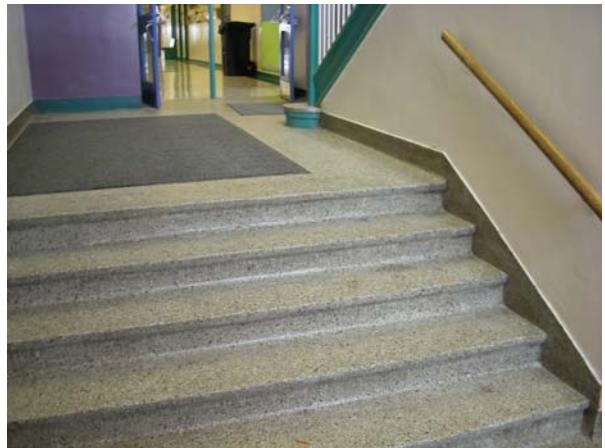
Terrazzo Stairs

- Rubber tile at ramps is generally in fair condition, requiring routine maintenance and cleaning only.
- Terrazzo at the 1928 building stairwells is in good condition, though some minor cracking was observed and discoloration occurs in many areas.
- Epoxy paint at the stairwells is generally in fair-to-good condition. Epoxy paint in basement areas (custodial office, toilet rooms, pump room, etc.) is in poor-to-fair condition and should be refinished.

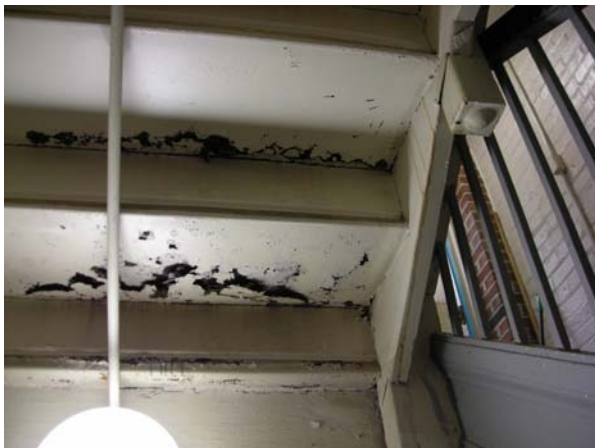
Peeling and Corrosion on Underside of Stair

- There is substantial corrosion at the base of the two steel stairs at the basement pump room. These stairs should be repaired and repainted.
- Corrosion exists at the bottom of the first floor landing at the “east” stair of the 1928 building. This corrosion should be repaired and repainted.
- Metal lockers at the second floor are generally in good condition, with some required repair of bent/damaged locker doors or ends. Metal lockers at the 1958 building classrooms are typically in fair condition.

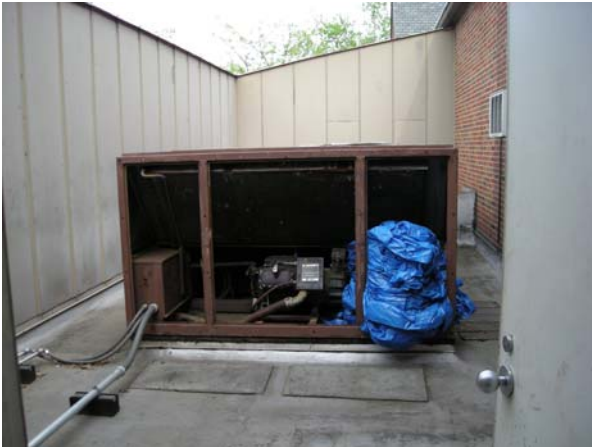
Rooftop Unit

The 1974 addition added a multizone rooftop unit that served the new media center and some central offices. This unit is in bad shape and in need of replacement.

- Replace all unit ventilators. The unit ventilators are over 30 years old and should be replaced.
- Replace the media center's rooftop multizone unit.
- Add dual water softeners to the boiler's make-up water system. This will help prolong the life of the boilers.

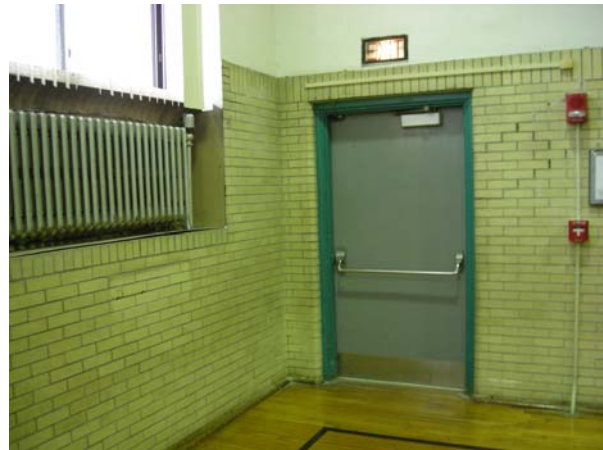
Radiator in Gymnasium
