District Wide Facilities Evaluation  
Building Assessment Report

# Fairfax Elementary School

3150 Fairfax Rd, Cleveland Heights, Ohio

July 20, 2007

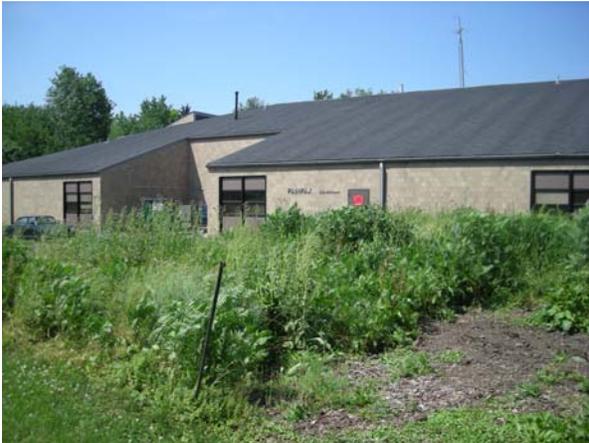
Overgrown "Fairfax Garden"

- The landscaped area to the East of the building is suffering from neglect. This area was clearly designed and planted with care, but has been taken over by weeds and tree seedlings. Given its potential value to the community and the school, prioritizing its restoration should be considered. If continued maintenance is not possible, the area could be returned to a low maintenance lawn area.
- The "Fairfax Garden" on the South side of the building appears neglected. Restoration should be considered.
- Other landscaped areas adjacent to the building should be replanted.
- Large areas of bare earth adjacent to paving show attempts at reseeded, which have not been effective. Factors preventing grass from growing need to be remedied prior to reseeded.

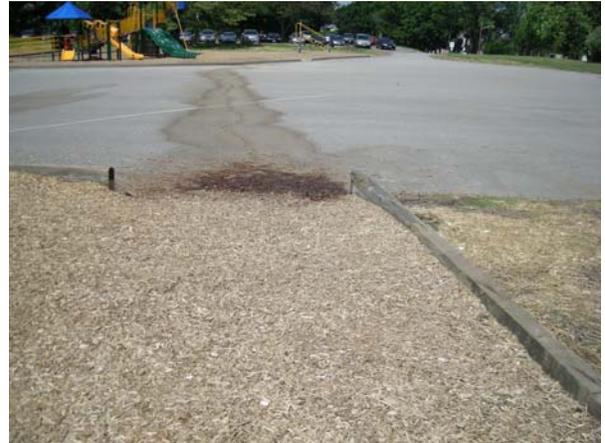
Stained Asphalt

- Concrete pavement was typically in fair to poor condition, a significant percentage showing cracks, breakage and previous repairs.
- Concrete curbs around the main playground are new. Parking lot curbs are in good condition, although the island that defines the drop off needs repair.
- Asphalt pavement needs to be replaced at the parking lot and adjacent sidewalk. The large asphalt play area on the West side of the building is in good condition, but markings need to be repainted. There are large stains running across the area, from a woodchip-filled area opposite the drain. The rest of the asphalt is in good condition.

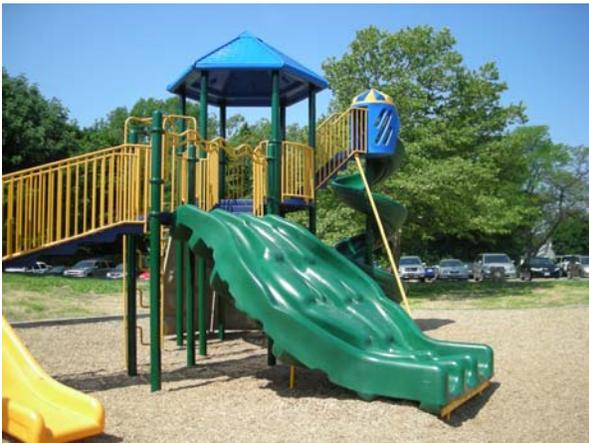
New Playground Equipment

- The main playground equipment was recently replaced, and appears new. A smaller wood playground to the southeast is older and in good condition. The ramp leading to this playground has loose handrails.
- Wooden site furniture is in good to fair condition.
- Wooden fencing is in poor condition, deteriorating and incomplete. It should be replaced.
- Wooden structures, such as arbors and trellises, are in good condition. There is a tall wooden structure on the West end of the site that has no discernable function, but is in good condition.
- Both bike racks should be replaced. Parents, staff and students are using the racks.
- All landscape timbers need to be replaced.
- Concrete bollards are generally good, but several were very rust stained and/or deteriorating. The rusted chain linking several of the bollards has no discernable purpose.

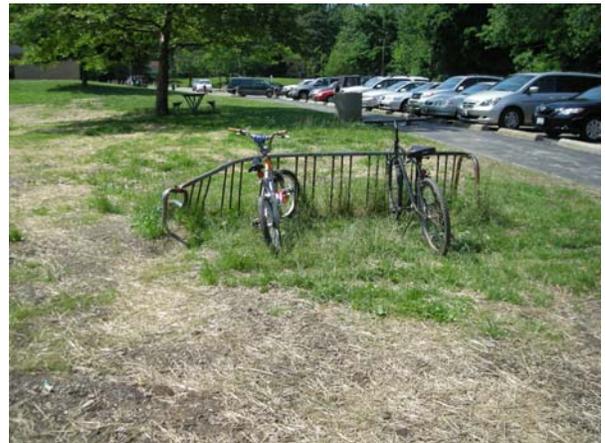
Bike Rack

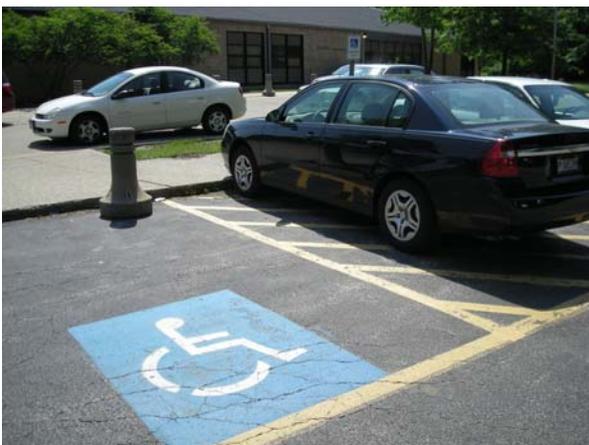
Evidence of Parking Shortage

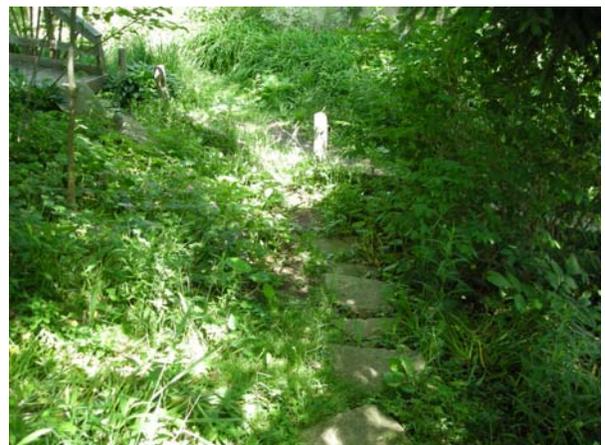
Overgrown West Garden

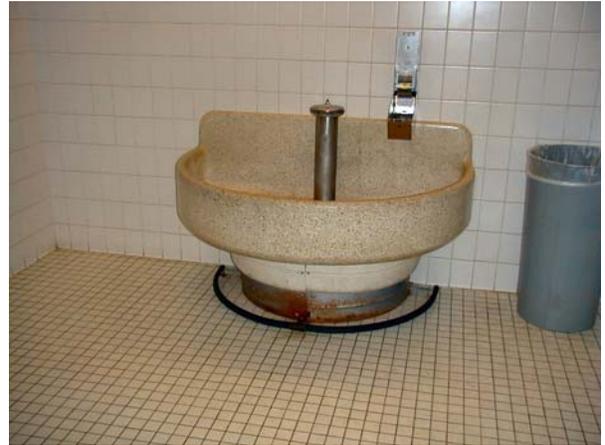
Non ADA Wash Fountain

- There are not handicapped toilet stalls in each toilet room. Toilet fixtures are floor mounted.
- Group sinks are inaccessible semi-circular wash fountains. These are typically in fair-to-poor condition, with staining and rusting at metal bottoms.

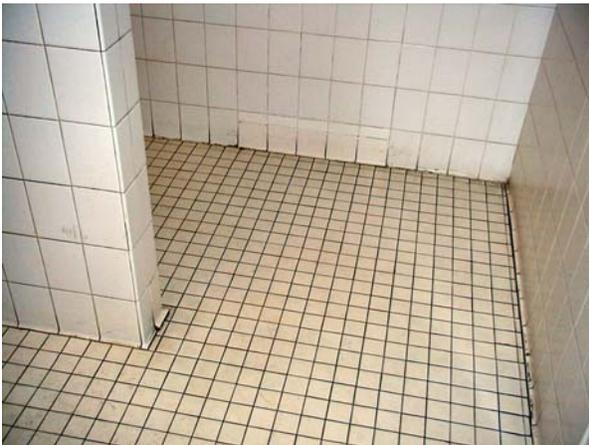
Discolored Tile Floor, Damaged Base

- Carpet is generally in fair condition. Custodians have indicated it is 10+ years old. Carpet appears more worn at mezzanine, especially at corridors.
- VCT is generally in fair-to-good condition, with some areas somewhat scuffed but serious problems uncommon.
- Rubber tile at ramps/stairs is in fair condition, but dirty.
- Ceramic tile floors at toilet rooms are good to fair, but there are holes where toilet partitions were replaced. Ceramic tile floors typically have discolored grout.

- Tile base at toilet rooms is cracked in many locations.
- Carpet base is in good condition. A few areas have delaminated from the wall.
- Vinyl base is generally in fair-to-good condition. Base at the ramp/bottom of ramp is very worn and should be replaced.

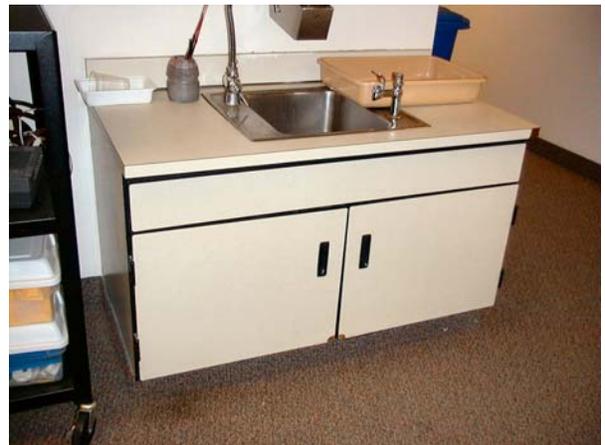
Sink Casework

- The condition of the tan-colored casework varies by location, but is usually in the fair-to-good range. Much of the observed casework damage occurs at sink base cabinets.

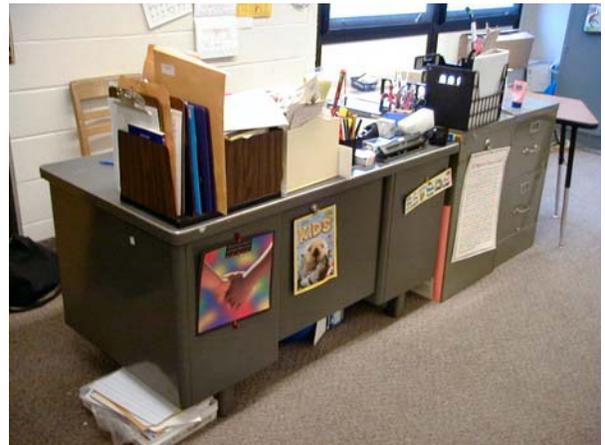
Typical Teacher Desk

- Many teacher desks are in poor-to-fair condition. Though serviceable, they seem to be nearing the end of their useful life.

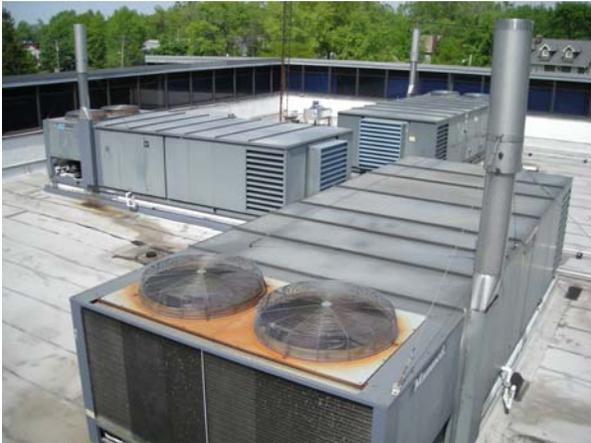
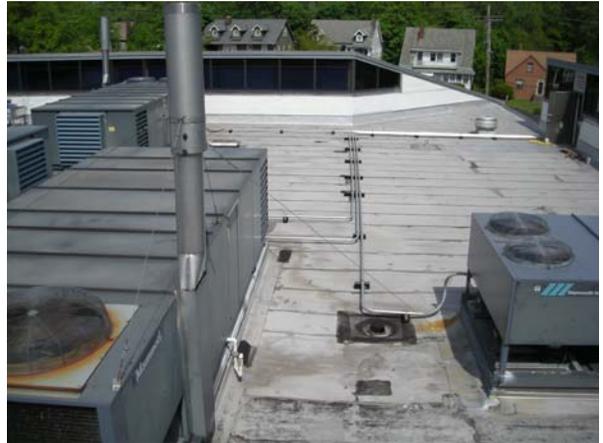
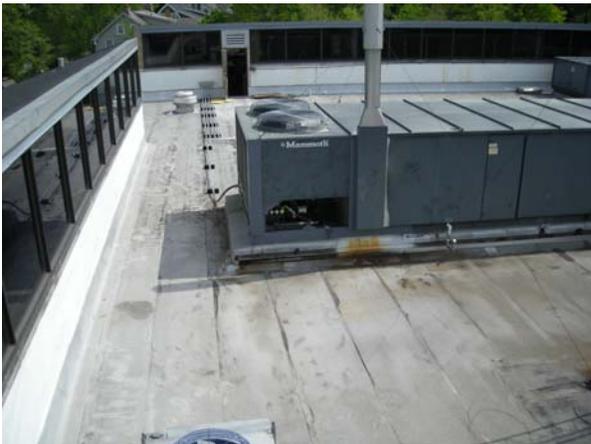
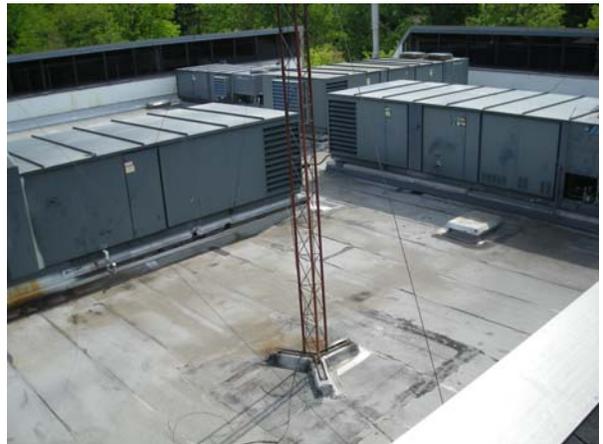
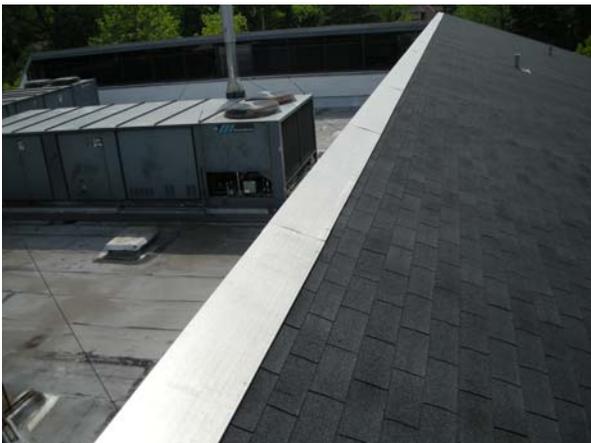
Rooftop Units

The building is heated, ventilated and air conditioned by three gas-fired multizone rooftop units and one single zone gas fired rooftop unit that serves the gym. All four units have exceeded their useful life and should be replaced. The fire exhaust fans on the roof should also be replaced. Note, variable speed drives were added to the rooftop units' supply and return fans but it is not known how these control the units. Electric baseboard heaters are located around many of the perimeter rooms.

- Replace the three multizone and one single zone rooftop units.
- Replace the five rooftop exhaust fans.
- Lower the exhaust fan above room 313 to a more accessible location

<i>Item</i>	<i>Unit</i>	<i>Qty.</i>	<i>Unit Cost</i>	<i>Assessed Cost</i>	<i>Comments</i>
Replace Rooftop A/C Units	Lump	1	\$ 212,000.00	\$ 212,000.00	
Replace Exhasut Fans	Each	6	\$ 2,500.00	\$ 15,000.00	
Subtotal Priority 1:				\$227,000

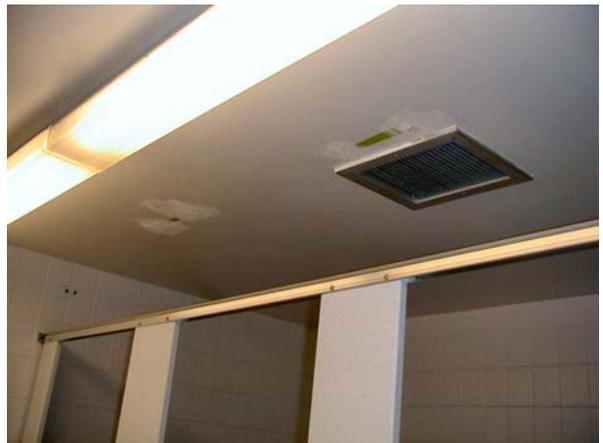
Restroom Ventilation
