2007 District Wide Facilities Evaluation
Building Assessment Report

Monticello Middle School

3665 Monticello Blvd, Cleveland Heights, Ohio

July 20, 2007

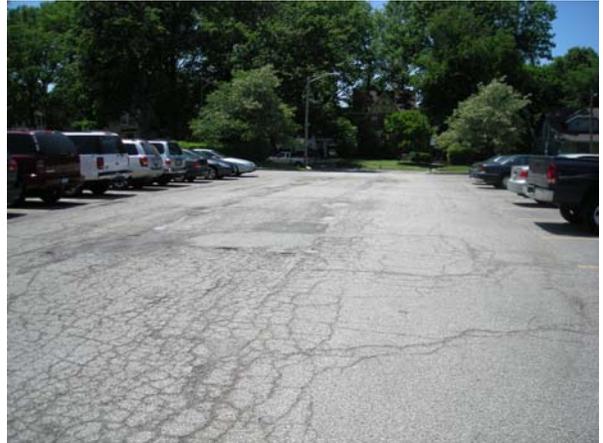
Damaged Asphalt in Parking Lot

- Concrete pavement (walks) are typically in good condition. Cracked and deteriorated concrete walks to be spot replaced .
- Concrete curbs are generally in fair condition. Cracked curbs to be spot replaced.
- The existing asphalt parking lot is in fair-to-poor condition. Many areas of asphalt have failed and require replacement down to (and possibly including) the existing base material. The entire parking lot should be resurfaced, sealed and re-stripped after asphalt and base repairs have been made.

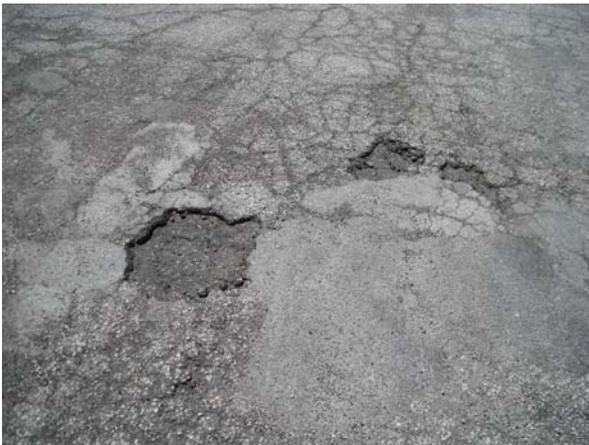
Damaged Asphalt

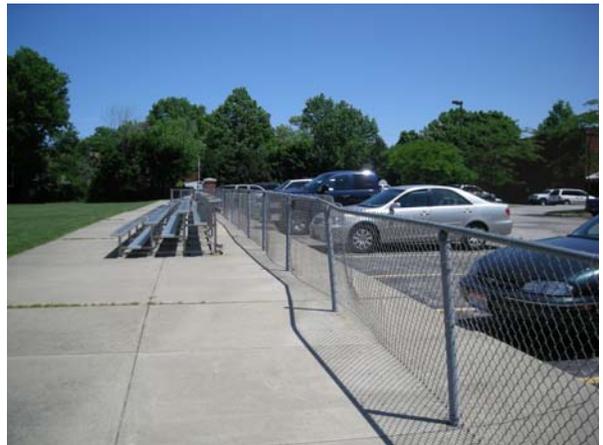
Damaged Fence

- Some areas of the existing chain link fence post, rail and gate have been damaged and should be replaced. Some areas of chain link mesh are rusted/bent, most notably at the baseball backstop. These areas of mesh should likewise be replaced.
- Brick piers to the north of the parking lot require selective replacement of broken and crazed masonry units.
- The existing football goal posts are rusting. These should be cleaned, primed and repainted. The football scoreboard is older – it is unknown whether it is operational. The steel support posts for the scoreboard should be cleaned and repainted.
- Existing bike racks are in poor condition and should be replaced.
- The track is in good condition, with minor patching of the rubberized surface required. The long jump track should be resurfaced completely.

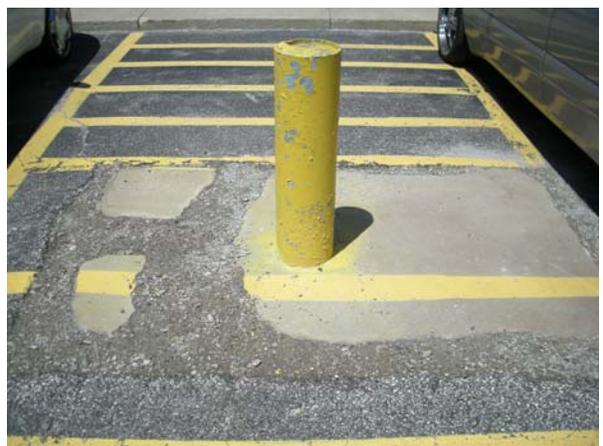
Damaged Concrete in Parking Lot

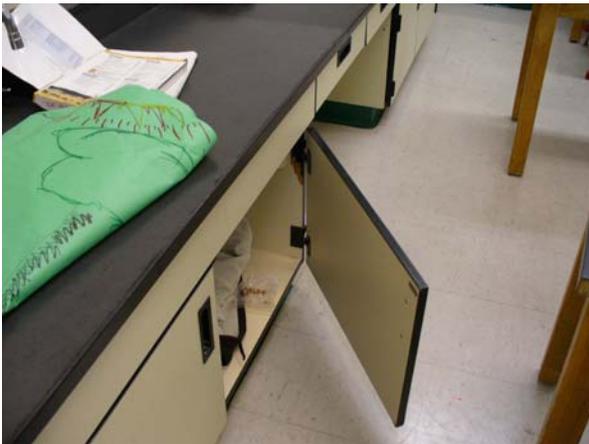
Typical Science Casework

- S: Music storage casework in the second floor music room is severely deteriorated and should be replaced.
- S: Science room casework is in poor condition, with chipped or missing melamine surfaces, and door and drawer front attachments pulling out of deteriorated particleboard. They should be replaced.

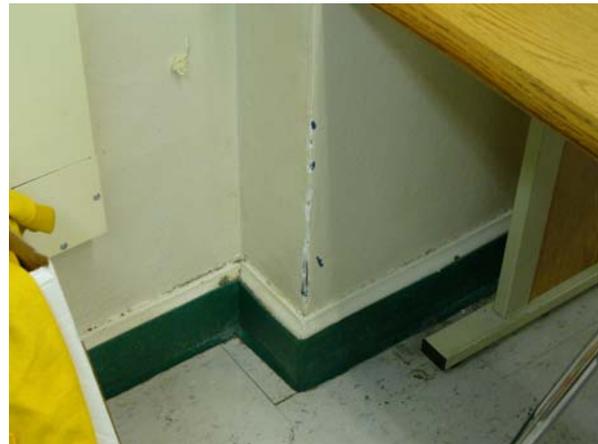
Typical Condition of Plaster at Corners

- Plaster walls vary in condition depending on location, but are generally in fair condition. Typical plaster walls have some cracking, possible minor water damage, and possible minor peeling paint. Most outside corners are chipped and slightly damaged. Plaster walls in poor condition usually exhibit more severe water damage, with substantial peeling paint and cracking.

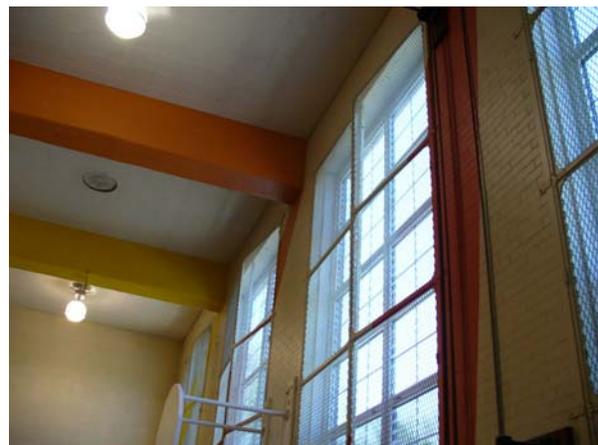
Gymnasium Window Guards

- Window treatments consist of horizontal mini blinds occurring at selected locations throughout the school. The blinds are in good condition.
- Hinged protective window covers at the West Gym are operable, but in fair-to-poor condition. These covers should likely be replaced. There are no such protective window covers in the Center Gym – they should be installed to protect the newly installed windows from breakage.
- Sills at all gyms, over radiators, are in an unfinished state. This should be remedied.

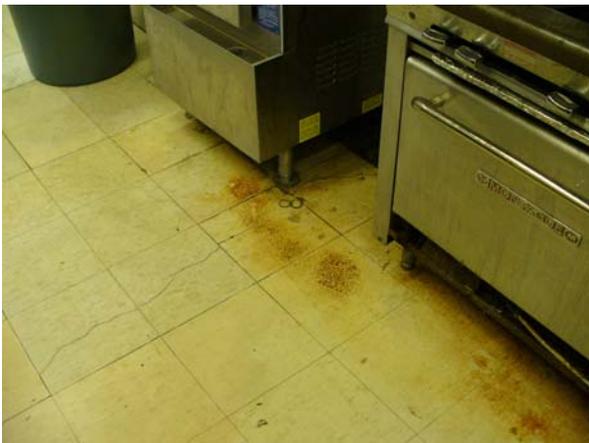
Damaged VCT in Kitchen

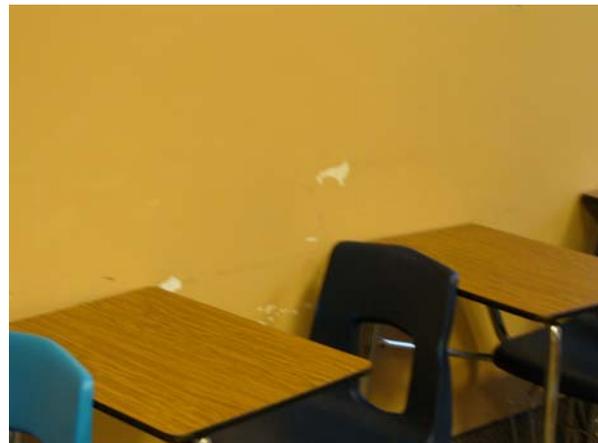
Typical Furniture Damage to Walls

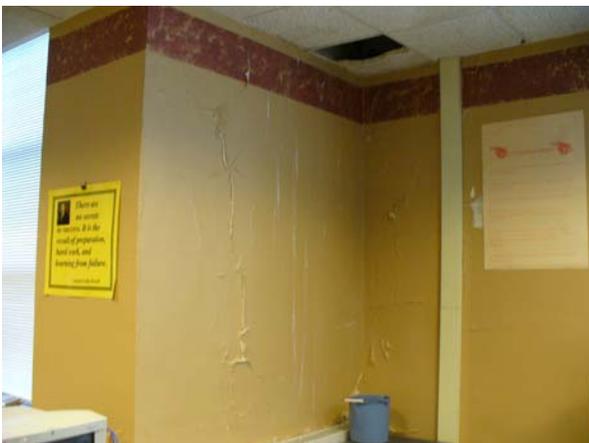
Water Damage in Technology Classroom

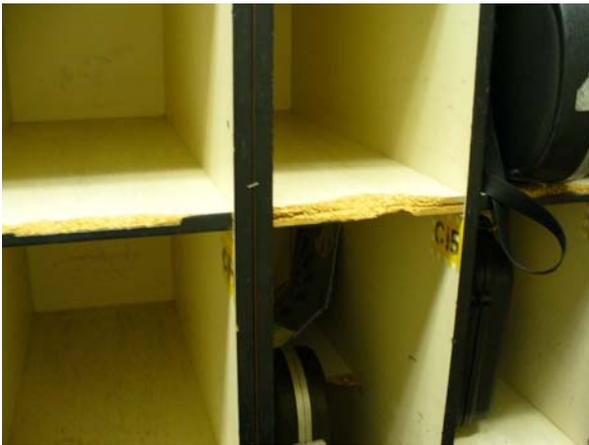
Deteriorating Music Storage Casework

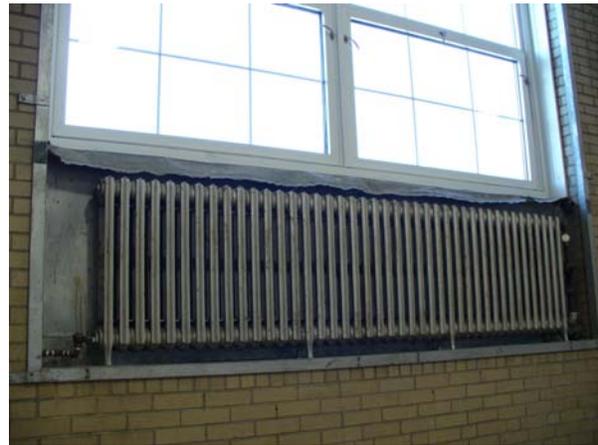
Typical Sill Condition at Gymnasia

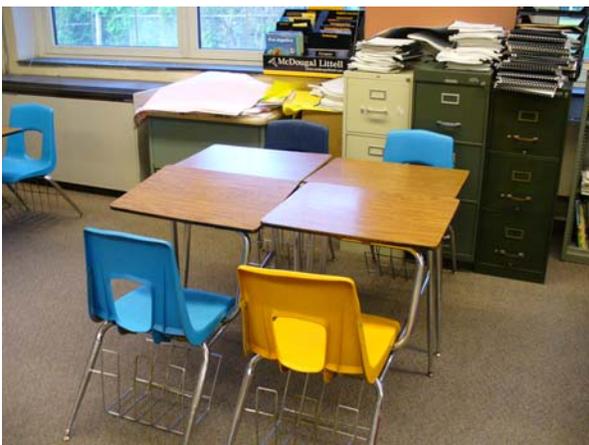
Typical Student Desks

- Many of the student desks are in poor condition. There is extensive chipping of tops and sides of the desks.

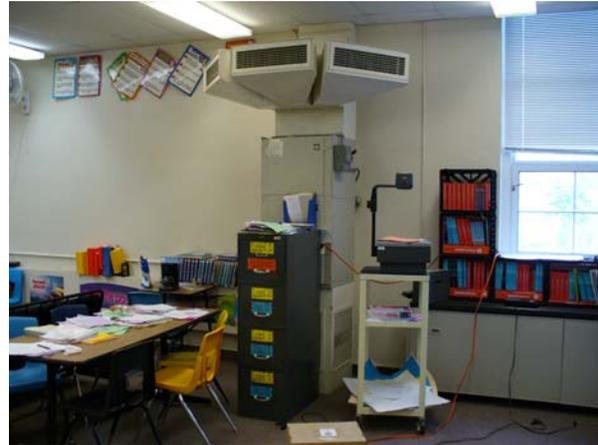
Unit Ventilator

- A vacuum breaker should be added to the main steam header.
- The 1930 original building classrooms are heated and ventilated by steam unit ventilators and steam finned tube radiators. Two exhaust fans provide relief for the unit ventilators. The unit ventilators were replaced in 1974, but the outside air ventilation rates designed into the unit ventilators fall short of current code requirements. The Unit Ventilators should be replaced.
