2007 District Wide Facilities Evaluation  
Building Assessment Report

# Wiley Middle School

2181 Miramar Blvd, University Heights, Ohio

July 20, 2007

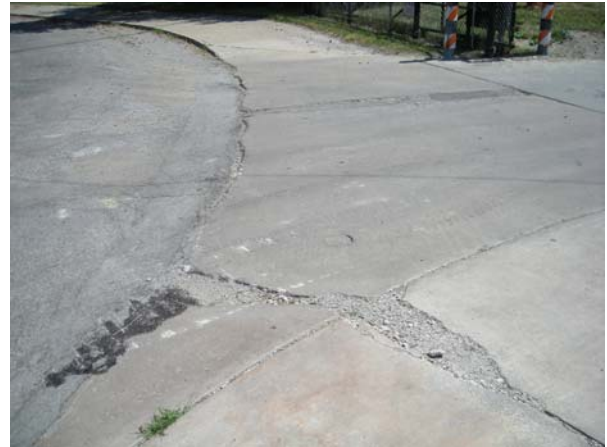
Deteriorated Concrete Drive

- All of the asphalt not yet replaced is in very poor condition, and should be replaced
- Many concrete pedestrian areas are deteriorating, and should be replaced. Concrete road surfaces should be replaced.

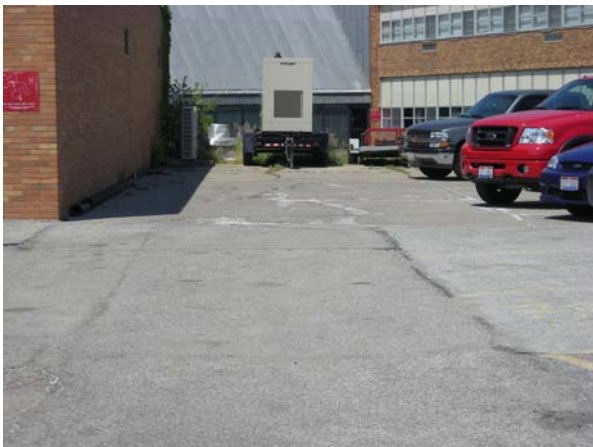
Deteriorated Asphalt

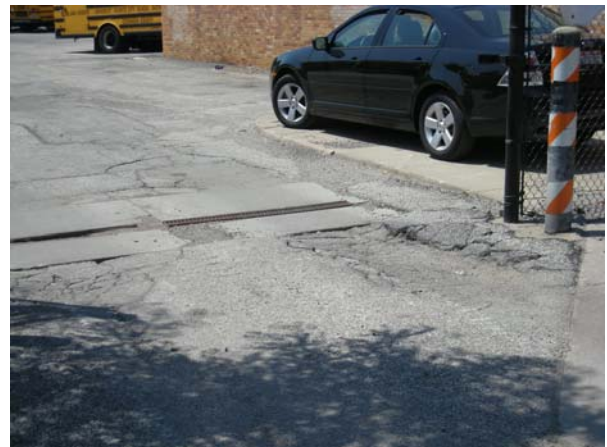
Deteriorated Asphalt

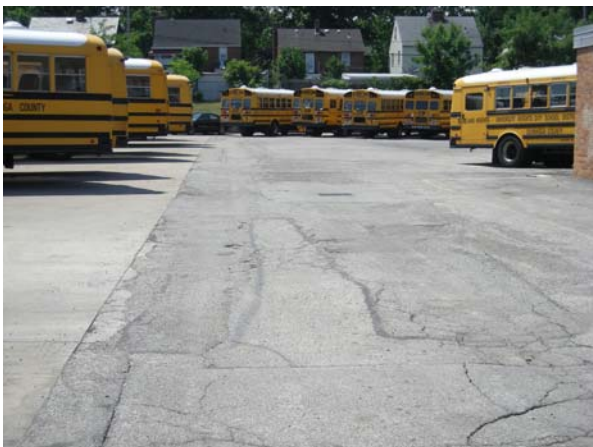
Deteriorated Asphalt

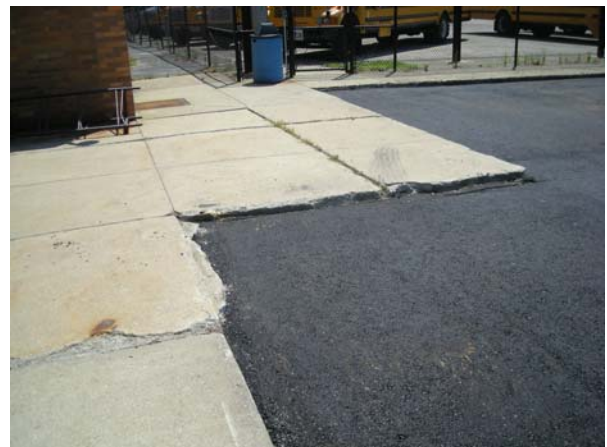
Deteriorated Concrete Walk

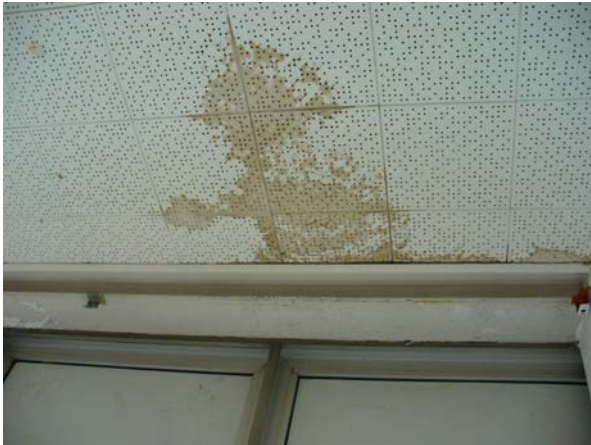
Water Damaged 12x12 Ceiling Tile

- Acoustical tile ceilings occur throughout the building. The condition of these ceilings varies by location, but is generally good.
- Older concealed spline (12"x12") tile ceilings are typically in fair to poor condition: uneven, damaged, vandalized, and mismatched. Most require substantial tile replacements. Several large areas, such as corridors and some classrooms, need to be completely taken down and replaced with new material.
- Plaster ceilings occur in spaces such as utility closets, stairwells, and group restrooms. Ceilings in these areas are in fair condition, requiring some repair and repainting.
- Virtually every masonry column on the first floor (between windows) showed water damage at the top. This damage ranged from peeling paint on the masonry to involvement of adjacent finishes (plaster damage, stained, failing tiles) over a significant area.

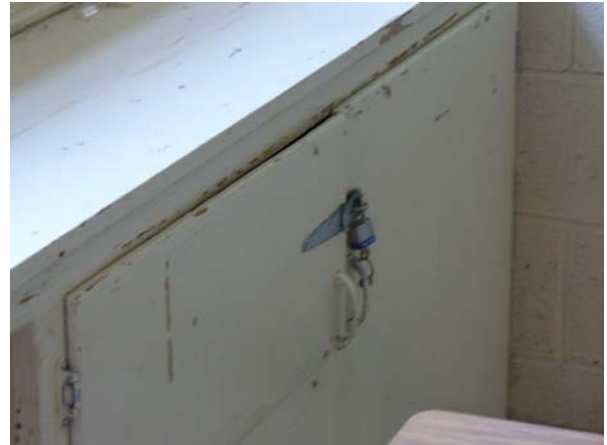
Casework Below Window

- Built in shelving and cabinets located under classroom windows is in uniformly poor condition, and should be replaced.
- All science casework, notably teacher's demonstration tables, is deteriorating and should be replaced.
- Casework in the Art room is deteriorating and should be replaced.
- Music Casework is deteriorating and should be replaced.
- Utility/storage shelving should be replaced.

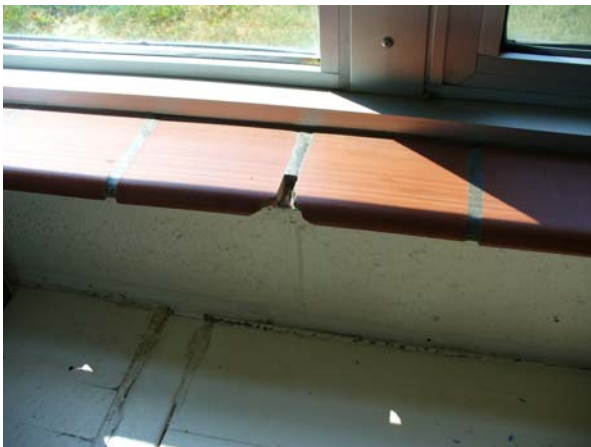
Crack at Tile Sill

- Window treatments consist of horizontal mini blinds occurring at selected locations throughout the school. The blinds are in good condition.
- The upper panes of Classroom windows have been replaced by opaque panels. The gasketing holding in these new panels is loose and should be replaced. Hardware from removed blinds remains at these locations, and should be removed.
- First floor tile window sills typically need minor grout repair.

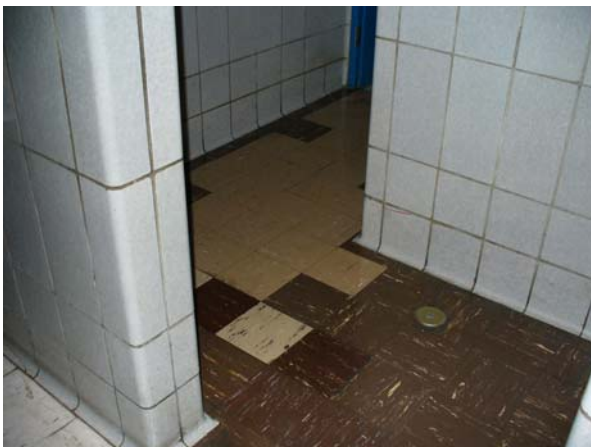
Mismatched VAT

- VAT occurs in numerous rooms throughout the school. It should be removed, regardless of condition, following proper abatement procedures.
- VCT is typically in poor condition, severely stained, scuffed and cracked.

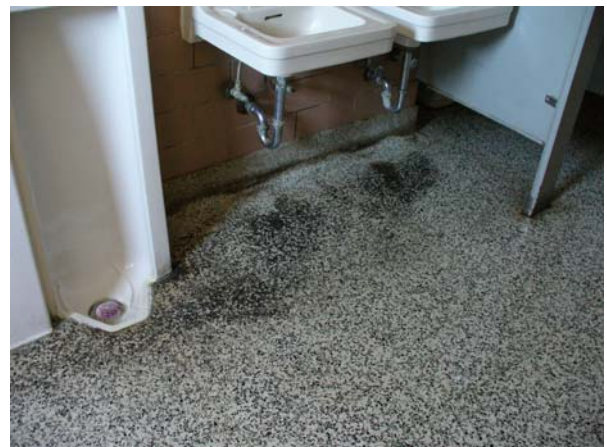
Stained Terrazzo at Toilet Room

- Terrazzo flooring in the school is generally in good-to-fair condition. There is some minor cracking and discoloration (especially around toilet fixtures), but the terrazzo appears solid.

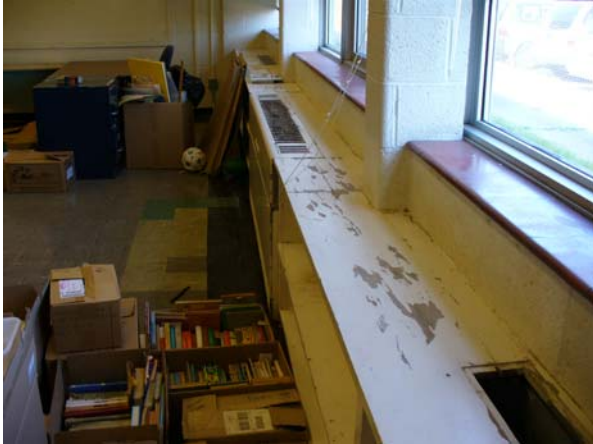
Peeling Paint at Casework Below Window

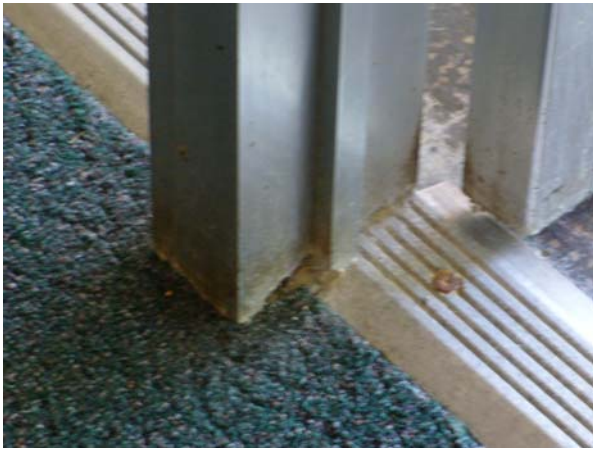
Corrosion at Bottom of Aluminum Frame

- Aluminum doors and frames at the lobby entrances are in good condition, showing minor erosion where they meet the floor.
- Wooden cooler doors are obsolete, and should be replaced.

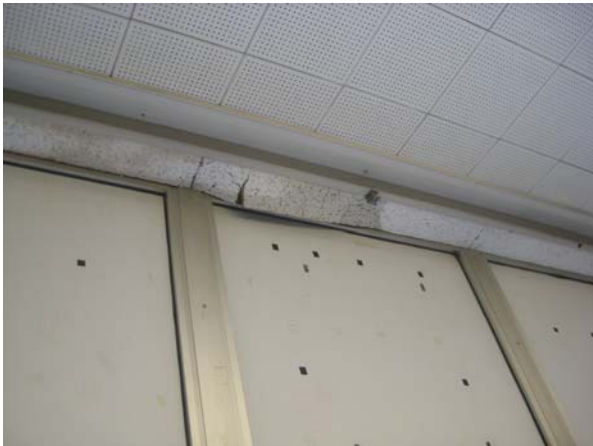
Deteriorated Tile at Window Head

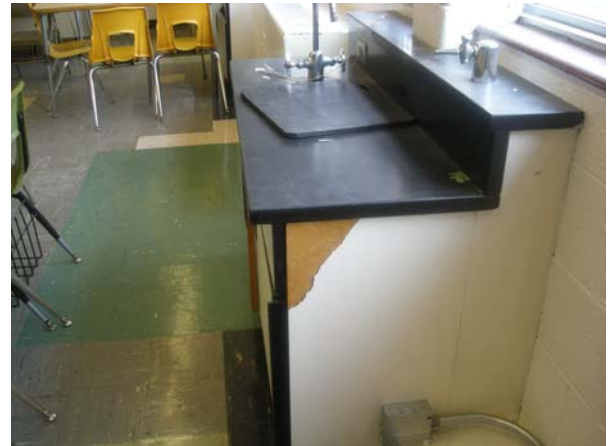
Peeling Laminate at Science Casework

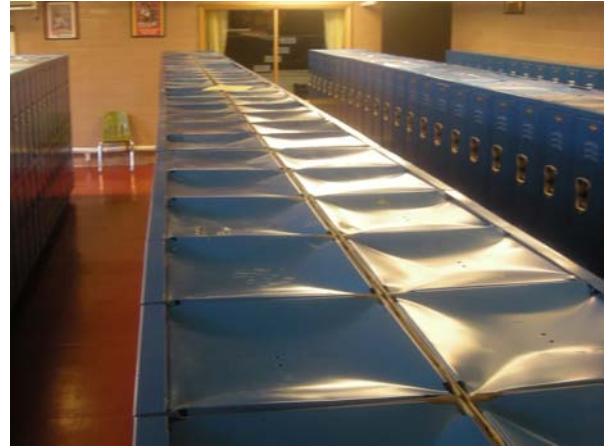
Dented Metal Locker Tops

- Corridor lockers are generally in good condition, with few repairs required. Trim is typically bent or poorly installed, and should be replaced.
- All Girls Locker Room lockers have dented, caved-in tops, presumably from being walked on. Boy's lockers have plastic laminate panels installed across the tops of the lockers.
- Handrails at the Choral and Band room risers are loose and should be stabilized.
- The expansion joint cover in the stairwell adjacent to the main lobby is loose and bent on all three sides (ceiling and two walls).

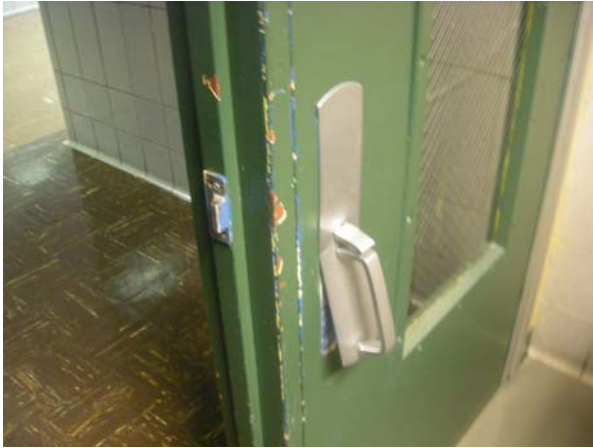
Damaged Door Hardware

- Hollow metal door frames are typically in good-to-fair condition – minor denting, scratching of paint, but functional.
- Panic Hardware at a majority of stair doors is in poor condition; broken or awkwardly repaired, mismatched, and loose, and should be replaced.

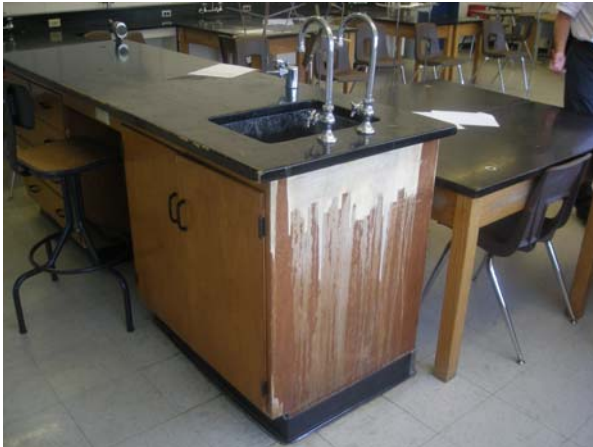
Damaged Science Casework and Table

- Generally, most of the remaining furniture is in fair-to-poor condition.
- Typical science tables are in poor condition, with bases very worn and vandalized. The plastic laminate tops are deteriorating.
- Free standing storage shelving is typically older, but still functional.

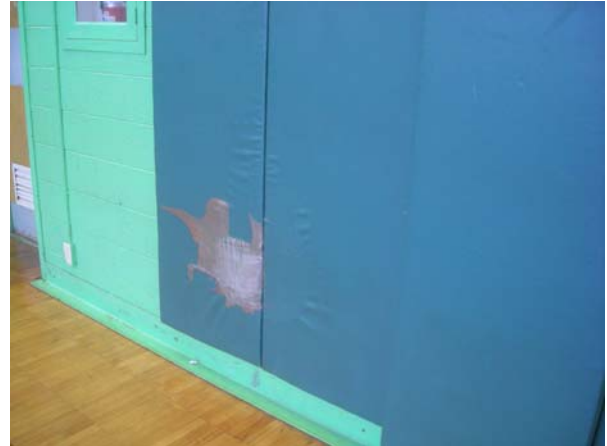
Damaged Gymnasium Wall Pads
