2007 District Wide Facilities Evaluation  
Building Assessment Report

# Cleveland Heights High School

13263 Cedar Road, Cleveland Heights, Ohio

June 18, 2007

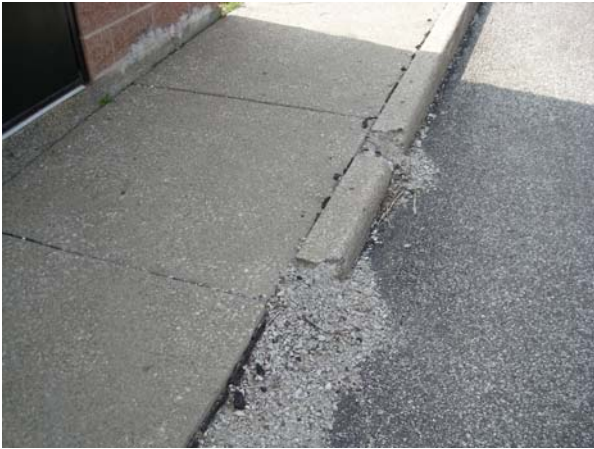
Typical Curb Deterioration

- Concrete pavements (walks) are generally in fair condition. Many areas require spot replacement, while other areas have deteriorated to the point where complete replacement is required.
- Concrete curbs are generally in fair condition. Cracked, deteriorated or missing curbs should be replaced where required.
- Asphalt pavement is in fair condition. Most paved areas require resurfacing, and many areas should be replaced down to (and possibly including) the existing base material. Parking areas should be sealed and restriped after work is complete.
- Many of the existing precast concrete bumpers are in poor condition and should be replaced.

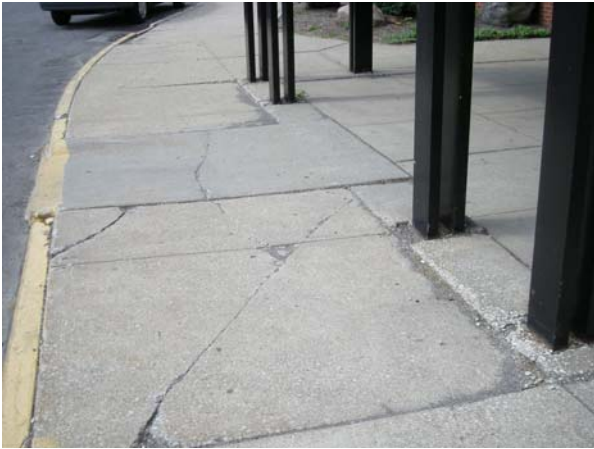
Typical Concrete Walk Damage

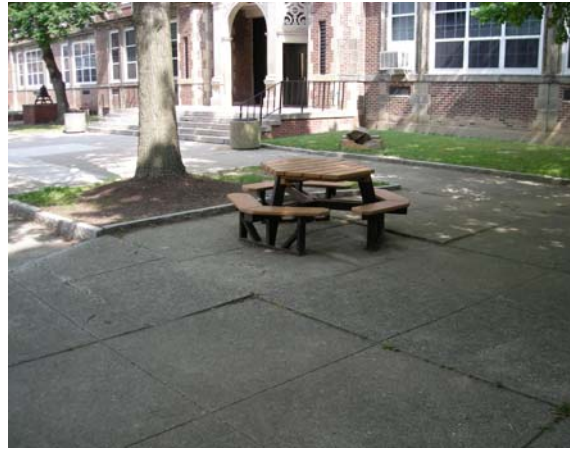
Courtyard Furnishing, Uneven Pavement

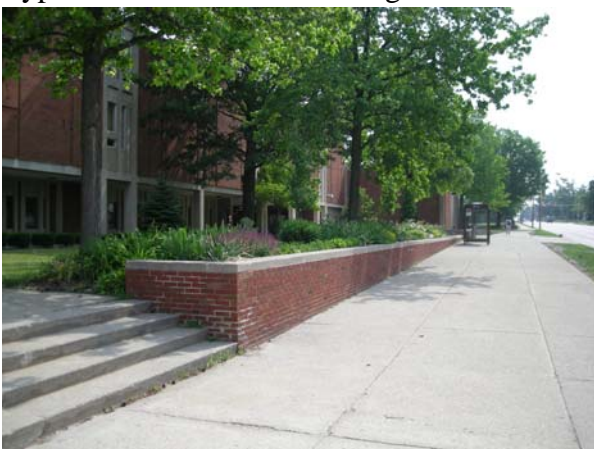
Cedar Road Planting Bed

- Planting beds are typically sparse and weedy, although the shrubs in them appear maintained and healthy. These beds should be replanted. Only the Cedar Road planting beds appear maintained. Large weeds were observed there as well.
- Large areas of bare earth adjacent to sidewalks are common, presumably from foot traffic and winter salt application.

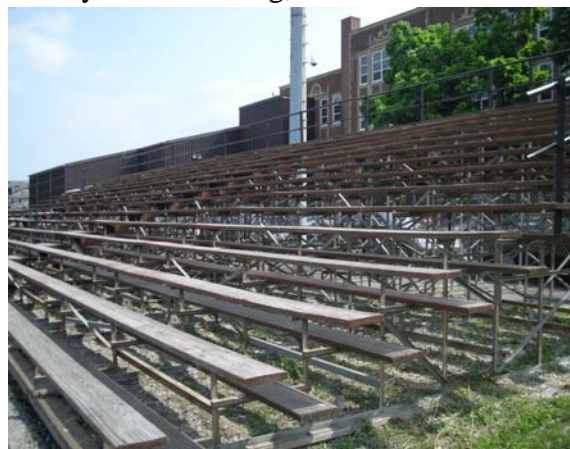
Visitor's Stands

- Chain link fencing at the stadium is in good condition.
- Some low masonry walls with stone caps require tuckpointing.
- The main bleacher aluminum framing and seating is in good condition. However, treated wood tread planks are deteriorated and require replacement. The press box at the top of the bleachers requires scraping and painting, and the wood canopy at the press box requires replacement.
- The secondary bleachers are in poor condition and in need of complete replacement.
- Bike racks are in poor condition and should be replaced.
- Backstops at the various ballfields should be painted, and new chainlink installed. Backstop #2 is small and in poor repair, and should be replaced or removed.
- Benches in the visitor's dugout at the baseball stadium should be replaced.
- The demountable outfield fence is in fair to poor condition, with many broken posts.

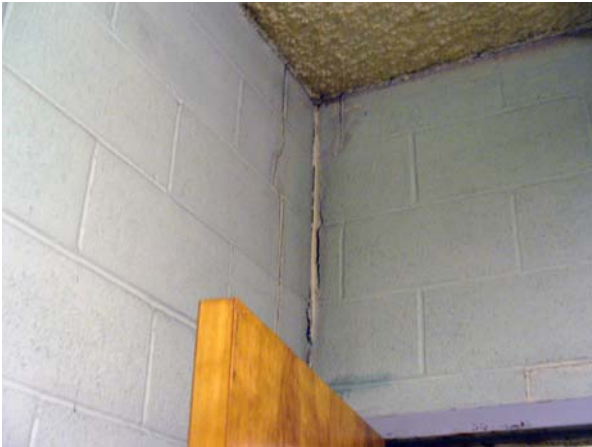
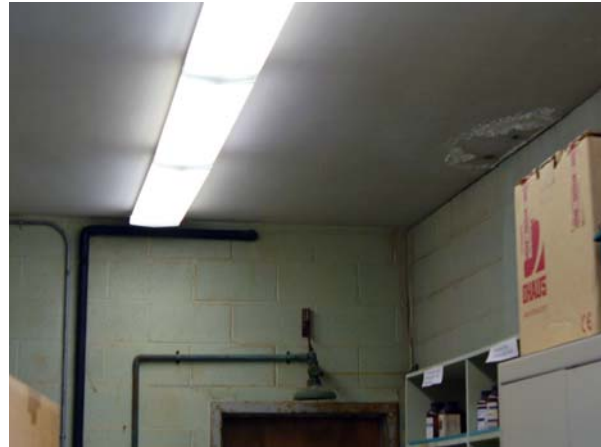
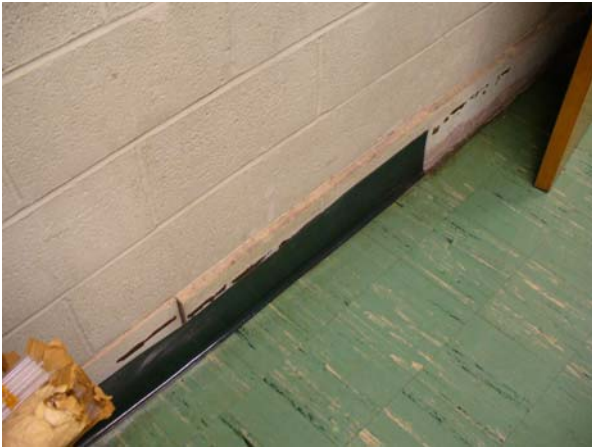
Science Wing Wall

- M: Masonry walls in the restrooms show extensive stair-step cracking at infilled openings and bearing conditions (lintels or precast slabs).
  - S, T: Masonry walls on the outside East side of the Science wing, where it meets the South Pool enclosure, show significant cracking and shifting. Walls are separated by as much as 2", and courses shift horizontally by that amount as well. Hairline cracks were widespread throughout these rooms. These may indicate a serious structural problem.

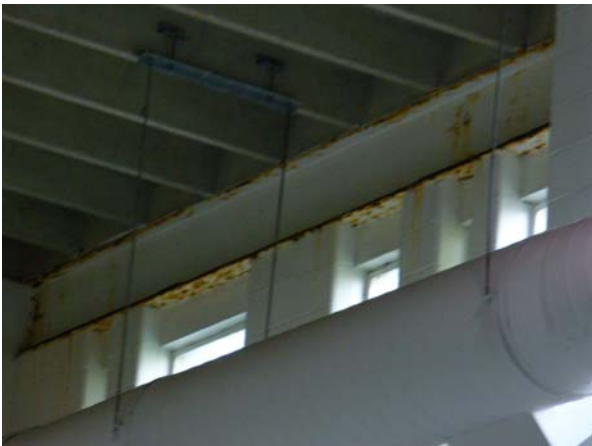
South Pool structural member

- F: Masonry walls in the South Pool are peeling and should be repainted. Elements within the window assemblies are in especially poor condition. Pilasters are typically cracked. Metal elements in the pool area, such as structural beams and access panels, have corroded surfaces and are staining adjacent walls. These elements should be cleaned, primed and painted, and the walls cleaned and painted as well. Maintenance of these finishes should be regular and ongoing.

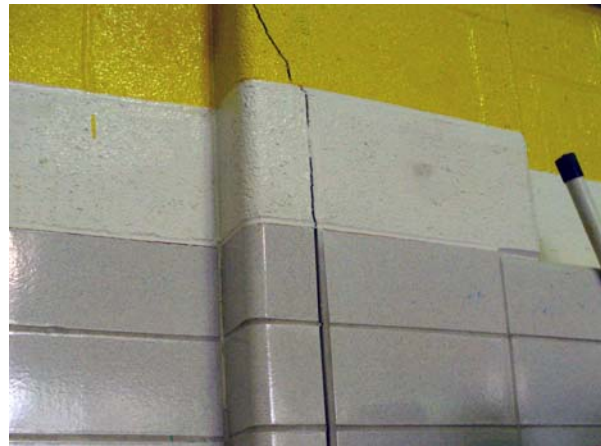
South Pool pilaster

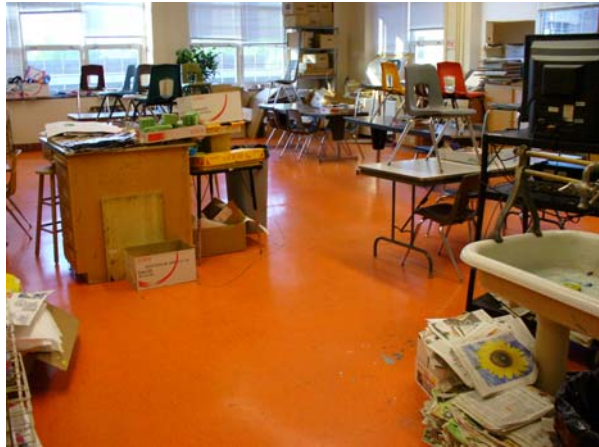
Art Classroom Vinyl Flooring

- U: VCT on this floor appears relatively new.
- Vinyl Sheet Flooring (orange) in the Art rooms is approaching the end of its useful life. New vinyl sheet flooring in the converted library Art room is in good condition.

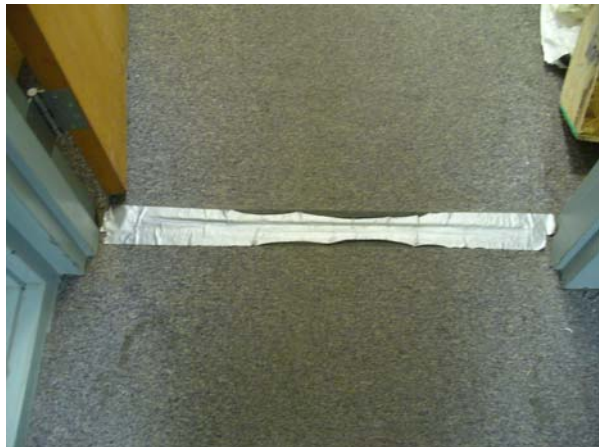
Carpet Repair

- F: Carpet in 131 A&B is worn through over many small, protruding floor repairs. This issue should be corrected, and the carpet repaired.
  - S, T: Carpet in the Science Wing stairwells needs replacement.

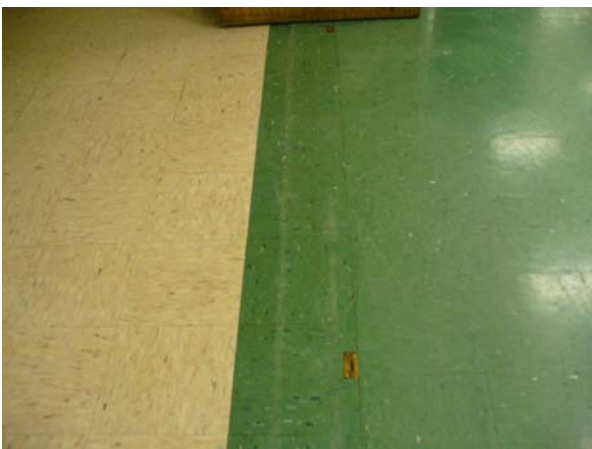
Broken VCT at Cafeteria

- Vinyl Composition Tile (VCT)
  - L: VCT occurs in very few places. Where it does, it is in poor condition, and should be replaced.
  - F: VCT in the Cafeteria is in good to fair condition, showing damage from furniture legs, and typical wear (small scuffs and stains) At the transition to the hallway, the VCT is continuously cracked, indicating a substrate problem that must be remedied before VCT is replaced.

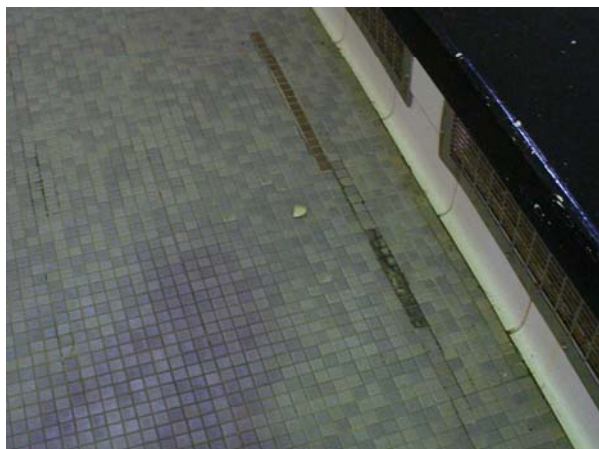
Cracked Tile at Pool

- F: The Pool Deck shows extensive previous patching. There are several areas of cracked/missing tile and grout, typically at ladder/fixture bases and in seemingly random areas throughout. Large linear cracks occur along the bench base on the east side of the pool. About 10% of the otherwise good to fair floor needs tile replacement or grout replacement. Large pools of standing water were observed along the west side of the deck.

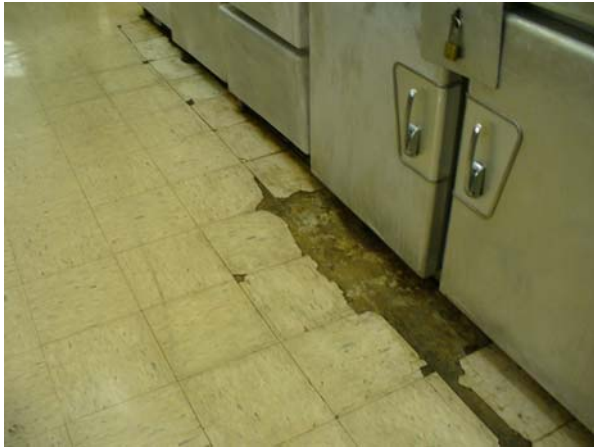
Deteriorating VCT at Kitchen

- F: VCT in the Kitchen area is in very poor condition, (discolored, broken,

mismatched) and should be replaced with a material more suitable for a harsh, high traffic environment.

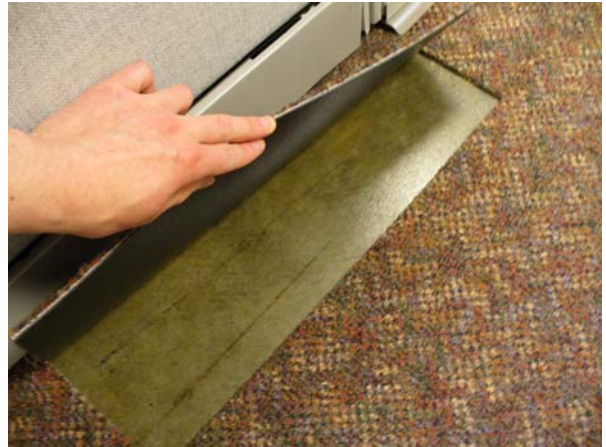
Poorly Adhered Carpet Tile in Offices

- F: Carpet tile in the Minor Band Room, Classroom 133, and the Special Education offices was improperly installed. Despite being in very good condition, it is not adhered to the floor, and shows numerous gaps between tiles. The Band Room shows poor workmanship, while improper substrates (wood, VCT mastic residue, concrete in poor condition) seem to be the cause in other cases.

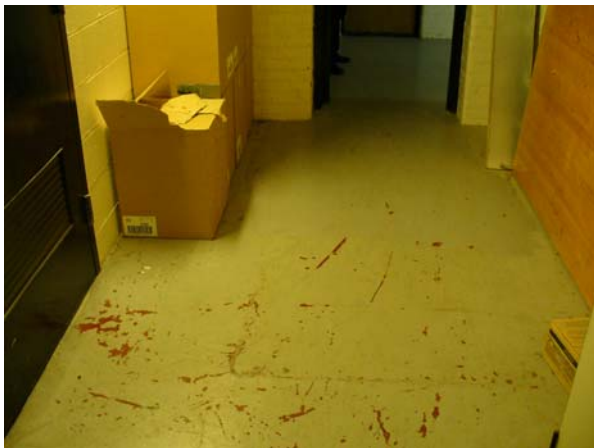
Typical Lower Level Concrete Floor

- Concrete Floors are generally sound, needing minor repair and resealing or repainting.
  - L: Concrete floors in the boiler room and adjacent areas are severely cracked and spalled. These areas should be repaired to a level condition prior to painting. The concrete hallway floor adjacent to the custodial elevator is heaving dramatically, up towards a piping trench partially covered by bent, rusting and displaced steel plates. This is unsafe, and should be remedied.

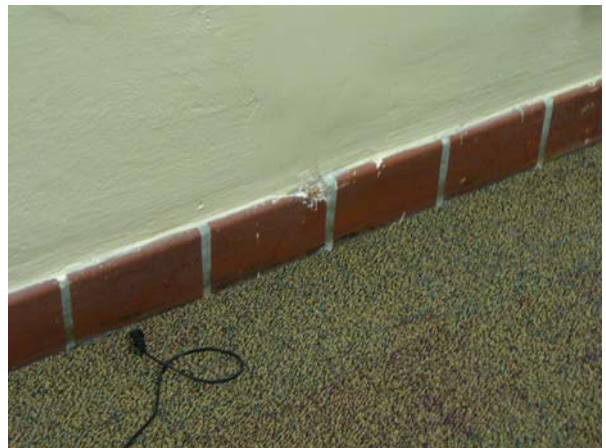
Typical Tile Base Damage

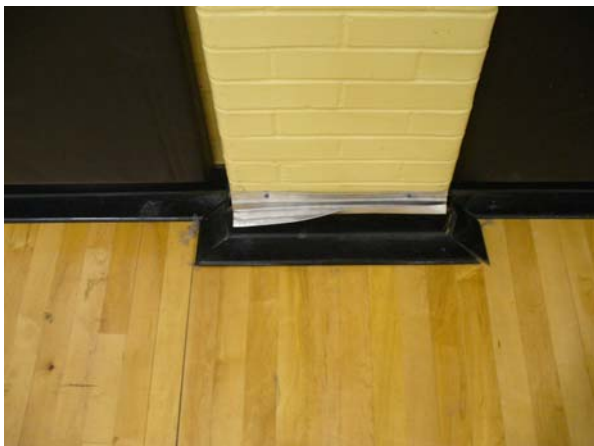
Bent Pad Track in Gymnasium

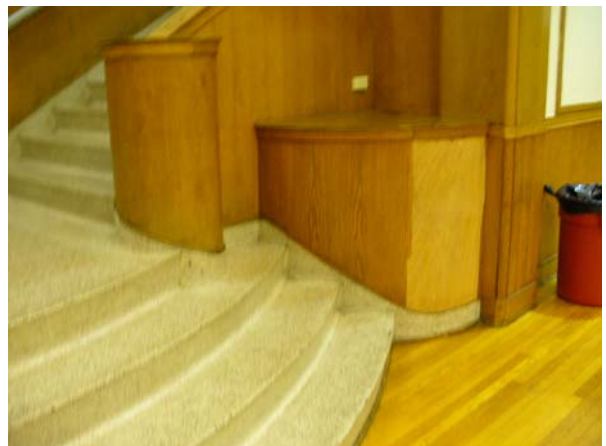
Missing Paneling in Social Room

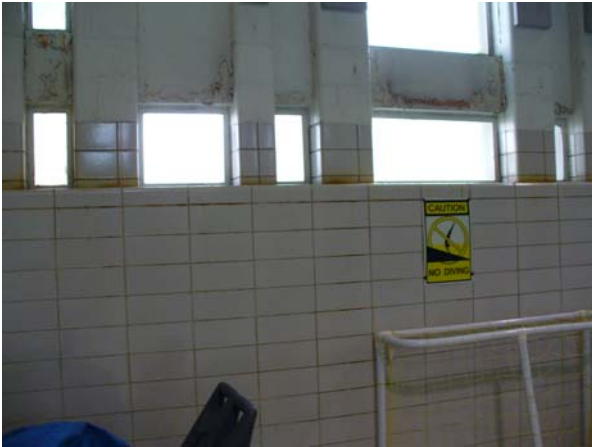
Deteriorating Window Assembly in Pool

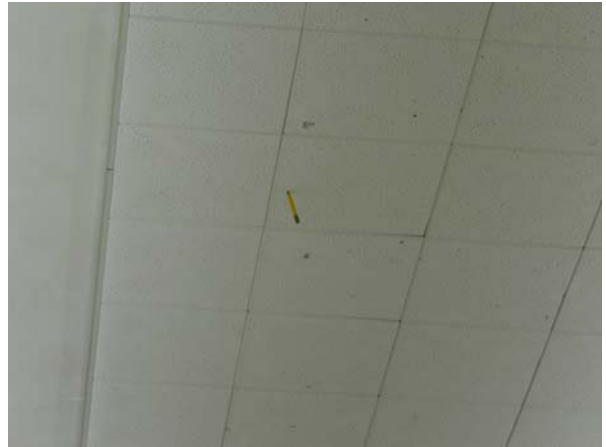
Typical Ceiling Damage

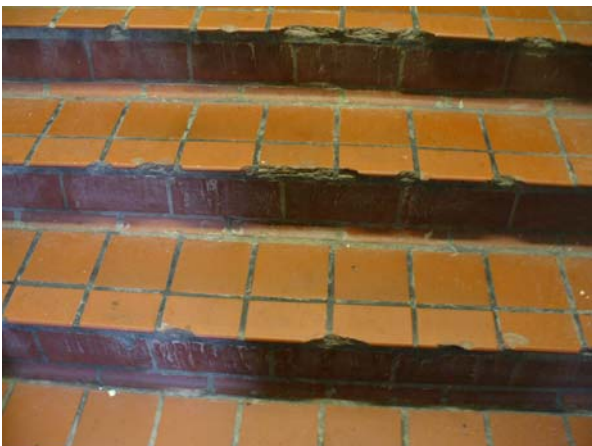
Damaged Tile Stairs

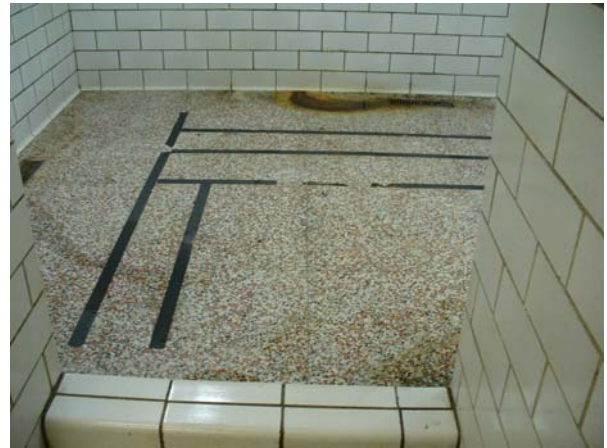
Stained Terrazzo at Girls Swimming Shower

- L: Terrazzo floors in the Girls Swimming Locker Room Showers is heavily mineral and rust stained, and should be replaced. Standing water was observed in most areas of both Swimming Locker Rooms.

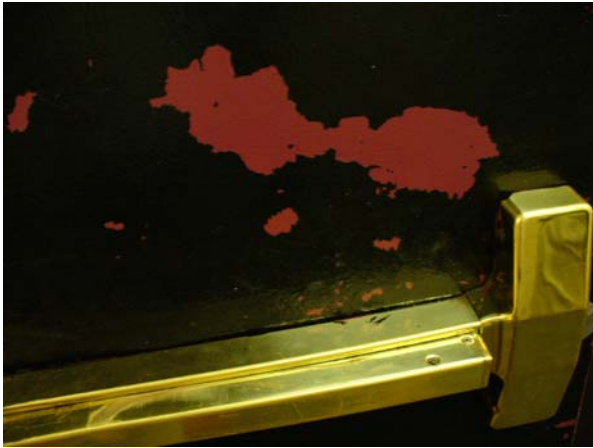
Typical Door Damage

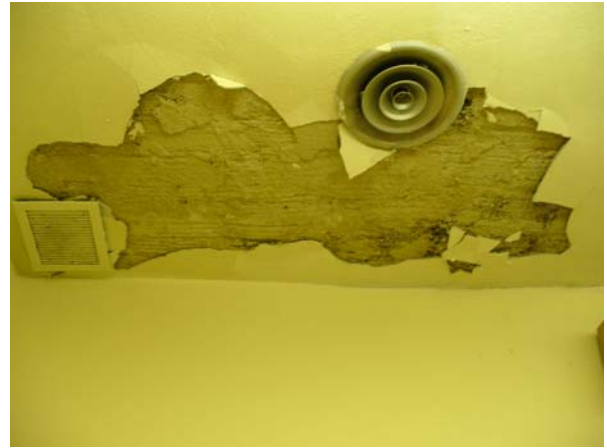
Water Damage at Ceiling

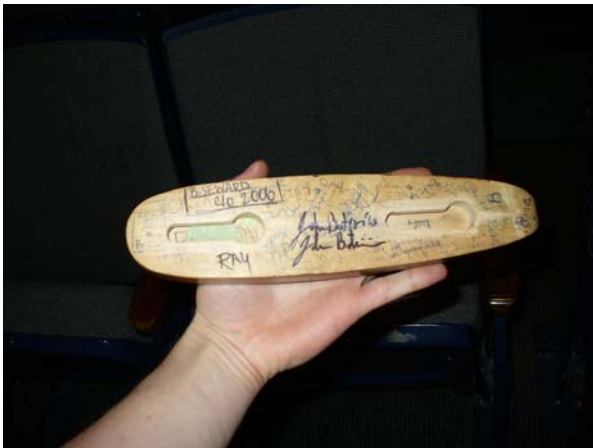
Removable Armrest at Auditorium

- Armrests on the Main Auditorium seats are easily removable. They easily fall off on their own, and are often vandalized and stolen by students. Missing armrests should be replaced, and all should be securely glued down.

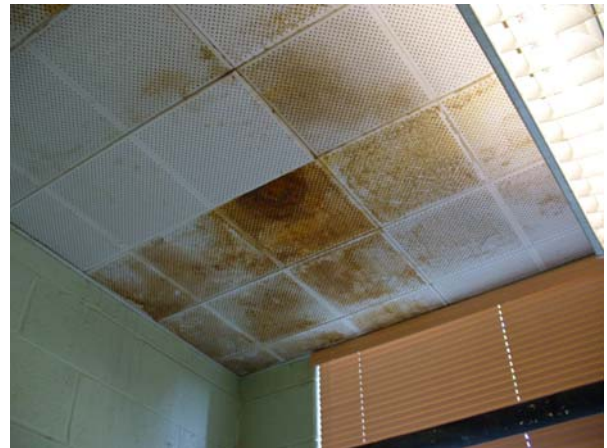
Rusted Metal Ceiling at Science Wing

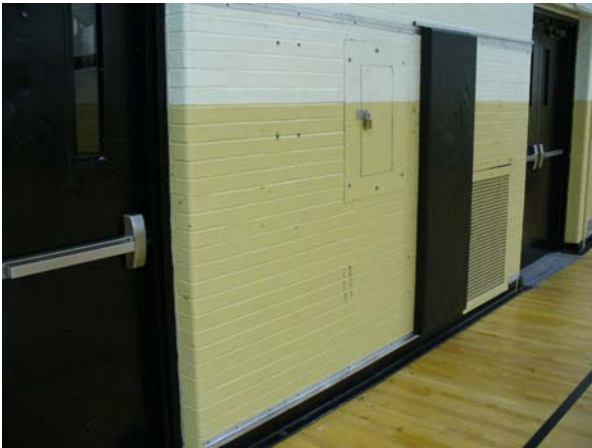
Missing Gymnasium Wall Padding

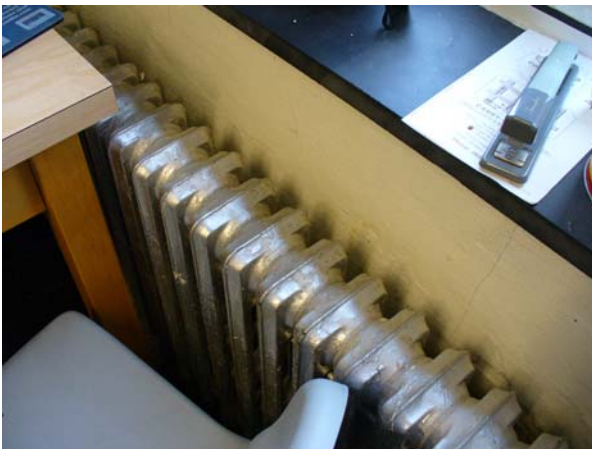
Obsolete Radiator
