2007 District Wide Facility Evaluations
Building Assessment Report

Boulevard Elementary School

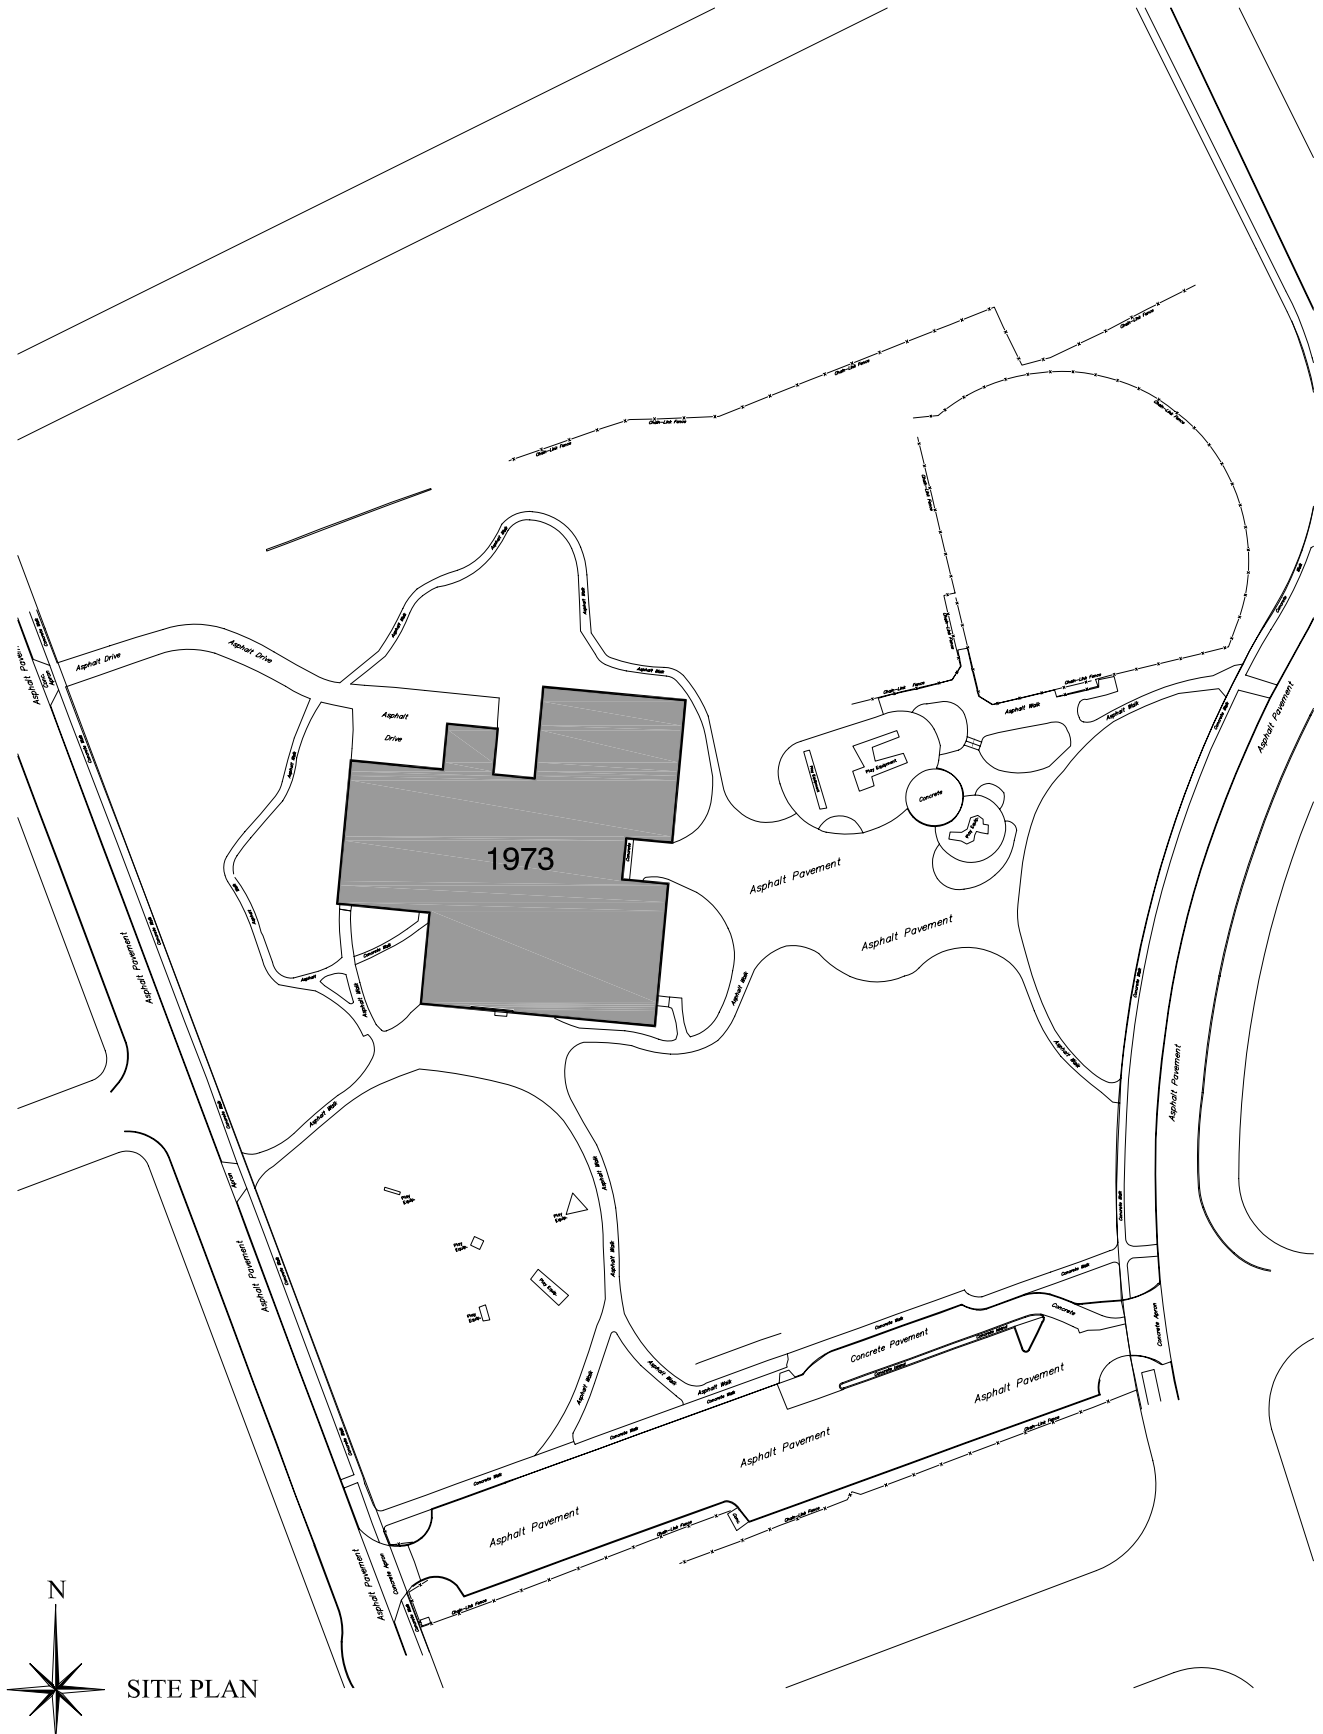
Note: Additions, renovations and repairs listed above are from CHUH original drawings. Some minor renovations and repairs may not have been listed.

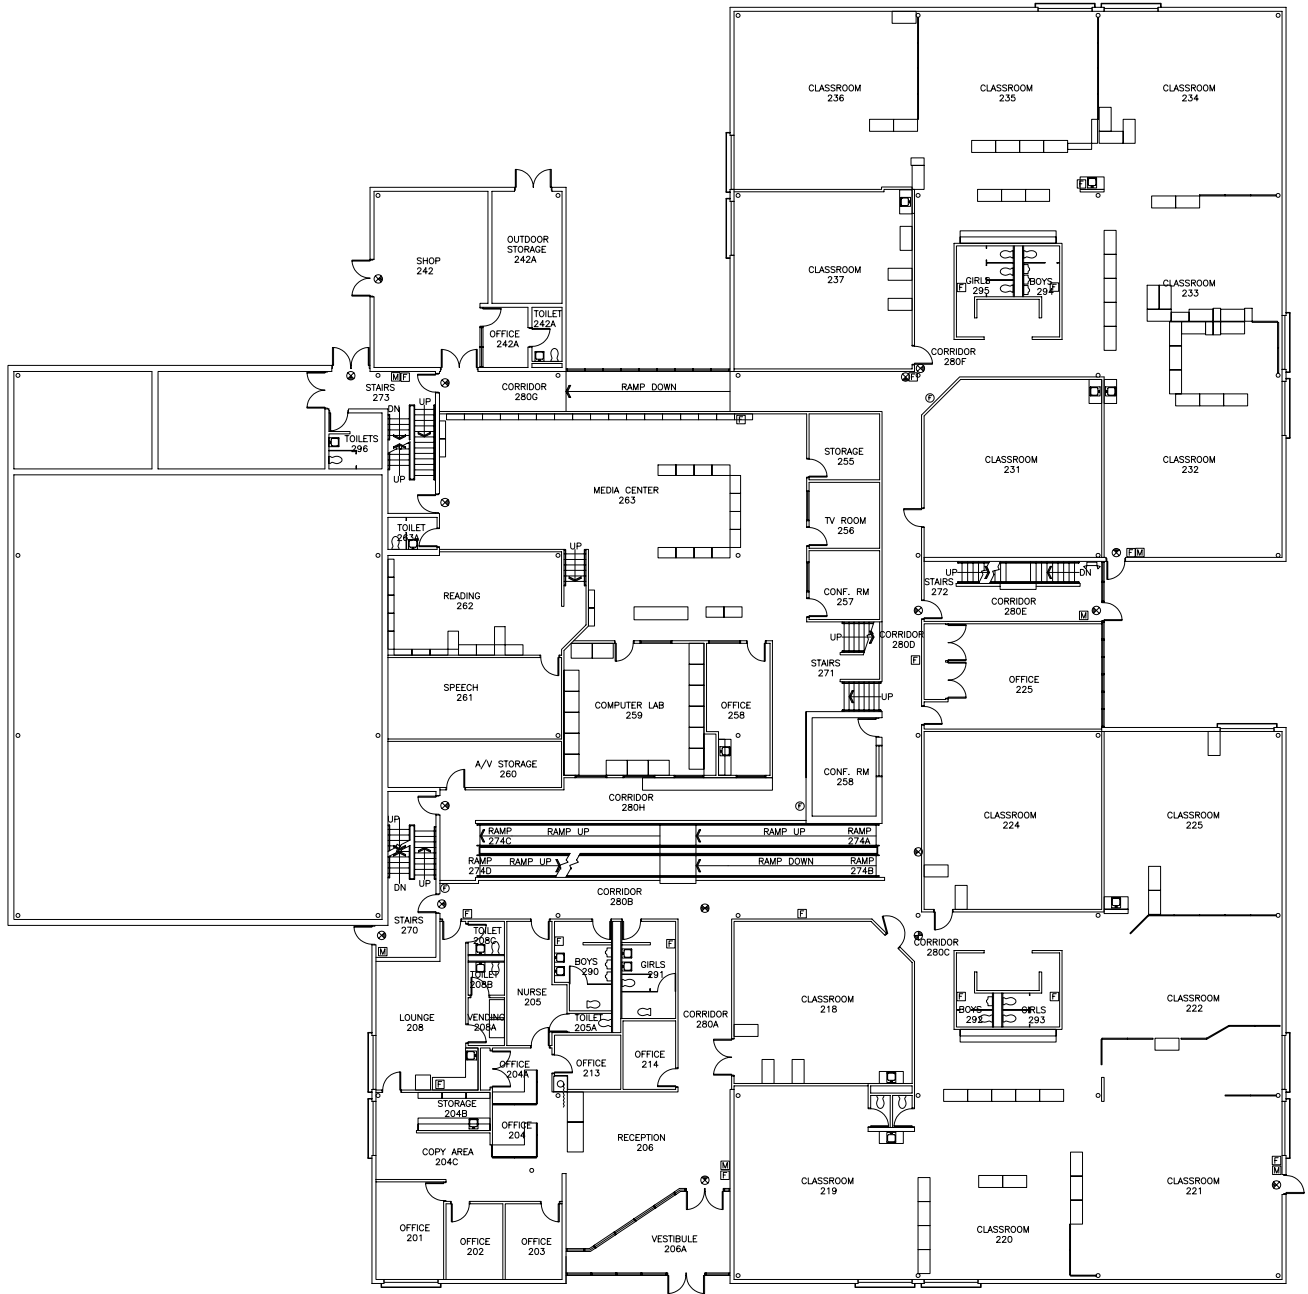
A:Hazardous Material

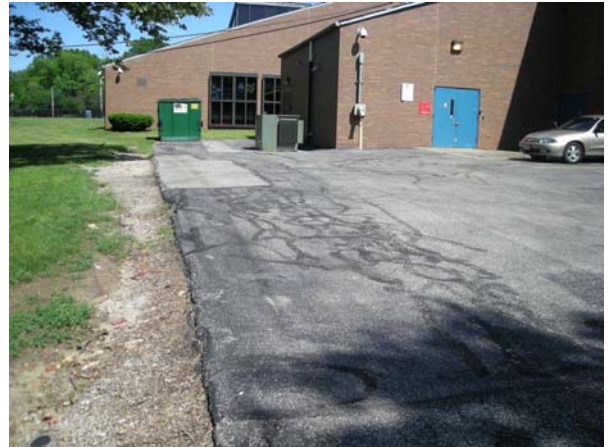
Repeatedly damaged and repaired asphalt

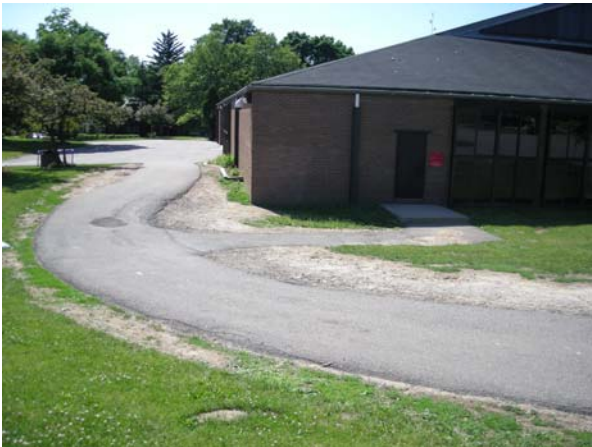
Paths and planting beds

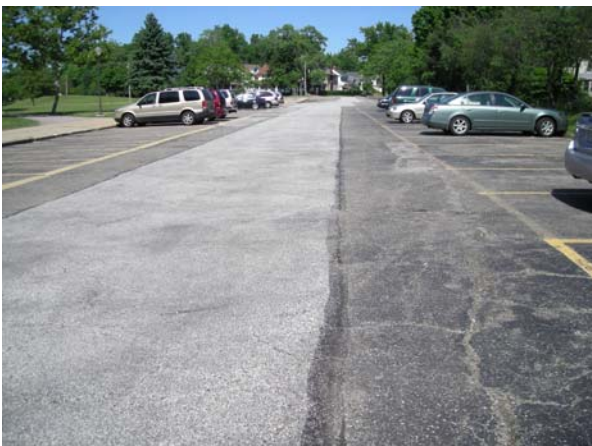
Damaged asphalt in parking lot

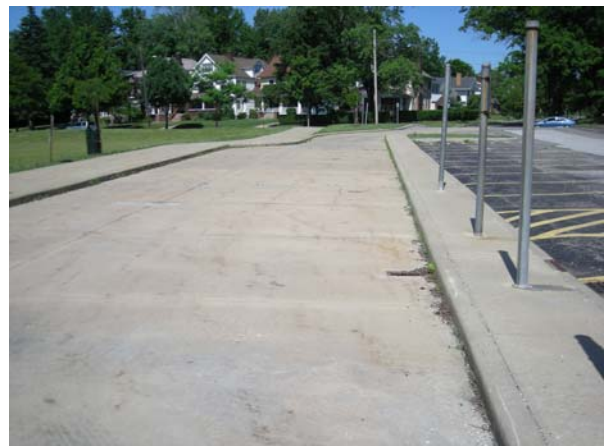
Damaged concrete at bus dropoff

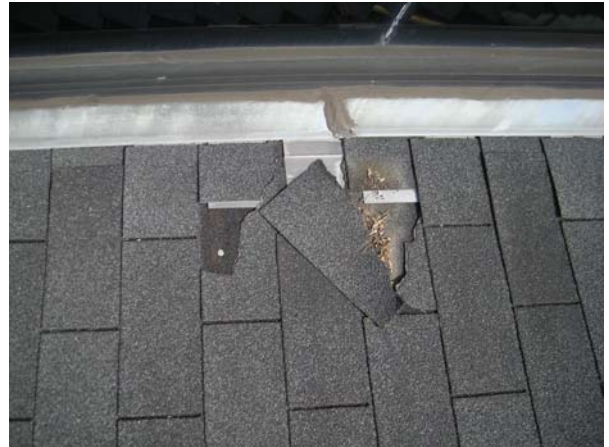
Damaged asphalt shingles

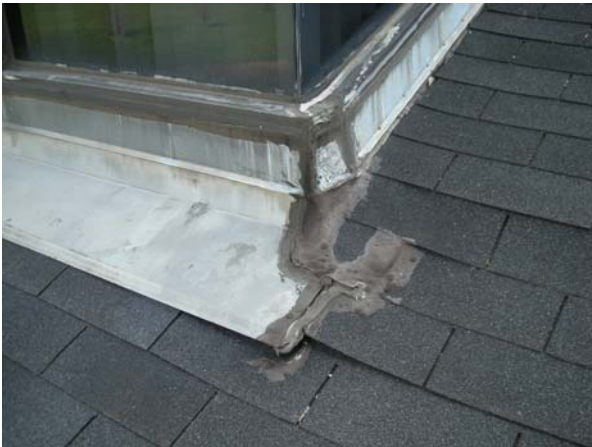
Damaged flashing and sealants

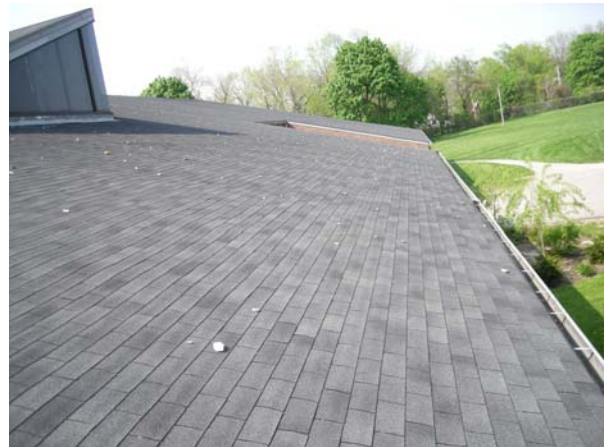
Roof deck deflection

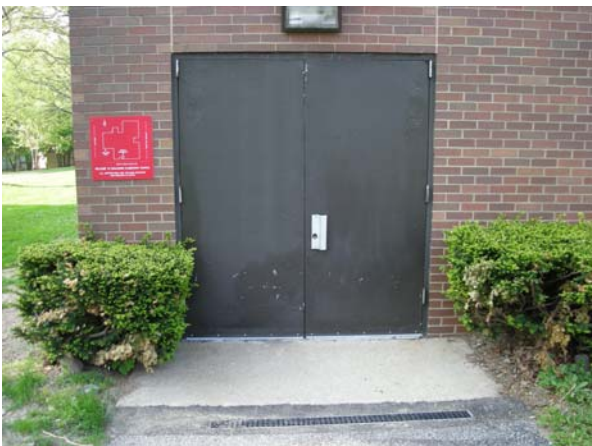
Typical exterior door condition

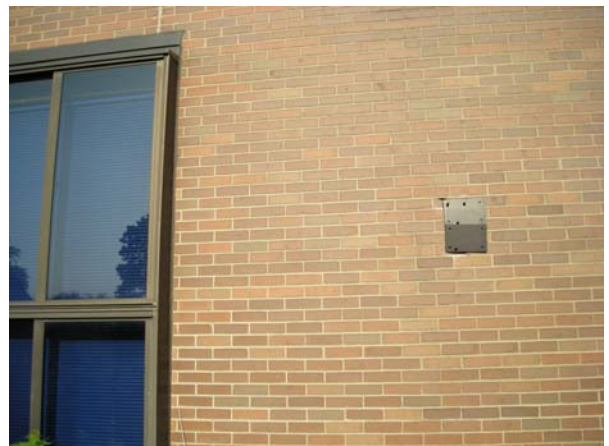
Patched exterior wall

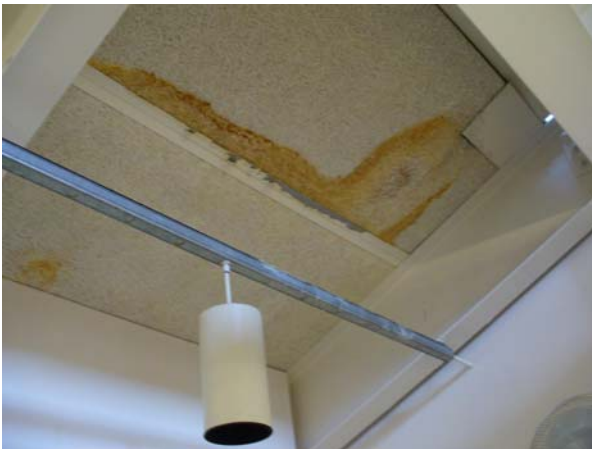
Water damage to ceiling

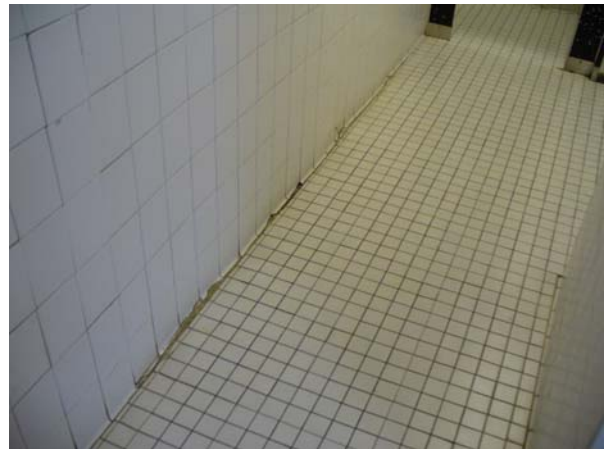
Damaged tile walls and base

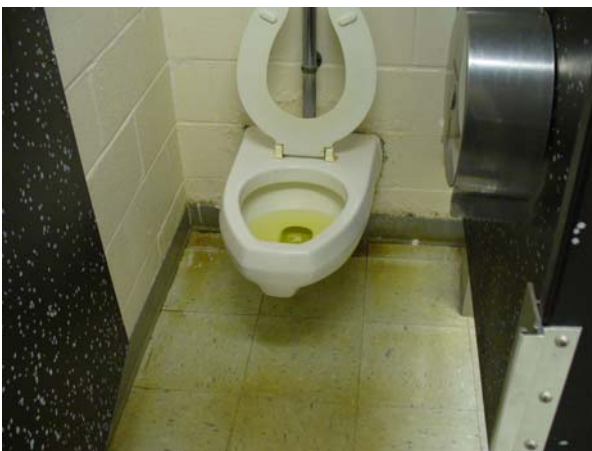
Discolored restroom VCT

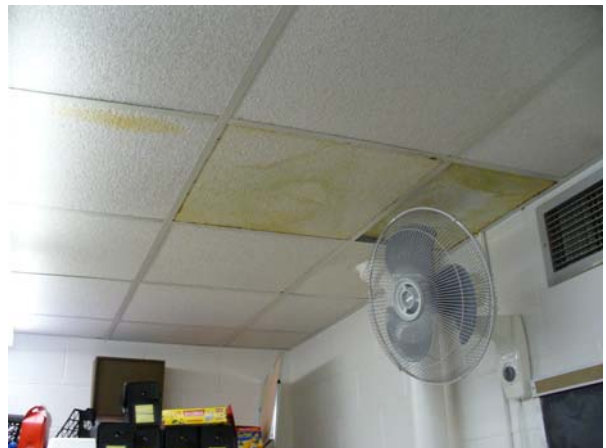
Water damage to tile ceiling

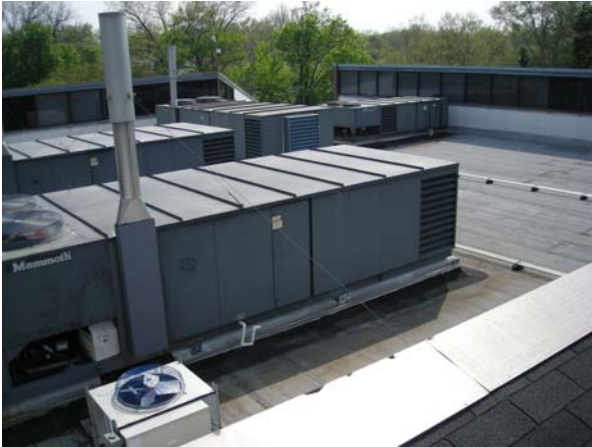
Gas Fired Multizone Rooftop Unit
