2007 District Wide Facilities Evaluation  
Building Assessment Report

# Gearity Elementary School

2323 Wrenford Rd, University Heights, Ohio

## Cleveland Heights University Heights City School District

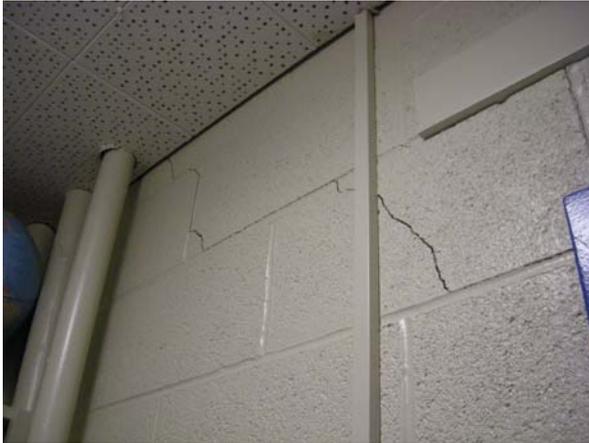
Cracking in CMU partition wall

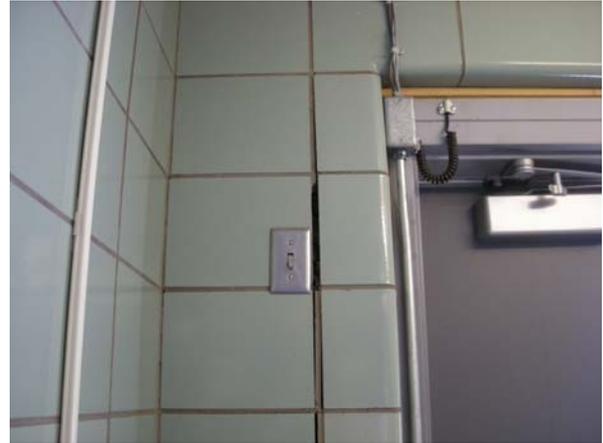
Cracking in SGFT wall

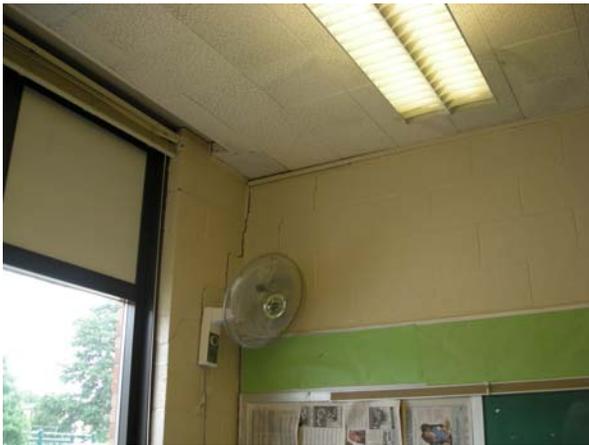
Cracking in CMU partition wall

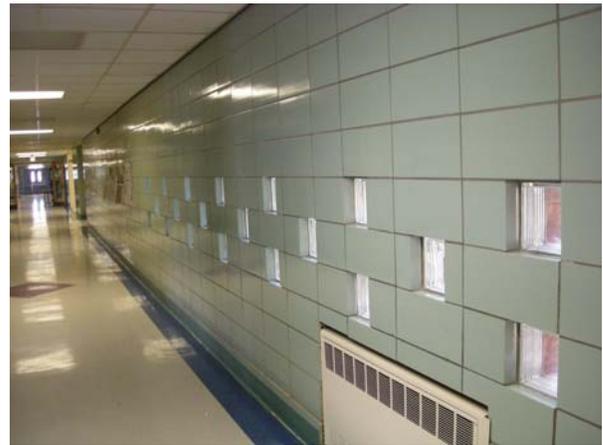
Lowest course in SGFT wall shifted

<i>Item</i>	<i>Unit</i>	<i>Qty.</i>	<i>Unit Cost</i>	<i>Assessed Cost</i>	<i>Comments</i>
Repair SGFT wall - first floor	s.f.	120	\$ 45.00	\$ 5,400.00	Lowest course kicks out into corridor. Located at exterior wall. Further structural investigation required prior to correction.
CMU partition walls cracking away from exterior wall	s.f.	200	\$ 25.00	\$ 5,000.00	Vertical separation of interior partitions from exterior walls in 1954 and 1958 addition, with cracks in partition walls. Rebuild corners and tie partition walls into exterior walls. Further structural analysis required prior to corrections.

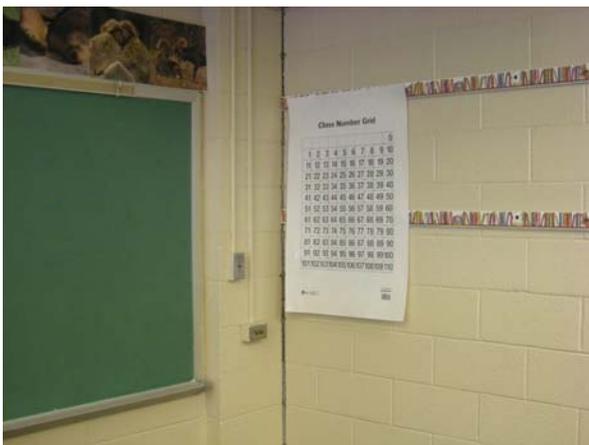
Separation of partition wall from interior wall

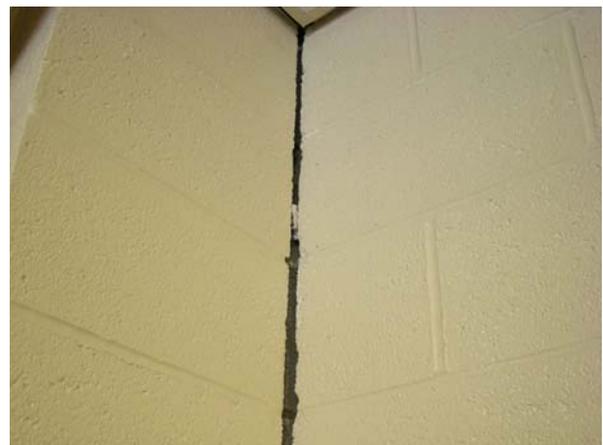
Separation of partition wall from exterior wall
