2007 District Wide Building Evaluation  
Building Assessment Report

# Noble Elementary School

1293 Ardoon Road, Cleveland Heights

July 20, 2007

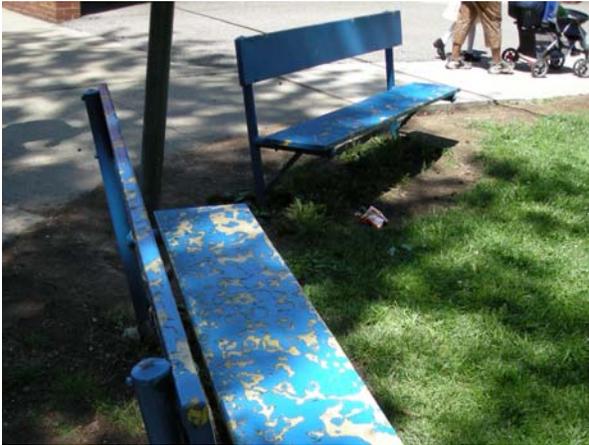
Benches Needing Replacement

- There are three main playground areas at Noble Elementary, and two auxiliary areas. The age of equipment varies considerably, but all of it appears safe and in good or better condition. Metal equipment should be repainted. Landscape timbers around all playgrounds need to be replaced.
- Site fencing is extensive and basically sound. Typical repairs needed are: intermittent post resetting or replacement, replacement of chain link mesh, and repainting. Backstops should be replaced.
- Benches outside of the main entrance should be replaced. Benches for adults are absent from most playgrounds.

<i>Item</i>		<i>Qty.</i>	<i>Unit Cost</i>	<i>Assessed Cost</i>	<i>Comments</i>
Replace bench	each	4	\$ 800.00	\$ 3,200.00	
Replace bike rack	s.f.	2	\$ 500.00	\$ 1,000.00	
<b>Subtotal Priority 3:</b>				<b>\$4,200</b>

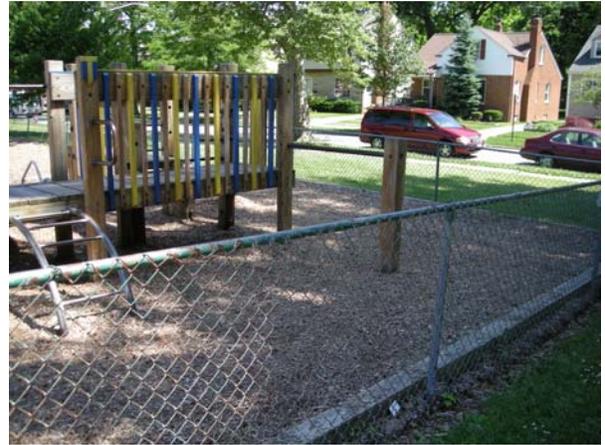
Typical Condition of Site Fence

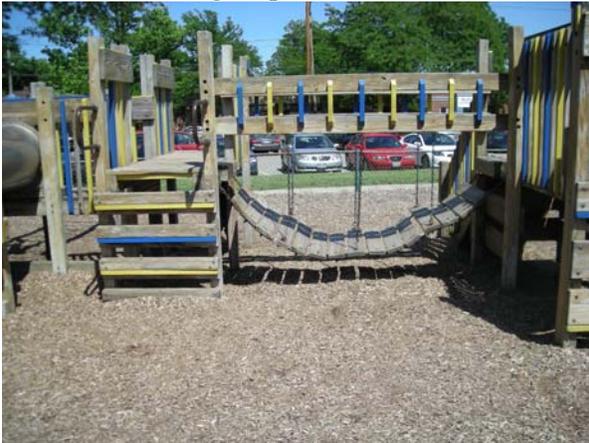
Typical Playground Equipment

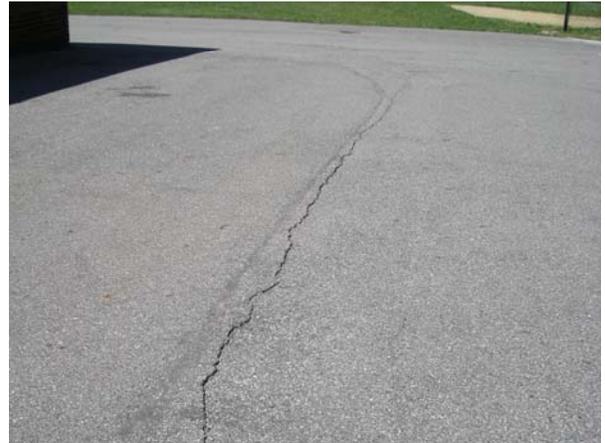
Typical Asphalt Condition

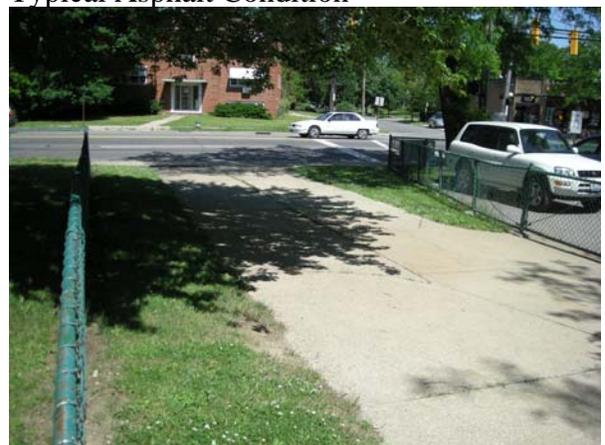
Concrete Needing Replacement

- Concrete pavements (walks) are generally in good condition, with selective repair needed. Walks between the parking lots and along the staff parking lot should be replaced.
- Concrete curbs are generally in good condition.
- Asphalt pavement is extensive, and in fair condition. A new wear layer should be applied, and markings repainted. Asphalt in the parking lots is in good condition.
- Bike racks need to be replaced and anchored into the pavement.

<i>Item</i>		<i>Qty.</i>	<i>Unit Cost</i>	<i>Assessed Cost</i>	<i>Comments</i>
Selective replacement of concrete pavement	s.f.	3,742	\$ 5.00	\$ 18,710.00	Cracks, chips
Replant bed	lump	1	\$ 1,750.00	\$ 1,750.00	
Asphalt new wear layer	s.f.	49,746	\$ 1.25	\$ 62,182.50	Damage to top layer only
Restripe Pavement	lump	1	\$ 5,200.00	\$ 5,200.00	Faded striping, recoated asphalt
Repair fence	l.f.	1,620	\$ 5.00	\$ 8,100.00	Reset/replace posts, painting
Replace chain link panel	s.f.	6,407	\$ 3.00	\$ 19,221.00	
Replace backstop	l.f.	60	\$ 2,500.00	\$ 150,000.00	Baseball backstop rusted, leaning
Replace landscape timber	l.f.	1,065	\$ 5.00	\$ 5,325.00	Deteriorated, out-of-place
<b>Subtotal Priority 2:</b>				<b>\$270,489</b>

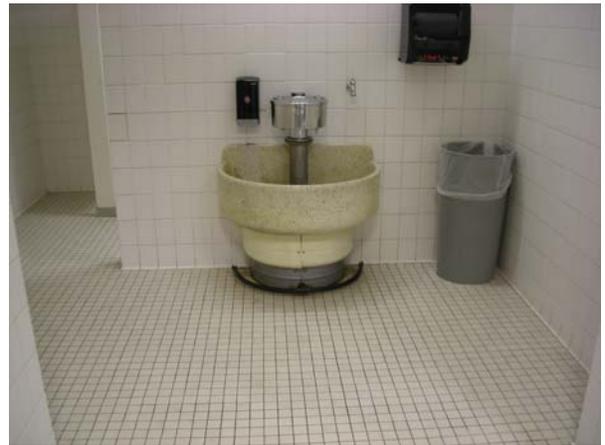
Restroom Fixtures and Accessories

- There are no ADA-compliant toilet stalls in Noble Elementary School.
- Group sinks are inaccessible semi-circular wash fountains. These sinks are typically in poor to fair condition, with significant staining and rusting at metal bottoms.

<i>Item</i>	<i>Unit</i>	<i>Qty.</i>	<i>Unit Cost</i>	<i>Assessed Cost</i>	<i>Comments</i>
ADA- Provide accessible toilet stalls	each	10	\$ 1,200.00	\$ 12,000.00	All Group Restrooms.
ADA - Provide accessible restroom sinks	each	10	\$ 750.00	\$ 7,500.00	Where accessible stalls are provided
ADA - Provide accessible drinking fountains	each	4	\$ 2,500.00	\$ 10,000.00	Minimum 1 per floor. Locate central to student areas.
ADA - Provide accessible toilet room	each	9	\$ 17,000.00	\$ 153,000.00	At existing noncompliant toilet room
ADA - Replace interior signage	bldg s.f.	77,612	\$ 0.11	\$ 8,537.32	At all rooms. Rehang existing egress diagrams
ADA - Provide new elevator and hoistway	each	1	\$ 165,000.00	\$ 165,000.00	Access lower and second floors
ADA - Install platform lift	each	1	\$ 18,000.00	\$ 18,000.00	At stage
ADA - Replace inaccessible door hardware	each	11	\$ 450.00	\$ 4,950.00	Knobs and thumb levers

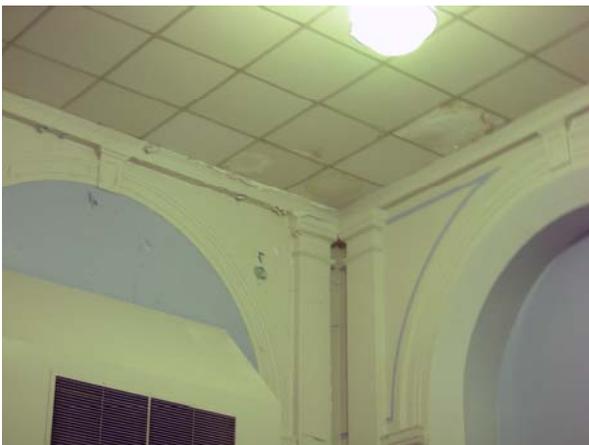
Plaster Damage in Cafeteria

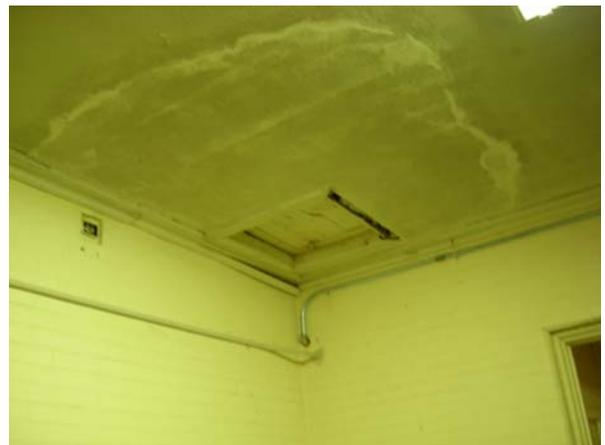
Plaster Damage in Basement

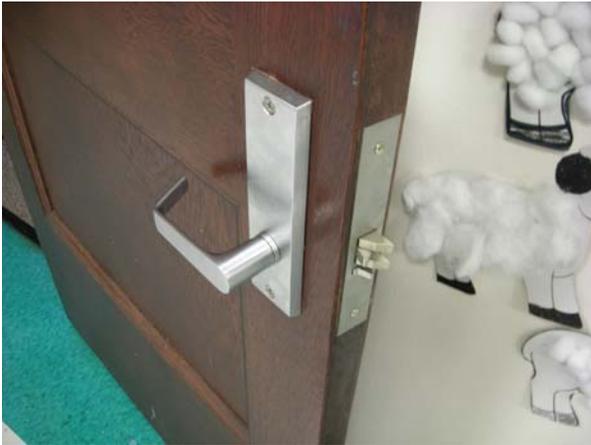
Retrofitted Door

- Drinking fountains at the school are not handicapped accessible.
- Many of the original wood doors within Noble Elementary School have been retrofitted with accessible lever type hardware. This work included installation of new strike plates at existing wood frames. Hardware is in good condition, though some doors and frames were aesthetically damaged during this retrofit.

Repair minor damage to wood doors	each	4	\$	50.00	\$	200.00	Broken glass, loose or missing muntins.
Replace wood door	each	2	\$	750.00	\$	1,500.00	Gouges, poor retrofitting
Replace metal frame and metal door	each	2	\$	765.00	\$	1,530.00	Gouges, dents, poor retrofitting
Replace metal frame and wood door.	each	3	\$	865.00	\$	2,595.00	Gouges, denting, poor retrofitting
Subtotal Priority 2:						\$123,385

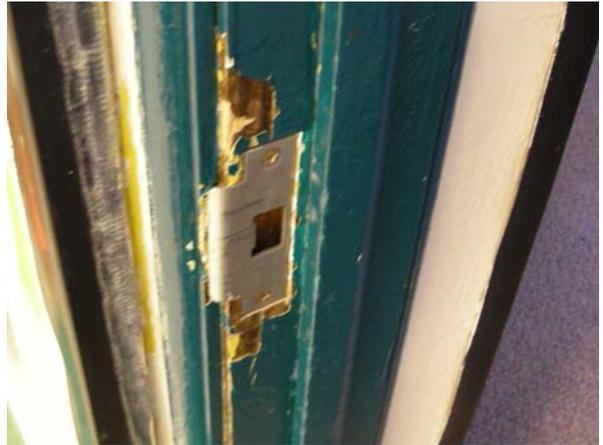
Retrofitted Frame

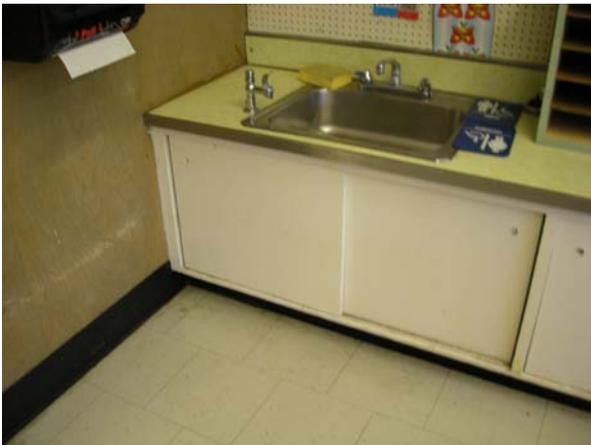
Obsolete Casework - Kindergarten

- Lower level casework should be replaced at the bottom of the main stairwells and at some storage rooms.
- At the first floor 1954 addition, cubbies and shelving should be replaced, as well as sink base cabinets and other casework as noted. Other areas of the first floor should have casework replaced as noted.
- Second floor casework should be replaced at the former stage, the kitchen and at other miscellaneous areas.
- The condition of modular tan-colored casework also varies by location, but is generally in the fair-to-good range.

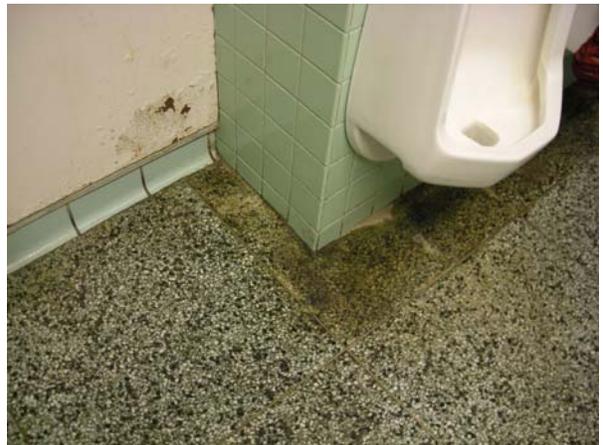
Damaged Terrazzo and Access Panel

- Terrazzo flooring occurs at the 1954 addition corridor and toilet rooms. Terrazzo flooring has significant discoloration at some areas of the toilet rooms (adjacent to some fixtures, beneath radiators) and at the floor/base intersection at corridors, but the floor itself is structurally sound with minimal cracking. Terrazzo flooring also occurs in the basement of the north and south stairwells of the 1921 original building. The floor at the south stairwell has many cracks and some holes, and should be repaired. The north stairwell basement floor is in better shape, but still has some cracks. Both of these floors are very discolored.

<i>Item</i>	<i>Unit</i>	<i>Qty.</i>	<i>Unit Cost</i>	<i>Assessed Cost</i>	<i>Comments</i>
Replace carpet	s.y.	426	\$ 27.00	\$ 11,490.00	Stained, frayed
Repair and Refinish terrazzo	s.f.	920	\$ 11.00	\$ 10,120.00	Small cracks/chips, dulled finish
Repair and repaint/reseal concrete floor - fair condition	s.f.	3,250	\$ 1.50	\$ 4,875.00	Small cracks/chips, loss of finish
Repair and repaint/reseal concrete floor - poor condition	s.f.	2,430	\$ 7.00	\$ 17,010.00	Cracks, spalling, general surface deterioration
Spot repair ceramic tile base	l.f.	70	\$ 11.00	\$ 770.00	All toilet rooms

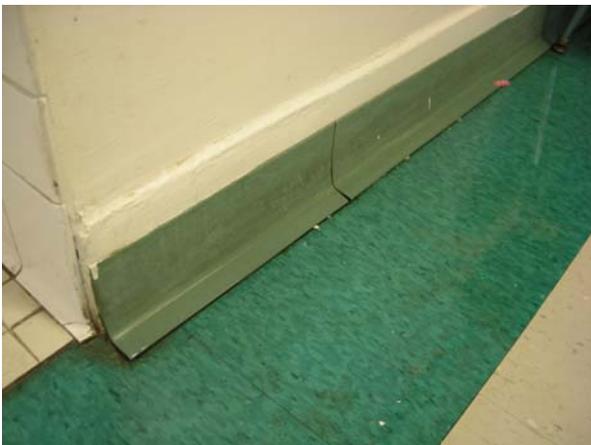
Vinyl Base

- Wood base at the 1921 original building and 1925 addition is generally in fair condition - sound, but dented with some scraped paint.
- Much of the existing vinyl base is in fair condition. However, vinyl base at first floor corridors, the gymnasium and some stairwell locations is in poor condition and should be replaced.
- Carpet base is generally in good condition. Carpet base at the second floor corridor requires some reattachment and spot repair.
- Ceramic tile base occurs at toilet rooms. Some of this base is cracked and should be replaced.

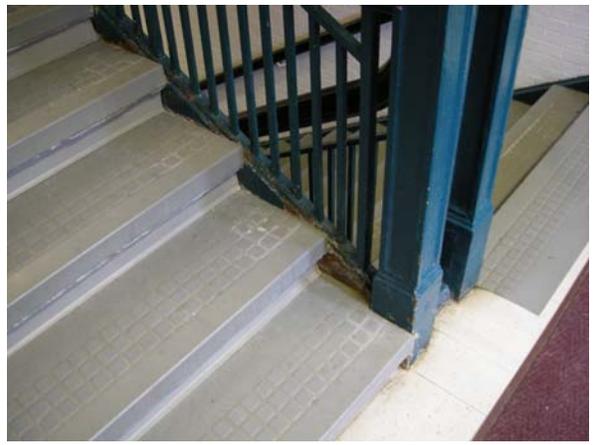
Staircase Corrosion

- Corrosion was observed at some stair treads, risers and stringers at the 1921 original building. Surface corrosion should be cleaned, primed and painted. More extensive rusting of these stair components should be repaired.
- Painted steel at stairs (treads, risers, stringers, pickets, etc.) is chipped and should be repainted.

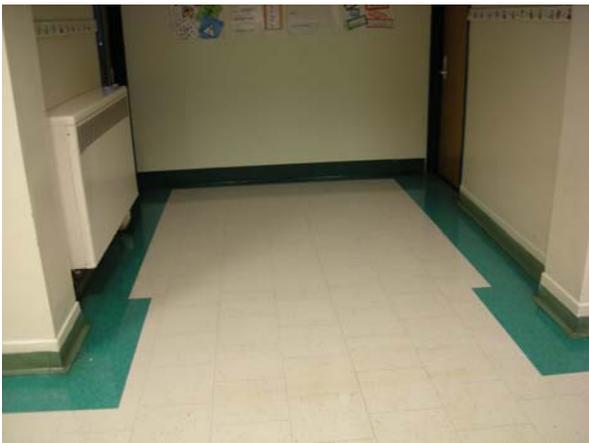
Unit Ventilator in Corridor

- Investigate/repair 1954 building air handling unit's control dampers that don't control properly.
- The outside air ventilation rates designed into the 1982 unit ventilators is close to current code requirements, but the unit ventilators exceed 30 years old and warrant replacement.. Cost estimates are included to replace the unit ventilators.
