2007 District Wide Facility Evaluations  
Building Assessment Report

# Oxford Elementary School

939 Quilliams Rd, Cleveland Heights, Ohio

July 20, 2007

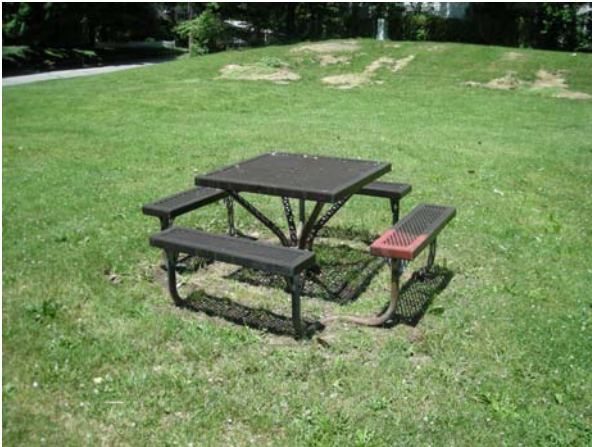
Typical Condition of Site Furnishings

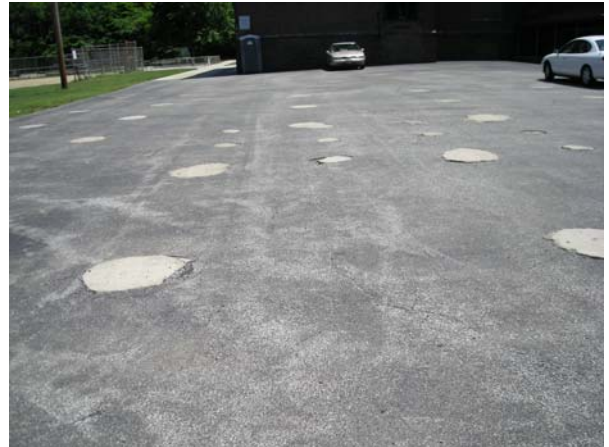
Patches in Bus Parking

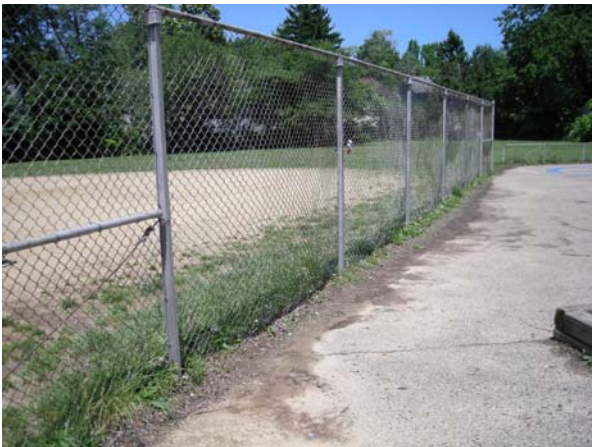
Typical Condition of Site Fencing

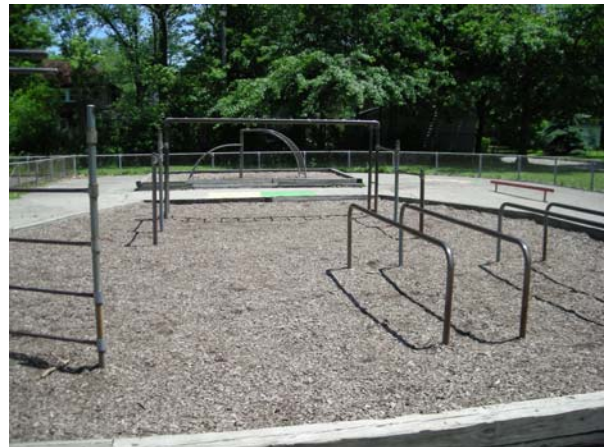
Older Playground Equipment

- The main playground equipment is in good condition, with minor repainting needed. The equipment on the north playground is old but sound, needing minor repair and repainting. The South playground equipment appears unsafe and should be replaced. All landscape timbers should be replaced.
- The suite of benches and picnic tables on the West end of the site should be replaced. All benches associated with the Playgrounds should be replaced.
- Fencing needs intermittent post repair/replacement, new chain link, and painting.
- The backstop in the west asphalt play area should be removed. The Backstop in the grass field should be replaced.

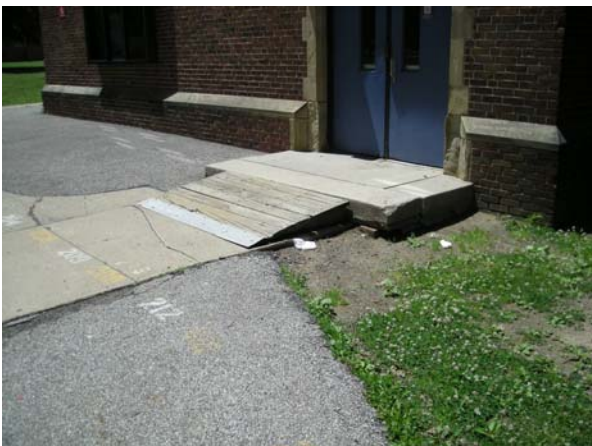
Noncompliant Wheelchair Entry Ramp

5.	Is there a ramp or curb cut from the parking to an accessible building entrance?		✓		Ramp is improperly designed
6.	If the main entrance is inaccessible, are there alternate accessible entrances?		✓		Designated entrance is not ADA compliant

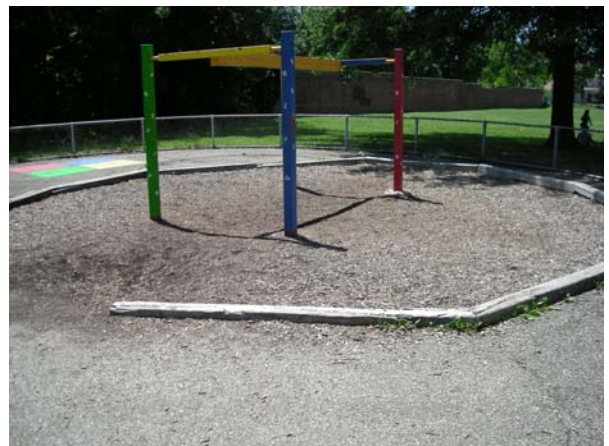
Older Playground Equipment

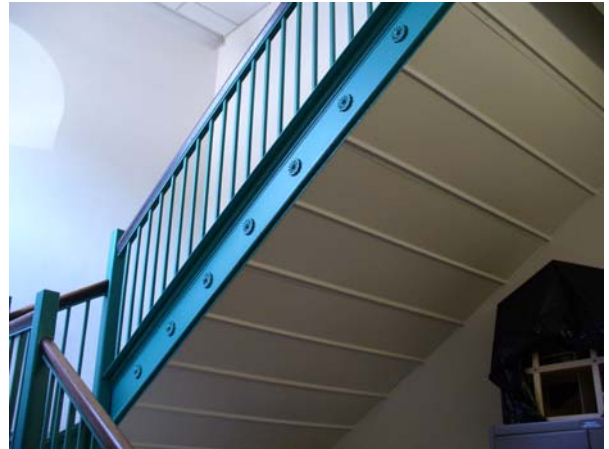
Decorated Stair Stringer

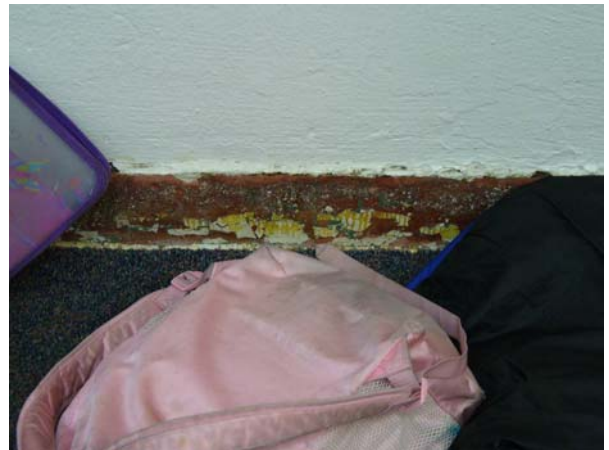
Damaged Carpet Base

- Carpet base is generally in fair condition. In first floor corridors, the solid-colored border is run up the wall as a base. The adhesive in these areas has failed completely. The lower level corridor carpet base is coming off the wall and is damaged, and should be replaced. The top of the base in the second floor corridors shows consistent minor fraying.

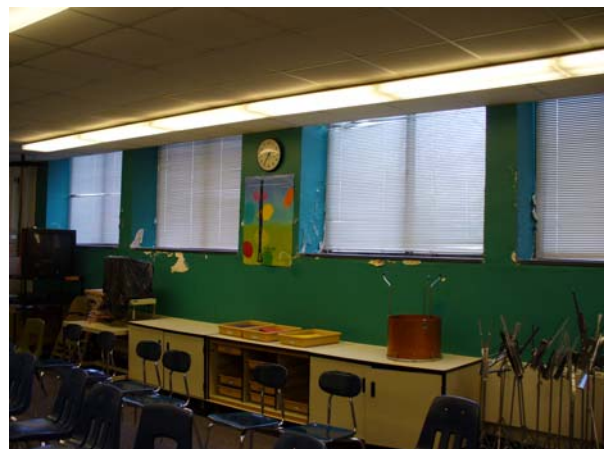
Water Damage in Music Room

- Significant water damage was observed at exterior walls in many second floor rooms, and along the entire outside wall of the Music room at the lower level.

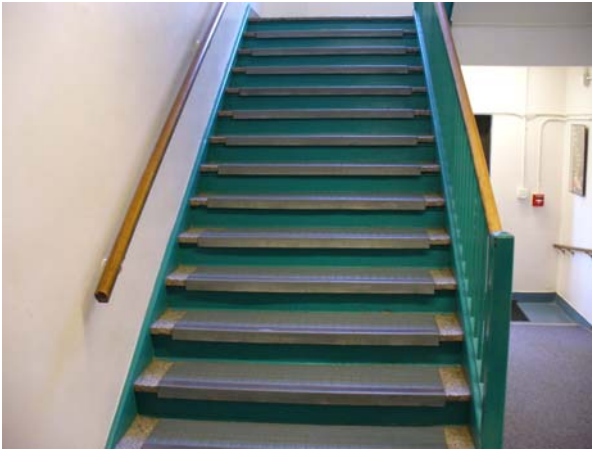
Rubber Stair Treads

- Terrazzo at the stairwells is discolored but generally in good condition where exposed. It is generally covered by discolored and dirty, but otherwise functional, rubber treads and nosings. Terrazzo treads at the central basement stair are uncovered, and show deterioration along the back edge. The bathroom at the second floor workroom has a terrazzo floor in worn, but good, condition.

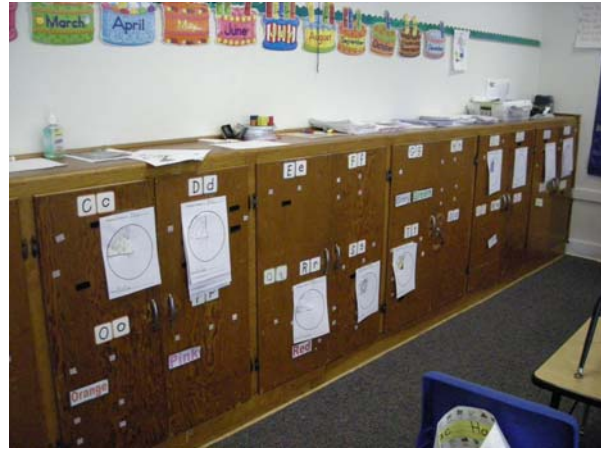
Obsolete Casework in Kindergarten

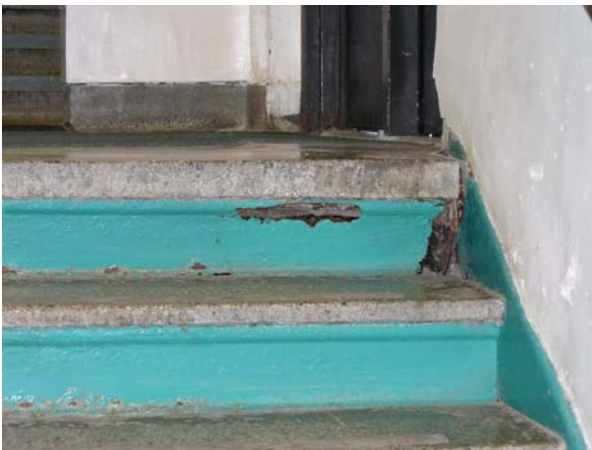
Corrosion on Metal Stairs

- In the custodial area, three steel stair treads are broken and should be replaced.
- Corrosion exists at steel stair stringers and risers at some locations. Surface corrosion should be cleaned, primed and painted. More extensive rusting of these stair components should be repaired.
- A wood handrail on the lower portion of the east stair is split and should be replaced. Another wood handrail in the north stair has apparently been patched. This rail is not

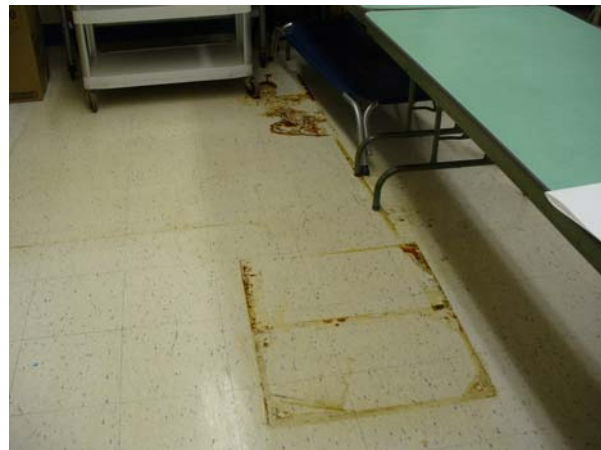
Damaged Kitchen VCT

- VCT is generally in fair to good condition, with some areas somewhat scuffed but serious problems relatively uncommon. Noticeable discoloration at the stairwells is present. VCT in the kitchen shows significant damage and discoloration in specific areas. Where VCT is present in restrooms it is typically extremely discolored around and behind fixtures.

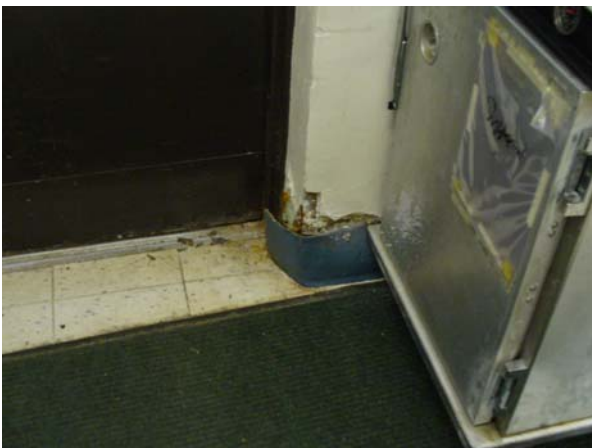
Wall Damage in Kitchen Receiving

- Walls in the Kitchen show significant water damage, especially around sinks and immediately above base. Walls in the areas behind the Kitchen have intermittent apparent water damage up to 20" (approximately) from the floor. Outside corners are consistently gouged and chipped. Several corners at the floor are severely damaged, notably at the exterior door frame.

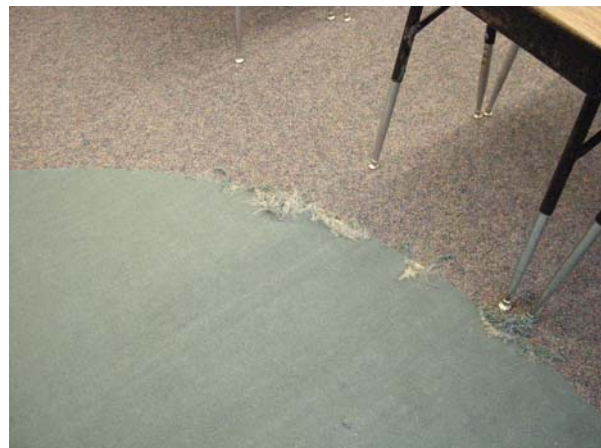
Frayed Classroom Carpet

- Carpet in the building is generally in fair-to-good condition and is beginning to show wear, especially in corridors. Where there are carpet patterns, the seams consistently show fraying.

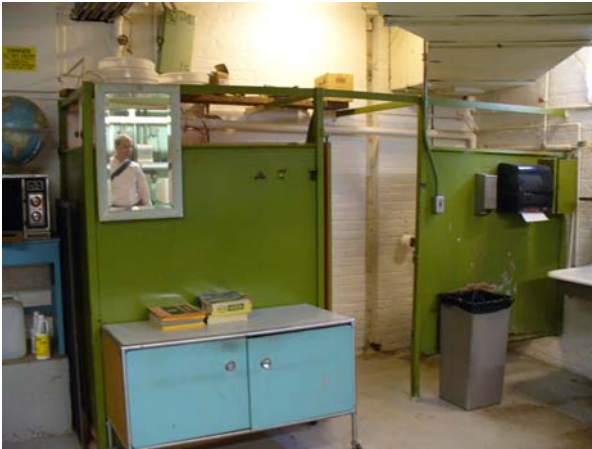
Custodial Office Partition and Furniture

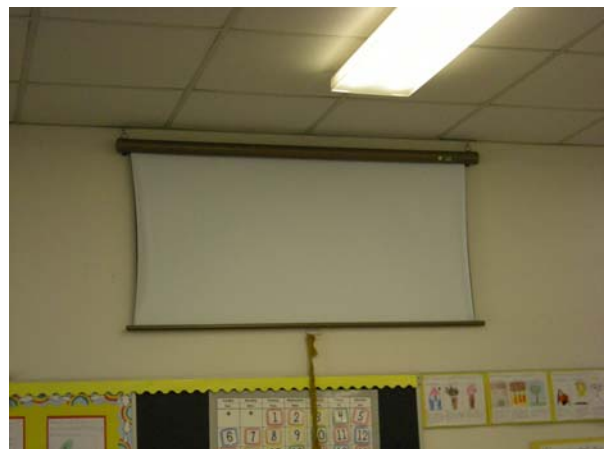
Projection Screen

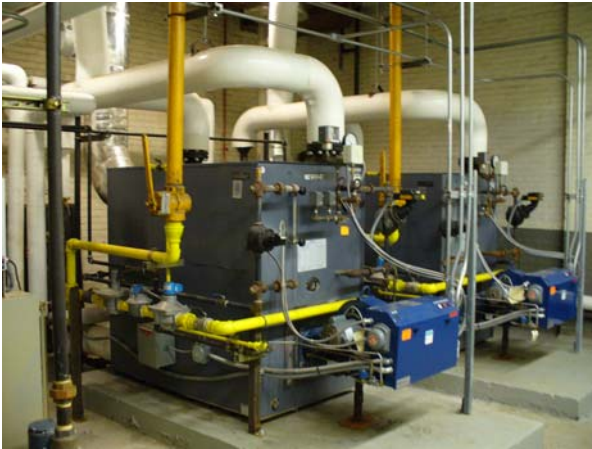
Boilers

- The building is heated by two steam boilers, which replaced the previous boilers in 2003. Steam heating coils are located in the gym air handling unit and original building unit ventilators and 1929 addition unit ventilators.

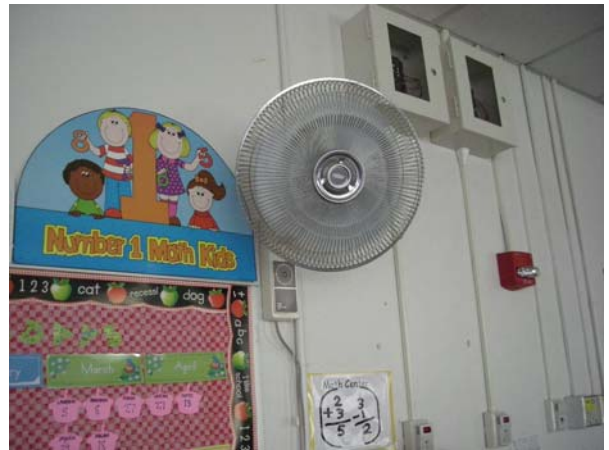
Wall Mounted Classroom Fan

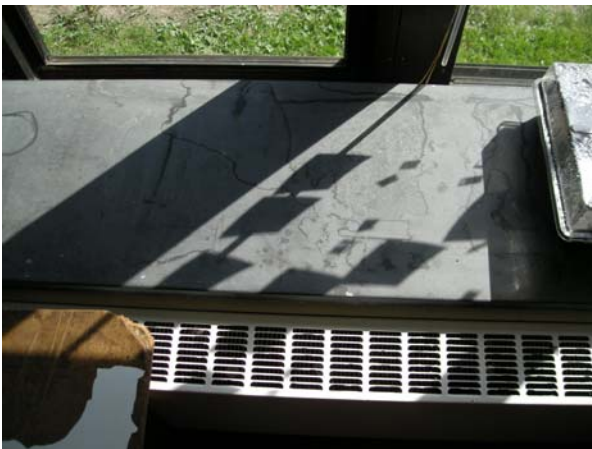
Fin Tube Enclosure at Windowsill
