2007 District Wide Facilities Evaluation
Building Assessment Report

Roxboro Elementary School

2405 Roxboro Rd, Cleveland Heights, Ohio

July 20, 2007

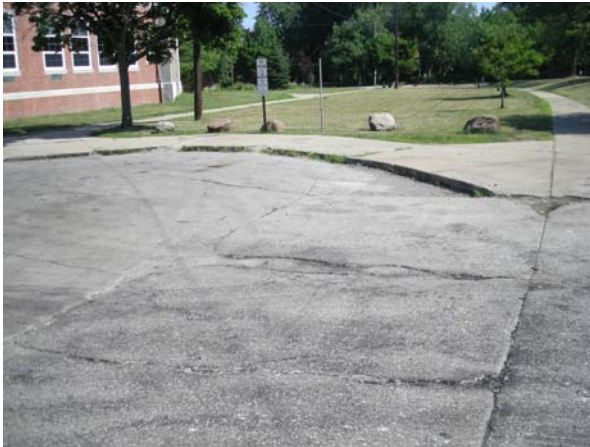
Deteriorating pavement and curbs

- Concrete pavements (walks) are in fair condition, with many areas requiring replacement.
- Concrete curbs are generally in fair-to-good condition. Spot cracked curbs replacement is required.
- Existing asphalt parking lot areas have recently been resurfaced and restriped.
- The asphalt play area should be resurfaced and restriped.
- New brick pavement occurs in the gazebo area

<i>Item</i>		<i>Qty.</i>	<i>Unit Cost</i>	<i>Assessed Cost</i>	<i>Comments</i>
Selective replacement of concrete walk	s.f.	6,271	\$ 5.00	\$ 31,355.00	Cracks, chips
Selective replacement of concrete drive	s.f.	2,413	\$ 6.00	\$ 14,478.00	Cracks, chips
Replant bed	lump	1	\$ 1,750.00	\$ 1,750.00	
Asphalt new wear layer	s.f.	26,850	\$ 1.25	\$ 33,562.50	Damage to top layer only
Restripe Pavement	lump	1	\$ 5,200.00	\$ 5,200.00	Faded striping, recoated asphalt
Repair fence	l.f.	180	\$ 5.00	\$ 900.00	Reset/replace posts, painting
Replace landscape timber	l.f.	700	\$ 5.00	\$ 3,500.00	Deteriorated, out-of-place
Subtotal Priority 2:				\$90,746

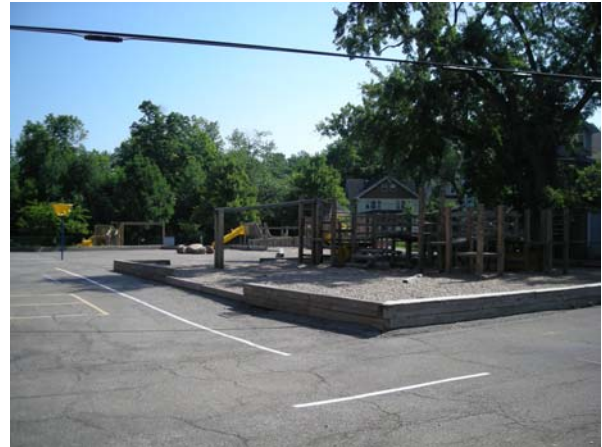
Playground Equipment

- The playground equipment at Roxboro Elementary School is wood, and in good condition. It is not new, but shows little deterioration.
- Bike racks are in need of replacement.
- Wood benches and tables are worn and should be replaced.
- Some areas of the existing chain link fence post, rail and gate have been damaged and should be replaced. Much of the fence is overgrown with vines, providing privacy to neighbors - this does not require correction.

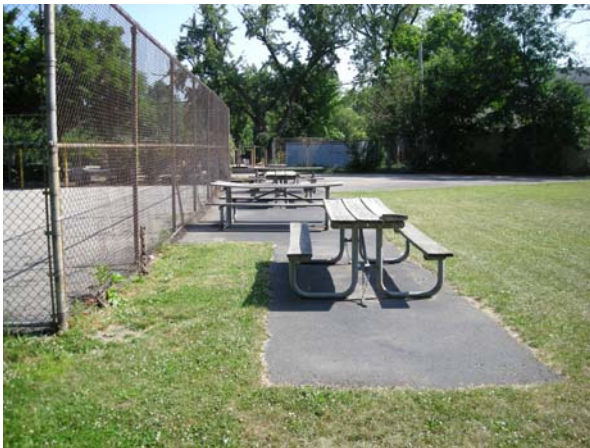
Picnic tables needing replacement

<i>Item</i>		<i>Qty.</i>	<i>Unit Cost</i>	<i>Assessed Cost</i>	<i>Comments</i>
Replace bench	each	5	\$ 1,600.00	\$ 8,000.00	
Replace bike rack	s.f.	1	\$ 500.00	\$ 500.00	
Subtotal Priority 3:				\$8,500

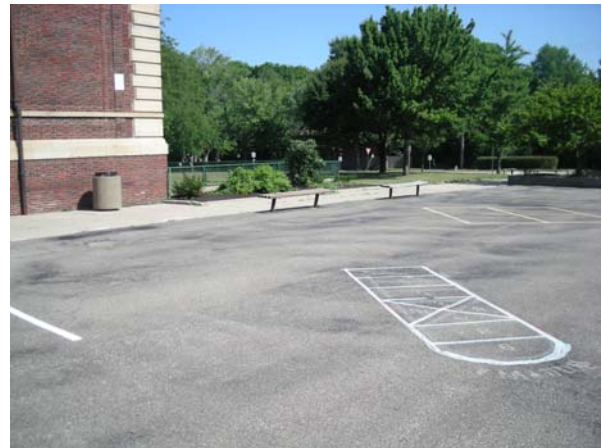
Worn asphalt play surface

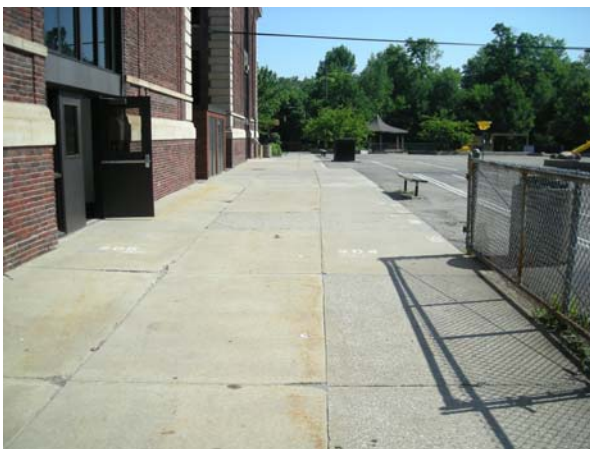
Concrete paving at rear of building

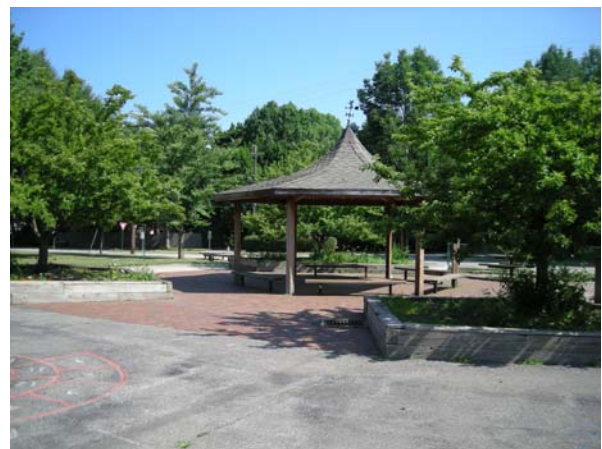
New gazebo and paving

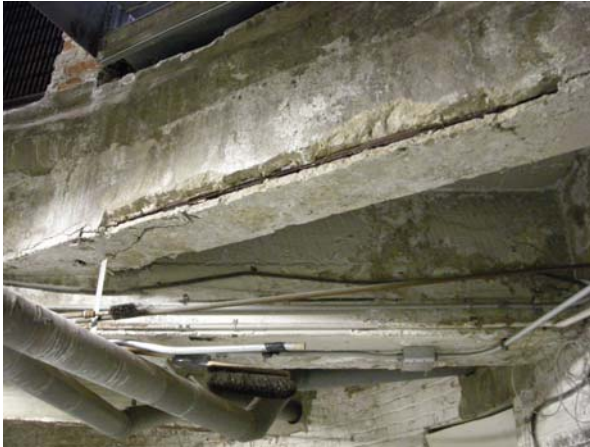
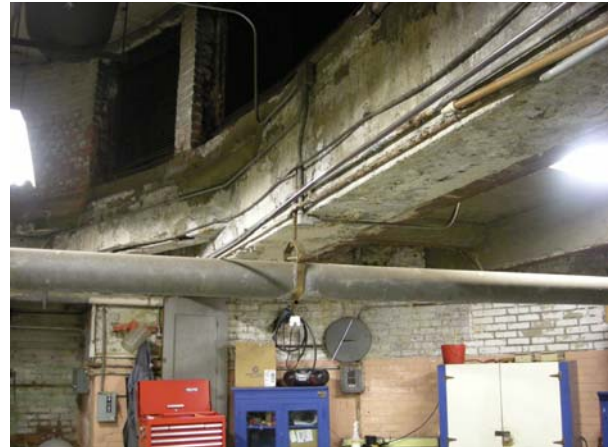
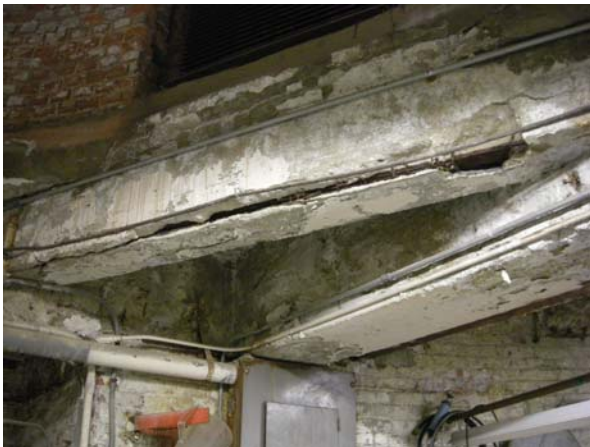
Deteriorating beams in boiler room

- The lower level of the original 1919 building contained a coal room, which was subsequently blocked off/filled in during the 1956 interior renovation project. Some corrosion was noted at concrete encased steel beams adjacent to this former coal room, within the current boiler room. In a few cases, corrosion of the bottom flange of the beam has caused the concrete encasement to spall off. The beams in question should be cleaned, primed, and encased with new concrete.

<i>Item</i>	<i>Unit</i>	<i>Qty.</i>	<i>Unit Cost</i>	<i>Assessed Cost</i>	<i>Comments</i>
Repair and encase boiler room beams	l.f.	50	\$ 300.00	\$ 15,000.00	Remove concrete, repair beams, and replace concrete encasement
Subtotal Priority 1				\$15,000

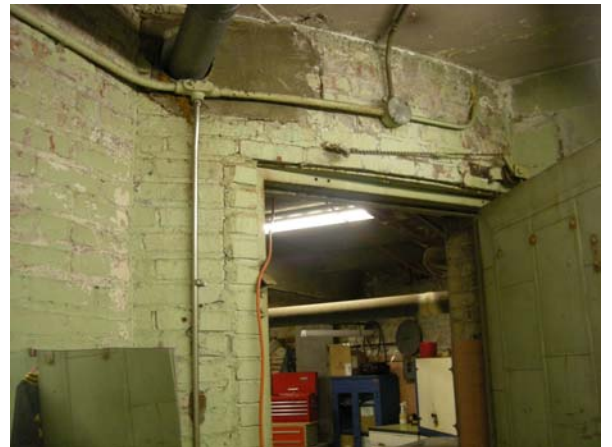
Boiler room wall

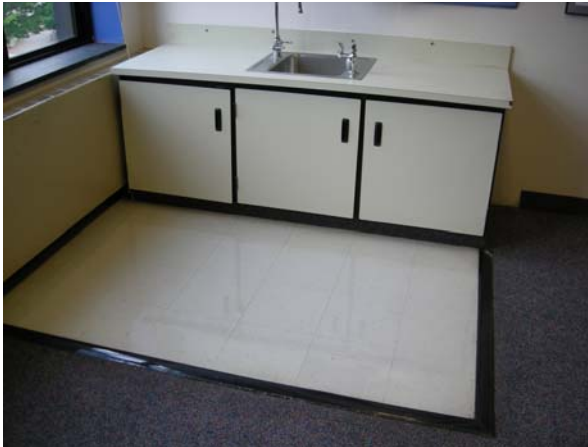
Typical casework

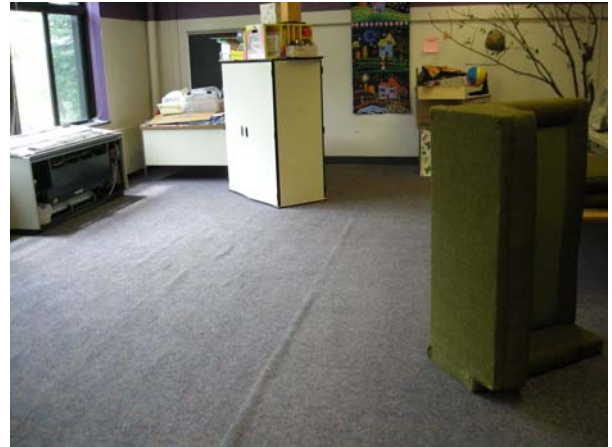
Problematic carpet installation

- Carpet in the building is typically in fair-to-poor condition. Worn, stained and/or poorly adhered carpet should be replaced.
- VCT is generally in fair condition, with some areas in poor condition which require replacement.
- Rubber flooring at the media center entry is worn and very stained, and should be replaced.
- Ceramic tile floors at the group toilet rooms are in fair condition. Some spot replacement is required where tile is cracked.
- Epoxy paint is generally in fair-to-good condition.

<i>Item</i>	<i>Unit</i>	<i>Qty.</i>	<i>Unit Cost</i>	<i>Assessed Cost</i>	<i>Comments</i>
Replace carpet	s.y.	1,400	\$ 27.00	\$ 37,788.00	Stained, poorly adhered
Repair and repaint/reseal concrete floor - fair condition	s.f.	725	\$ 1.50	\$ 1,087.50	Small cracks/chips, loss of finish
Spot repair ceramic tile base	l.f.	26	\$ 11.00	\$ 286.00	All toilet rooms
Spot repair ceramic tile wall	s.f.	109	\$ 12.00	\$ 1,308.00	All toilet rooms
Repair plaster and gypsum board walls - fair condition	room s.f.	5,060	\$ 2.50	\$ 12,650.00	Per assessment notes
Repair plaster and gypsum board walls - poor condition	s.f.	407	\$ 7.50	\$ 3,052.50	Specific areas of damage
Repair and repaint masonry wall - fair condition	floor area s.f.	1,153	\$ 2.50	\$ 2,882.50	Hairline cracks, peeling paint
Repair and repaint masonry wall - poor condition	floor area s.f.	1,277	\$ 6.00	\$ 7,662.00	Media Center
Repair plaster ceiling - fair condition (3)	s.f.	2,054	\$ 3.00	\$ 6,162.00	Peeling paint, minor damage

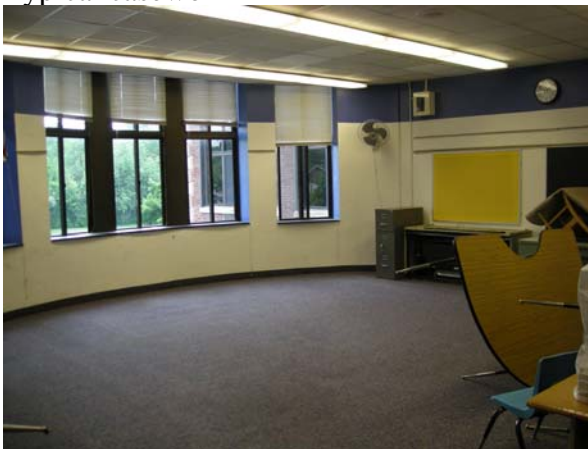
Round classroom

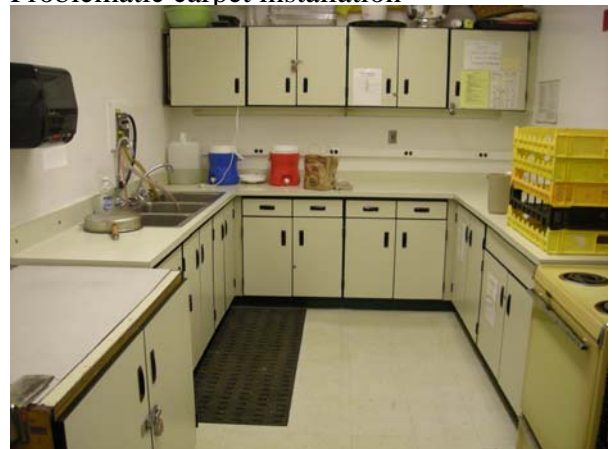
Warming kitchen

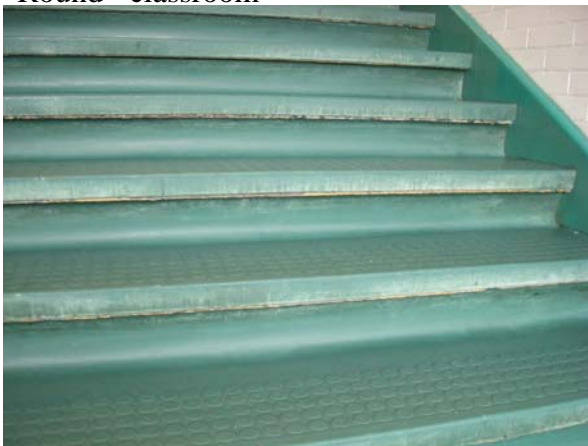
Typical riser and tread condition

Replace vinyl stair treads	l.f.	492	\$ 15.00	\$ 7,380.00	Cracked, dirty, loose
Clean and repair corrosion on stair stringer and risers	each per floor	8	\$ 750.00	\$ 6,000.00	Repair and prime corrosion, paint stringers
Subtotal Priority 1:				\$487,415

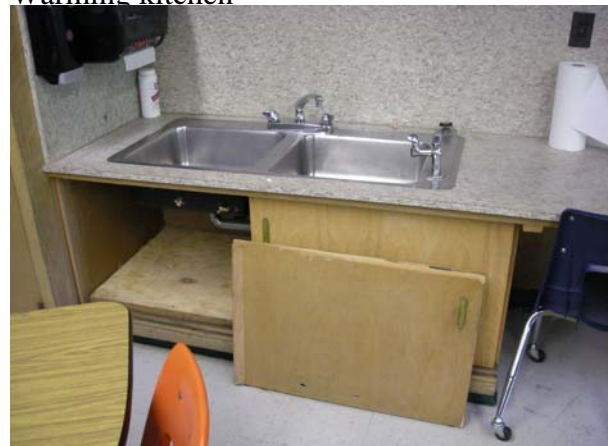
Casework needing replacement

- The condition of built-in casework (base/wall/tall cabinets) varies by location. Some

casework replacement is required, mostly at wet locations - sink base cabinets and countertops, cabinets at the kitchen, etc.

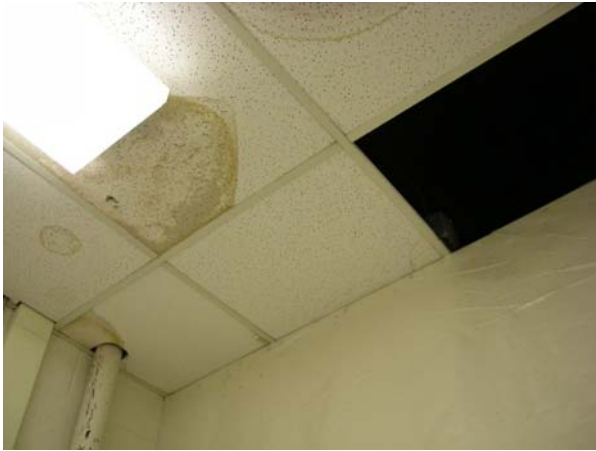
Ceiling water damage

- Acoustical tile ceilings occur throughout the building. Most areas are in fair condition, but some areas require complete ceiling replacement. Spot tile replacement should occur where damage exists. Some ceilings, while level and sound, had yellowed/discolored grid – an aesthetic concern which does not require immediate replacement.
- Plaster ceilings occur in toilet rooms and some service spaces, and are typically in good condition. Spot patching and repair only is required.

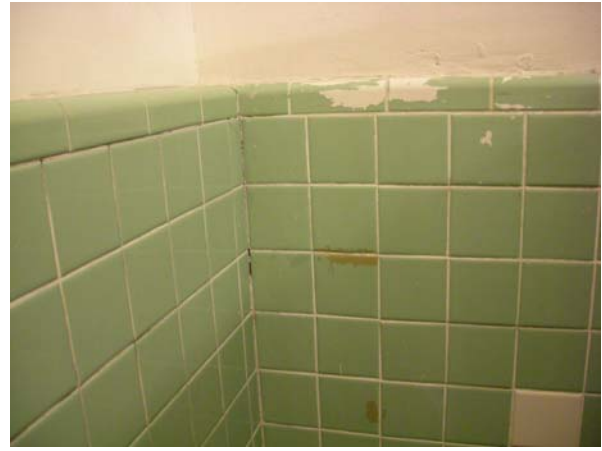
Tile wall damage

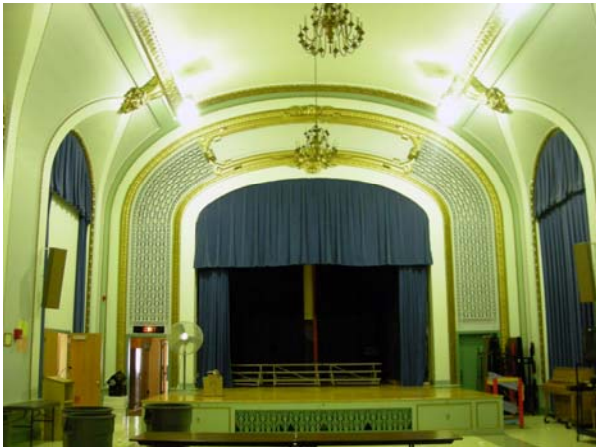
Auditorium/Cafeteria stage

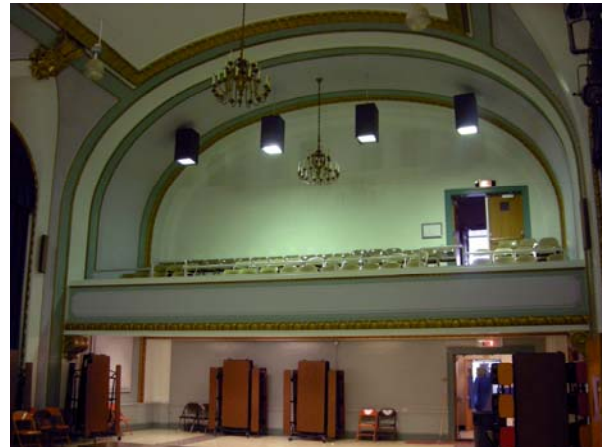
Auditorium Balcony

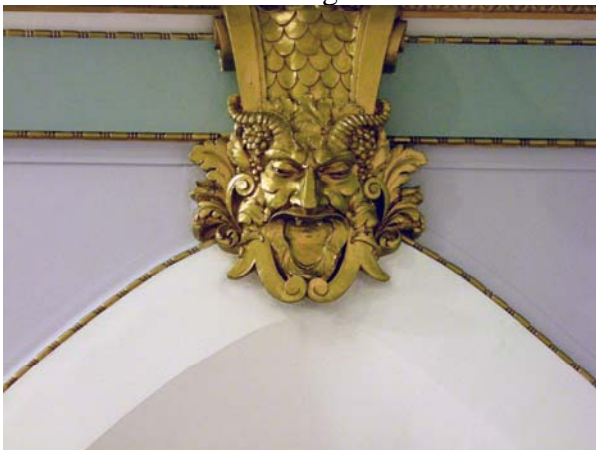
Decoration at top of arch

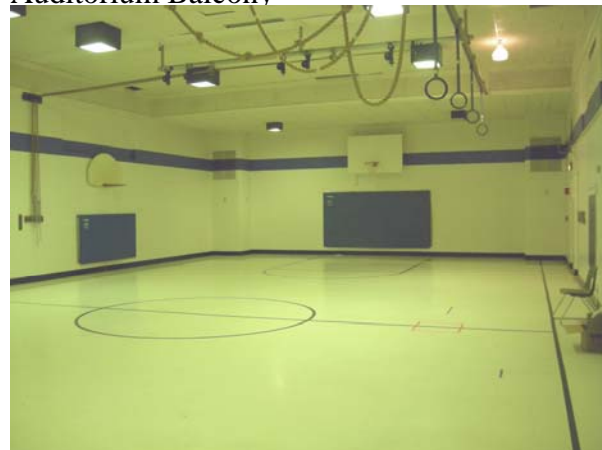
Basement Gymnasium

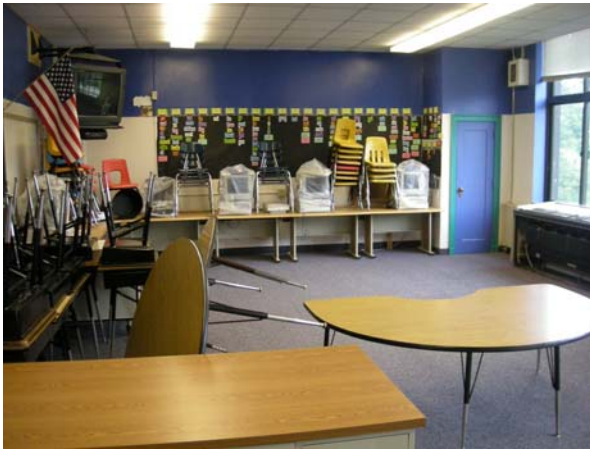
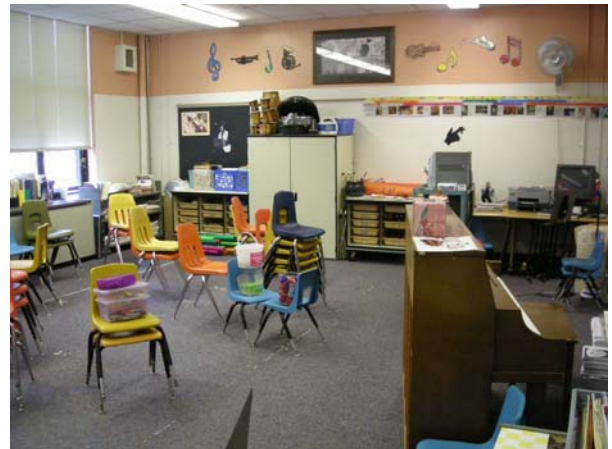
Typical classroom

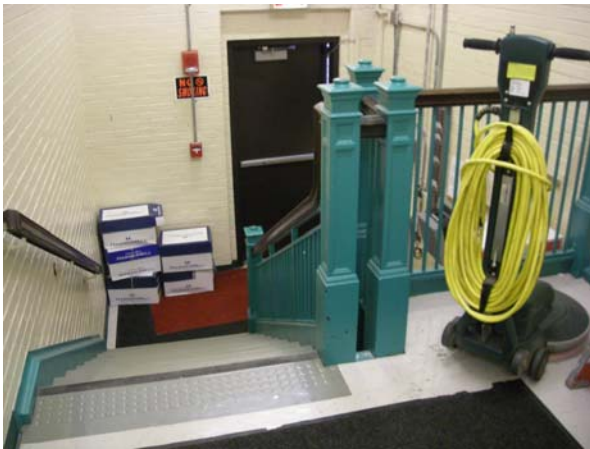
Possible platform lift location

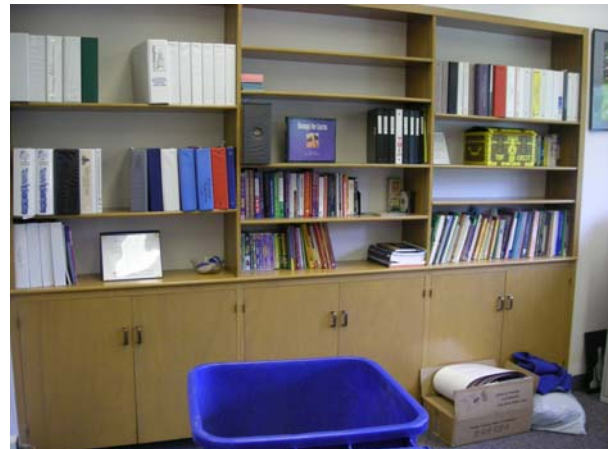
Casework

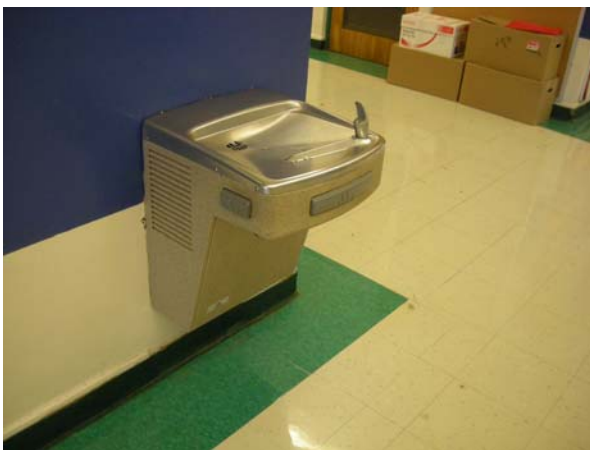
ADA Compliant drinking fountain

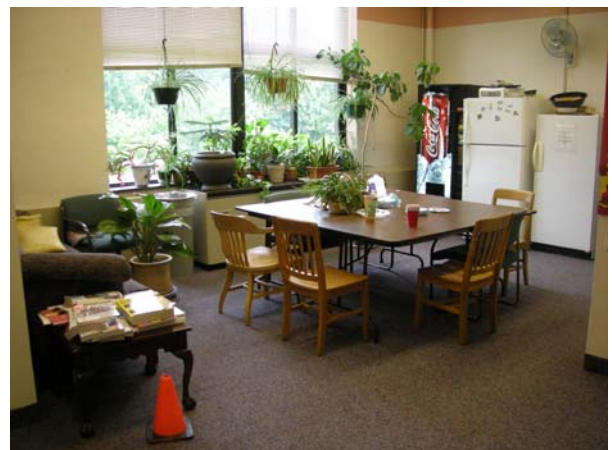
Teachers lounge

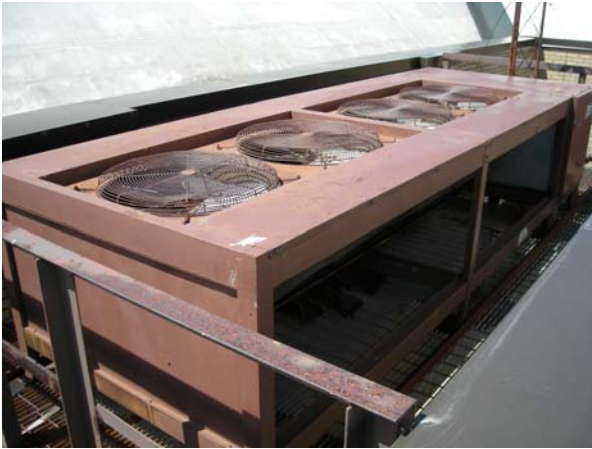
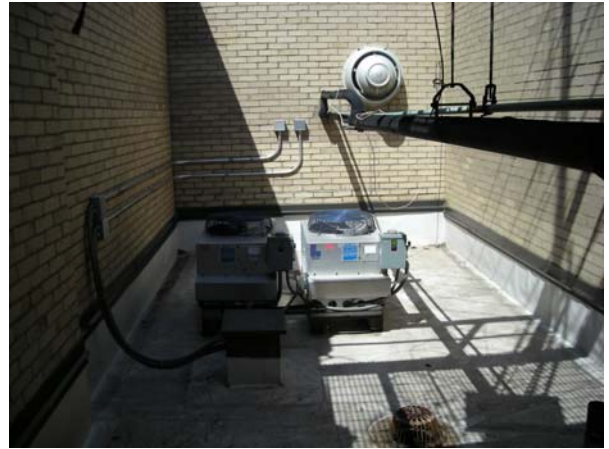
Rooftop Units

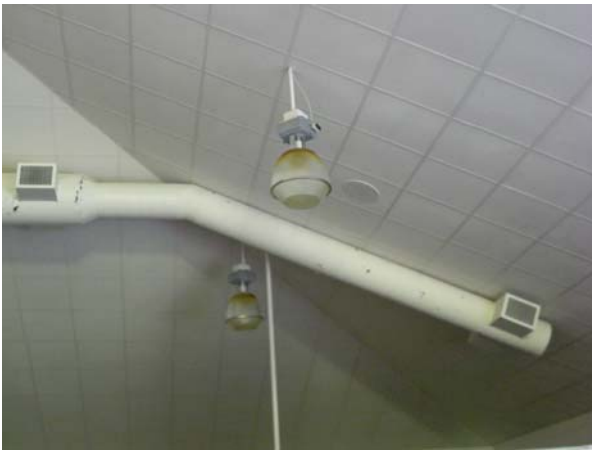
Media Center Ductwork

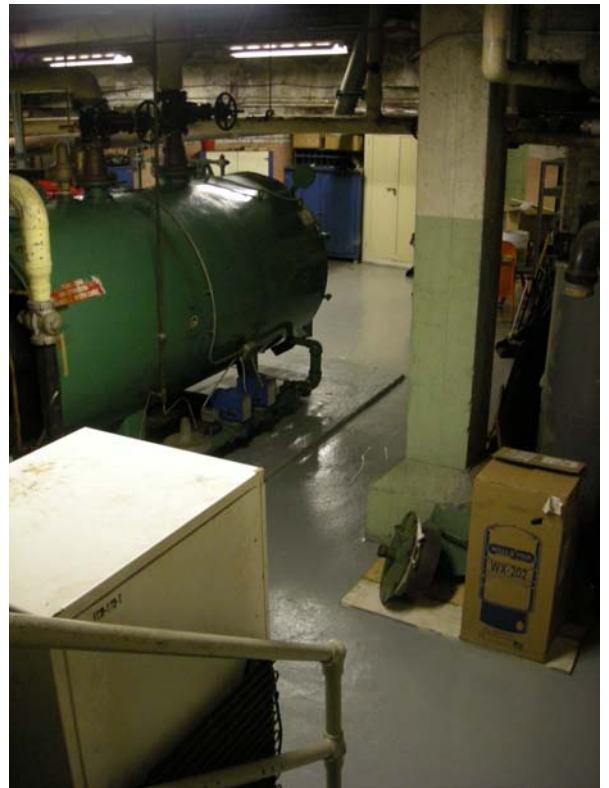
Boiler Room

The building is heated by two hot water boilers, which replaced the previous boilers in 1982. Hot water heating coils are located in the gym air handling unit, in the auditorium air handling unit and in the 1973 unit ventilators. The Media Center 1973 addition is heated by a gas fired rooftop multizone unit. All unit ventilators were installed in the 1973 renovations project. Air conditioning is provided to the auditorium by a split DX system.

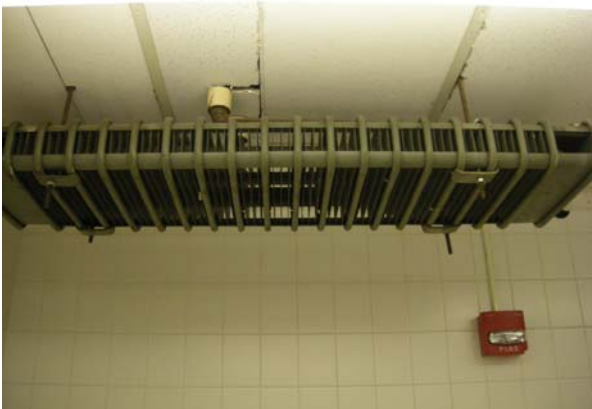
New Radiator in Basement
