2007 District Wide Facilities Evaluation  
Building Assessment Report

# Roxboro Middle School

2400 Roxboro Road, Cleveland Heights, Ohio

July 20, 2007

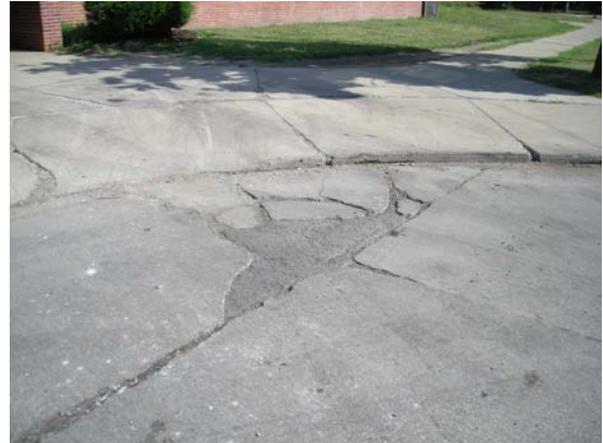
Damaged Asphalt Drive

- The parking lot should be resurfaced and restriped.
- Most of the concrete drive areas require replacement. Some are extensively cracked and broken, others are heavily stained with rust and oil.
- Large areas of concrete pedestrian pavement require replacement due to cracking.
- The tennis courts need replacement or extensive repair. The markings are faded, and the asphalt has wide cracks through its thickness. Net supports and fencing are rusted and nonfunctional. Three have not been resurfaced since their installation in the 1960s. Two have been repaired and resurfaced poorly, the work doing little to remedy the problems.

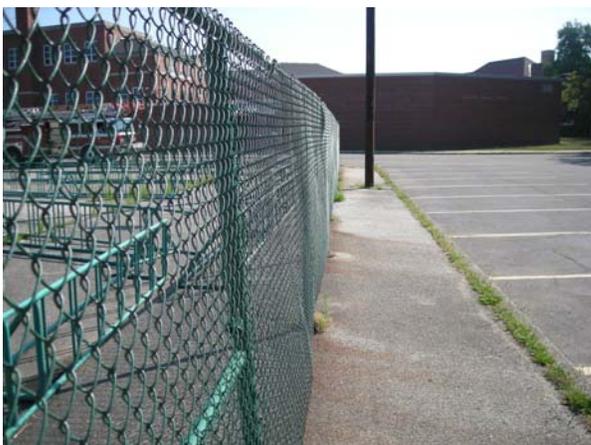
Damaged Chain Link Mesh

- The two small bleachers at the baseball field should be replaced.
- The main backstop should be painted, and the mesh replaced. The secondary backstop should be replaced.
- Site fencing is extensive, and mostly in good condition. Some areas show rusted and/or deformed mesh, and certain areas need total replacement.
- The small benches at the tennis courts should be replaced.

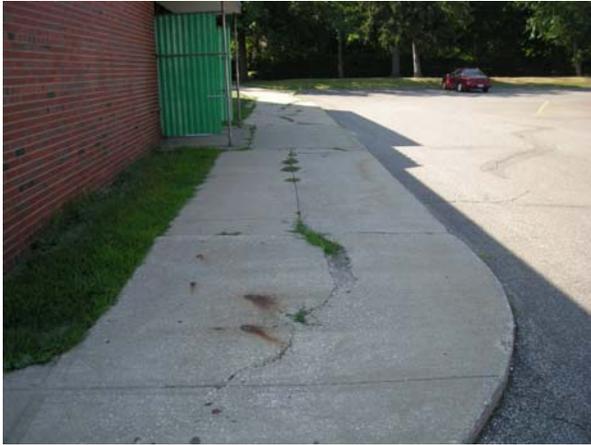
Damaged Concrete Walk

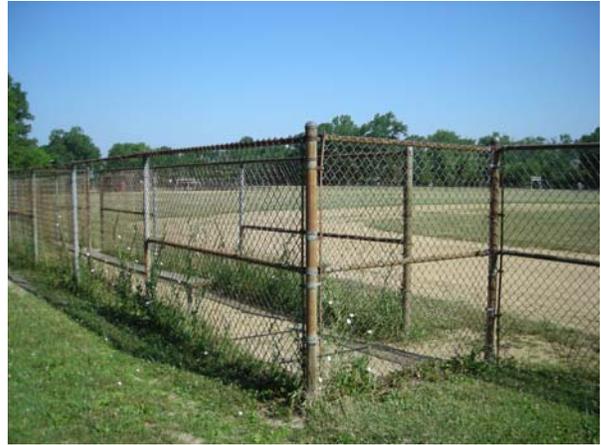
Deteriorated Chain Link Fence

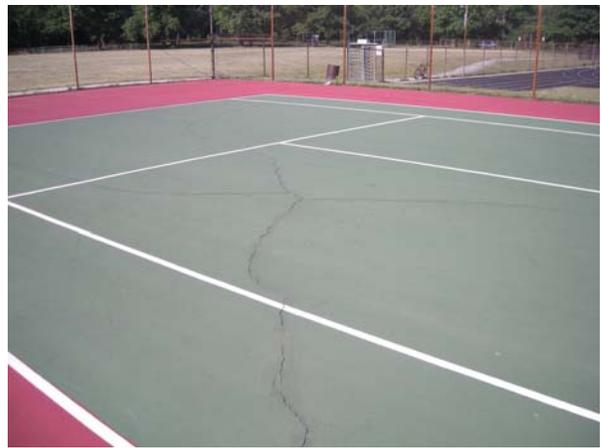
Tennis Court Damage

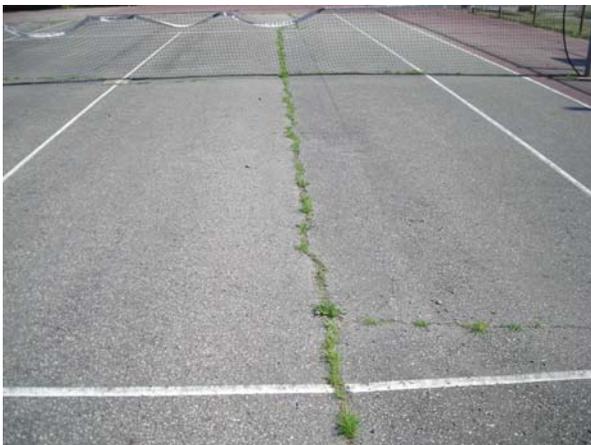
Tennis Court Damage

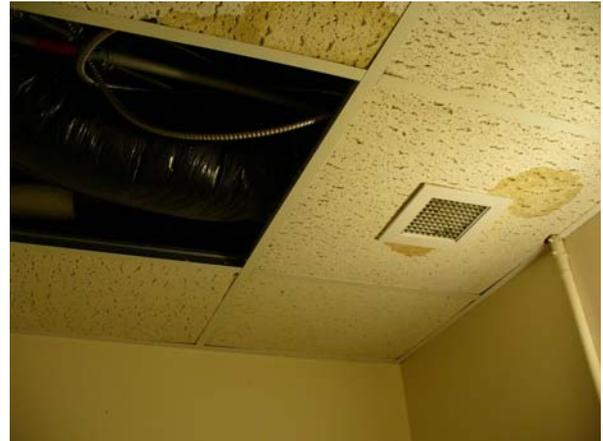
Lay-In Ceiling Damage

- Acoustical tile ceilings occur throughout the building. Most areas are in fair condition, but some areas require complete ceiling replacement. Spot tile replacement should occur where damage exists, and grid should be repaired or replaced where noted.
- Plaster ceilings generally occur in spaces such as janitor closets, stairwells, and toilet rooms. Plaster ceilings in most spaces are in fair-to-good condition. The plaster ceiling in the auditorium has some areas of water damage which should be corrected.
- Gypsum board ceilings occur in some group toilet rooms, and are in good condition.
- Exposed structural ceilings occur at many service spaces, including the lower level boiler room and adjacent areas. There is also an exposed concrete ceiling at the first floor gymnasium which is in good condition.

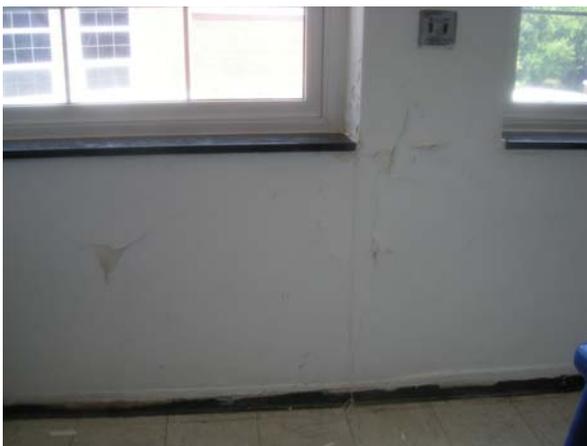
Plaster Damage

- Plaster walls vary in condition depending on location, but are generally in good-to-fair condition. Many plaster walls have some cracking, possible minor water damage, and possible minor peeling paint. Plaster walls in poor condition usually exhibit more severe water damage, with substantial peeling paint and cracking.

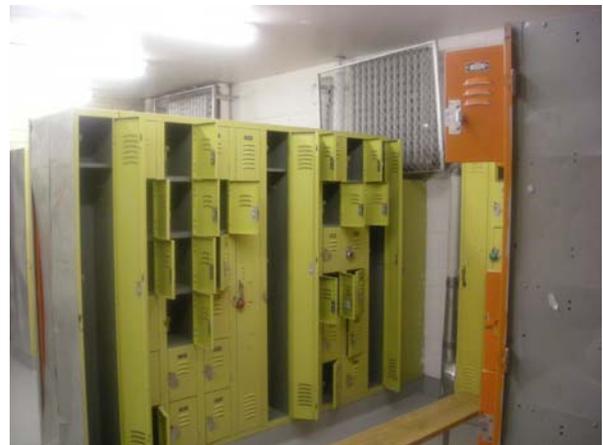
Locker Damage

- Corridor lockers are generally in good condition, with some repairs required. Lockers should be painted. Lockers in the following areas are in poor condition and should be replaced: lower level boys team locker room; first floor girls locker room and girls team locker room; second floor boys locker room and kitchen staff lockers.
- The operable partition between the first floor gymnasium and stage appears to be approaching the end of its useful life, and should be replaced.

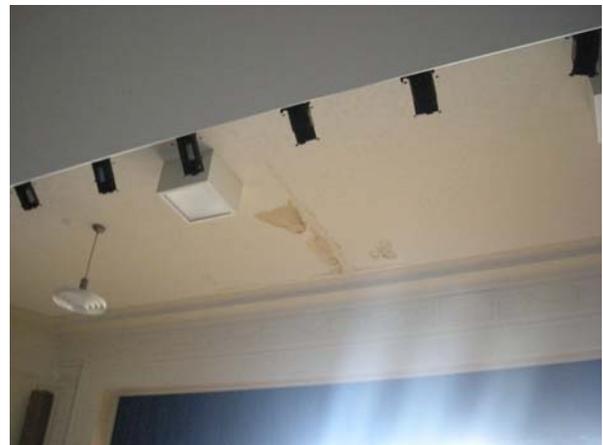
Water Damage at Auditorium Ceiling

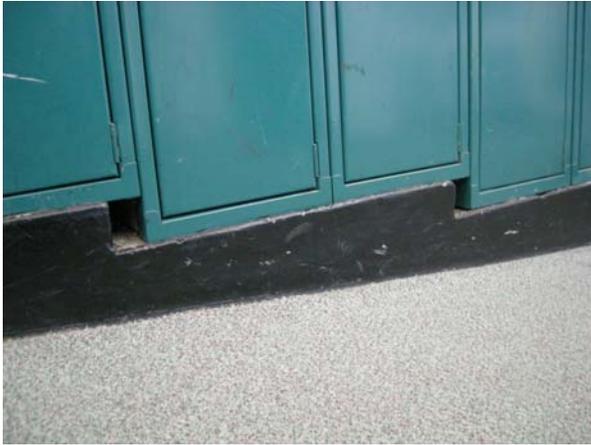
Gaps at Locker Base

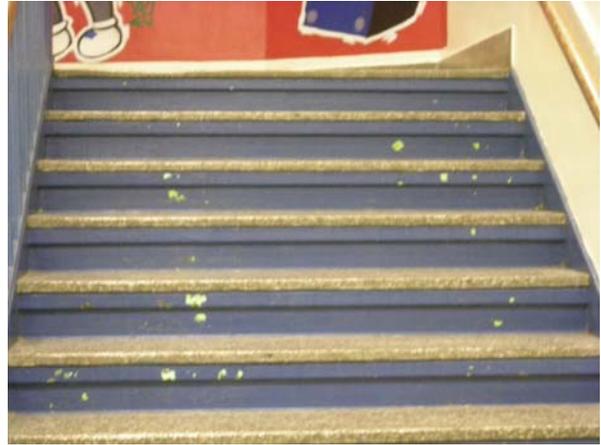
Chipped Paint at Metal Stair Risers

- Stairs at the original 1925 building and 1956 addition are typically steel construction, with painted stringers, risers, brackets, pickets and newel posts. Steel is typically in good condition, with painting required. Some minor corrosion was observed, which does not appear to affect the structure of the stair. This corrosion should be cleaned and primed prior to painting. These stairs have terrazzo stair treads, which are generally in good condition. Some terrazzo tread and nosing patching is required. Wood handrails and guardrails are in good condition.
- Stairs at the 1973 addition are steel pan construction with abrasive nosings and VCT finish at treads and landings. This VCT is in poor condition and should be replaced.

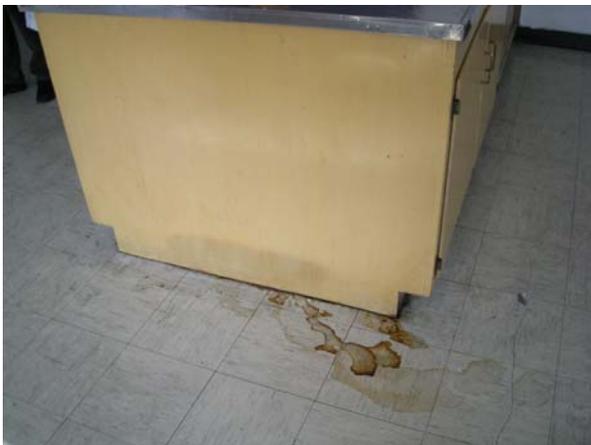
VCT Damage/Stain

- Carpet is generally in poor condition. Typical carpet problems include staining, excessive/noticeable wear patterns, and open seams. Most areas of carpet should be replaced.
- VCT is typically in fair-to-poor condition. Cracked/damaged, worn and stained VCT is common and should be replaced. Note that VAT was observed at one first floor classroom as a substrate to VCT, where the VCT was missing. It is unknown how many other rooms within the school have VAT as a substrate to either VCT or carpet.
- Ceramic tile floors are typical at group toilet rooms. Tile floors are generally in fair condition, with grout discoloration common. Spot replacement of missing or damaged tile

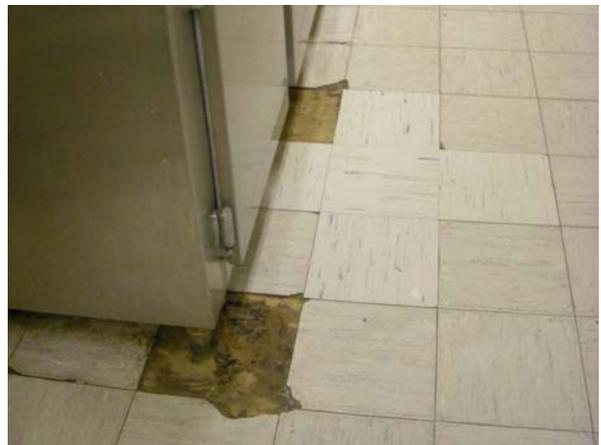
VCT Damage

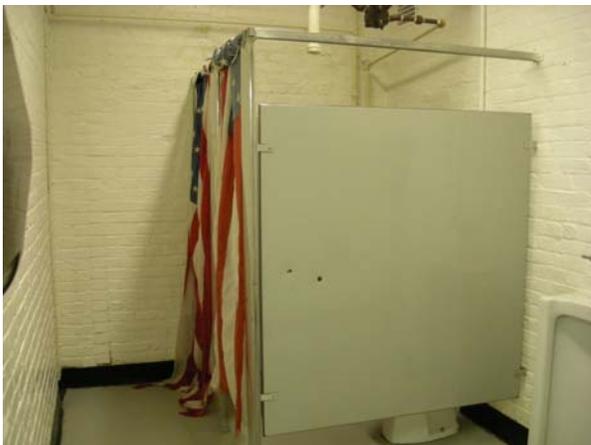
Missing Toilet Partition Doors

- Plastic partitions occur at some group toilet rooms. Plastic partitions are generally in good condition.
- Original metal toilet partitions are in fair-to-poor condition and should be replaced.
- Marble partitions occur at the girls team locker room. These partitions are cracked/damaged, and should be replaced.

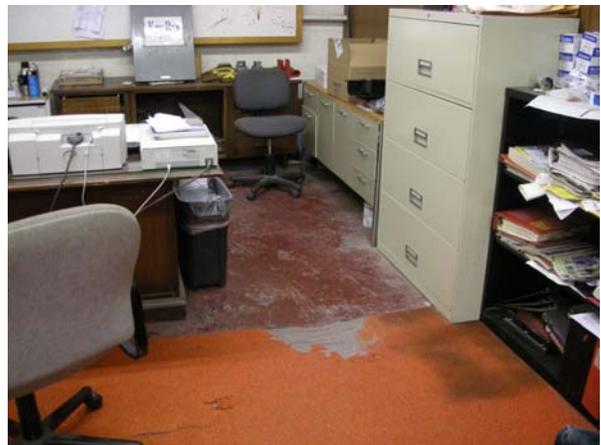
Worn and Missing Carpet

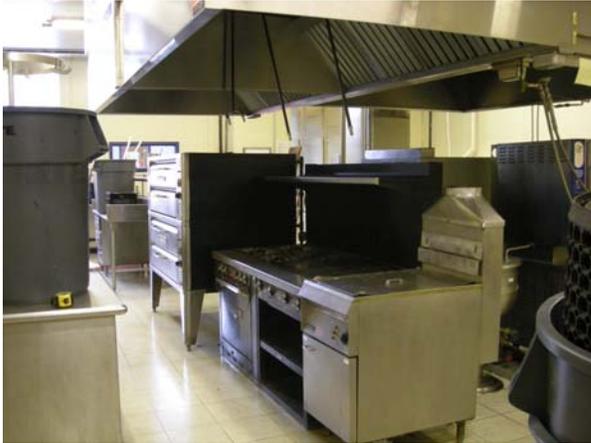
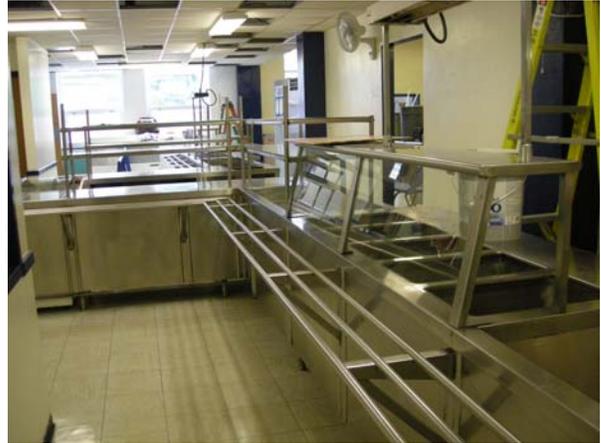
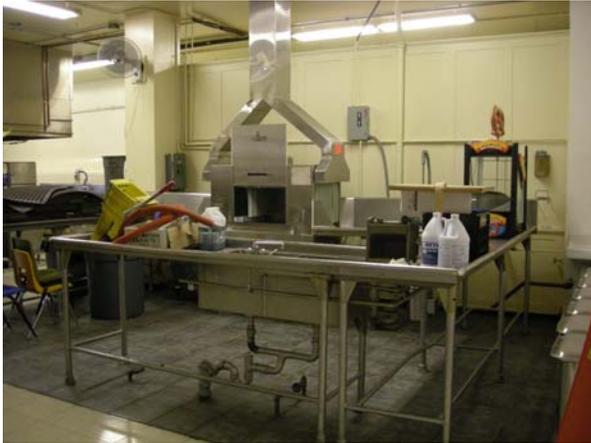
Kitchen Equipment

- Kitchen equipment at Roxboro Middle School is in fair-to-poor condition. Most kitchen equipment should be replaced within the next six years. Generally speaking, kitchen equipment replacement includes but is not limited to: walk in coolers/freezers; fryers; mixers; convection and conventional ovens; ranges; hot and cold serving units and cabinets; ice makers; refrigerators; disposers; dishwashers. Where observed, most stainless steel counters, storage units, work tables and multiple tub sinks were found to be in good condition.

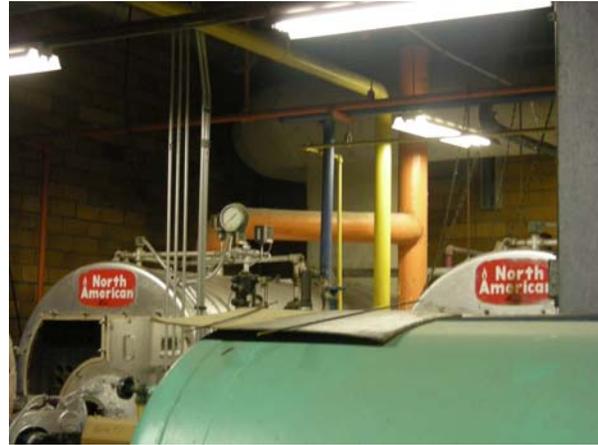
Boilers

The building is heated by three steam boilers, which were installed in 1973. The boilers do not utilize a water softener, and, according to the maintenance staff, the chemical treatment is typically out of desired range. All boiler water blowdown is done manually. Boiler #1 has a damaged shell.

- Replace all unit ventilators. The unit ventilators are over 30 years old and should be replaced.
- Add dual water softeners to the boiler's make-up water system. This will help prolong the life of the boilers.

- Add a vacuum breaker to the main steam header.
- Repair damaged boiler shell.
- Relocate the steam boilers make-up water backflow preventer to a more accessible elevation (it is currently about 18 feet above the floor).

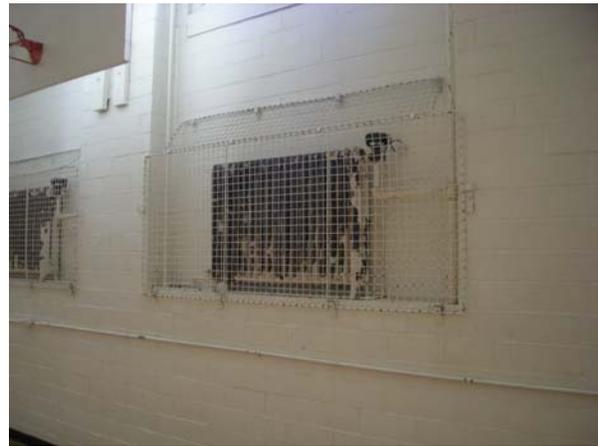
Obsolete Radiator in Gymnasium

Each gymnasium was originally ventilated by a 100% outside air supply fan with steam coil located in the fan room and exhausted by an exhaust fan located in the attic. Steam radiators provide heat in each of the gymnasiums. In 1973, an air handling unit with steam coil was installed in each of the gymnasiums. The original supply and exhaust fans were not intended to be abandoned, though their intended use is unclear. The original supply and exhaust fans and the 1973 air handling unit are not utilized, so the only means of conditioning is the steam radiators and there is no ventilation.

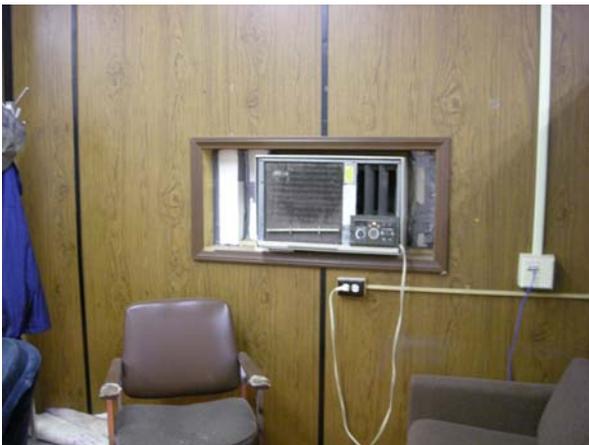
Custodian's AC draws air from Boiler Room

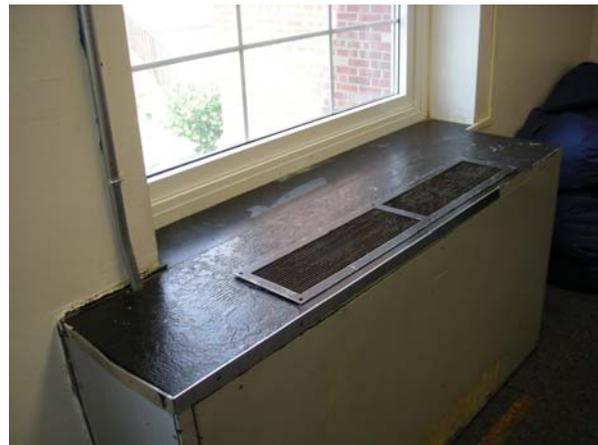
Typical Unit Ventilator
