2007 District Wide Facilities Evaluation  
Building Assessment Report

# Cleveland Heights High School

13263 Cedar Road, Cleveland Heights, Ohio

June 18, 2007

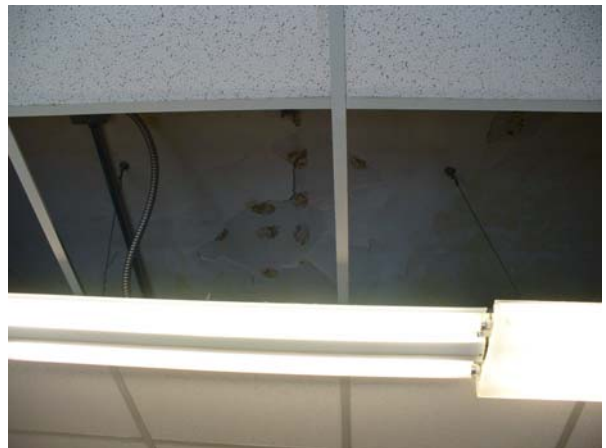
Ceiling in Offices
