2007 District Wide Facilities Evaluation  
Building Assessment Report

# Gearity Elementary School

2323 Wrenford Rd, University Heights, Ohio

## Cleveland Heights University Heights City School District

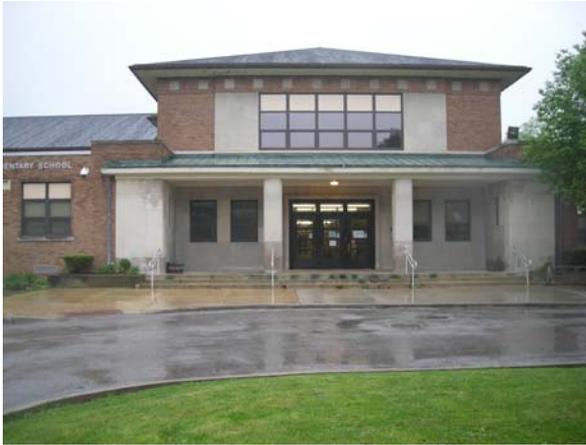
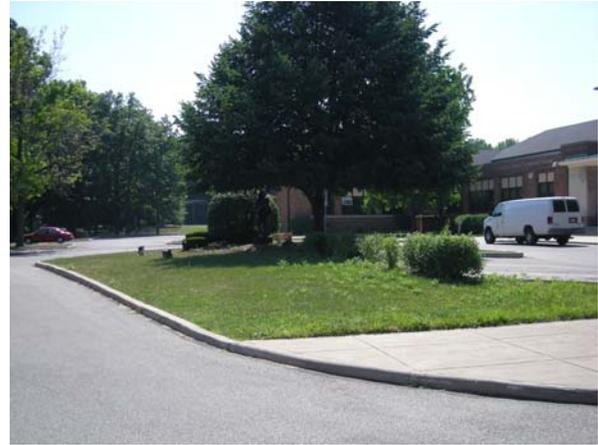
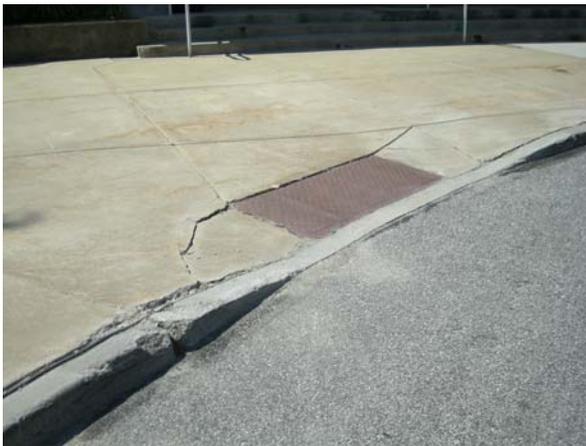
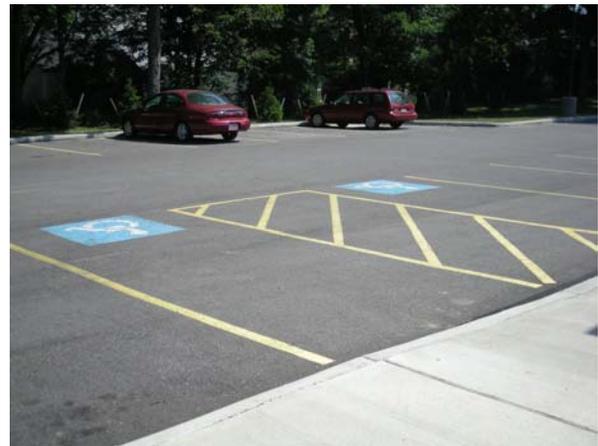
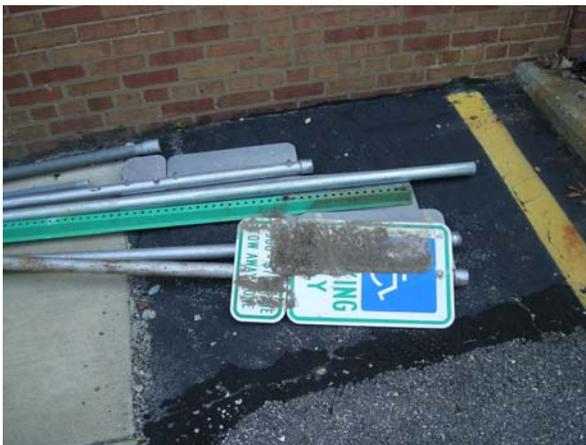
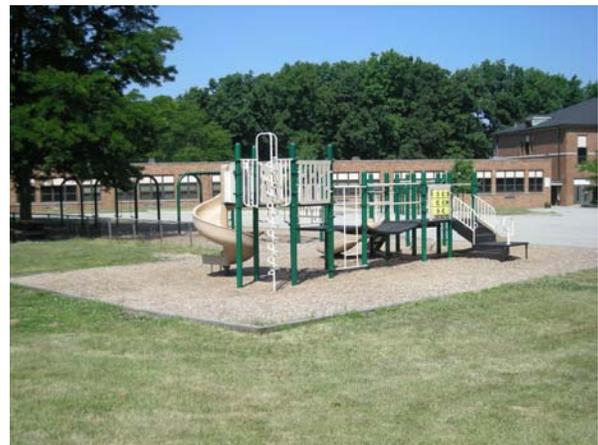
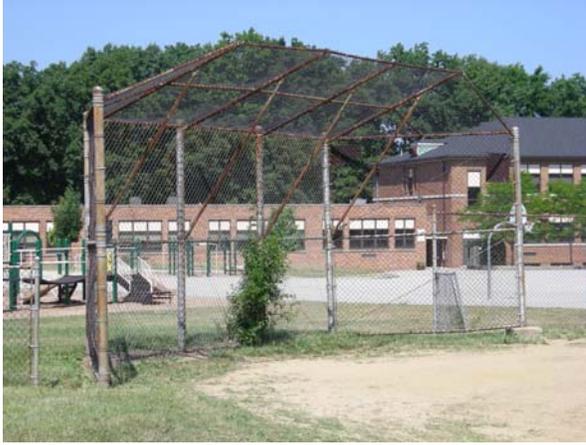
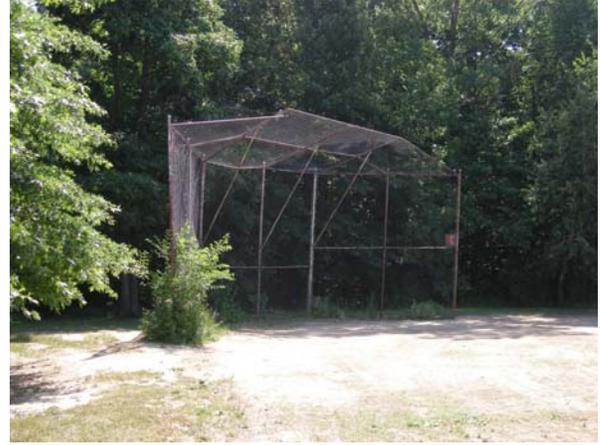
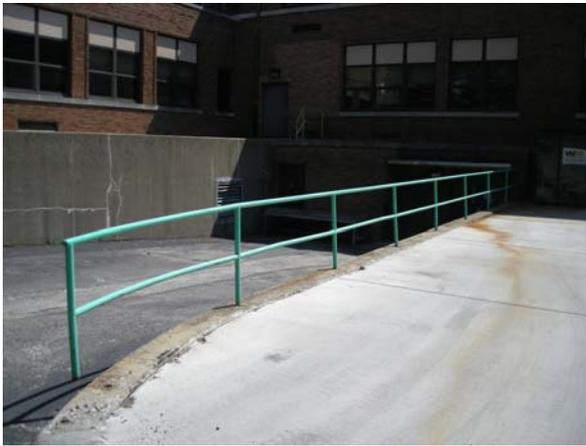
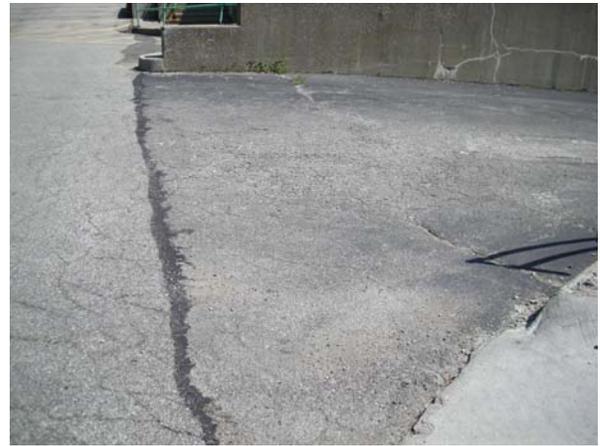
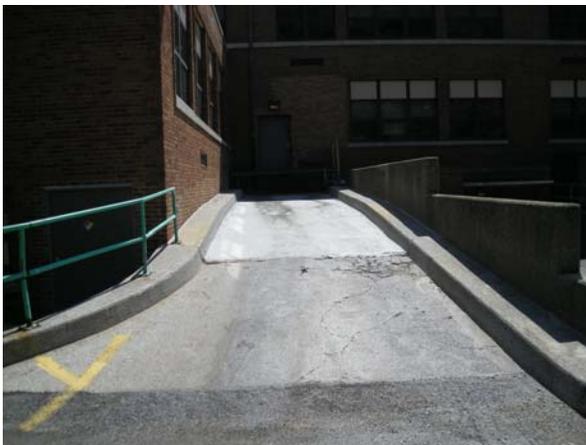
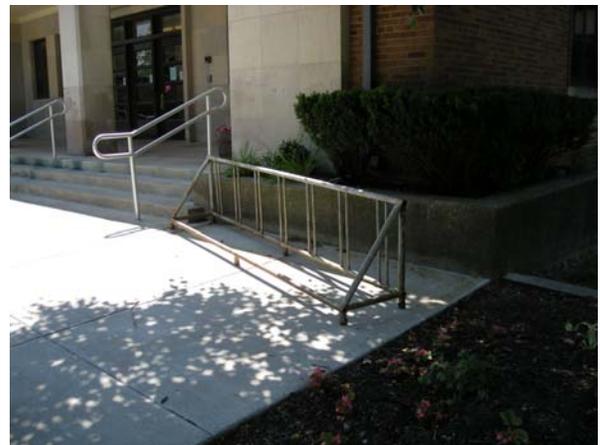
**B:Building Site**

- All playground equipment at Gearity Elementary School appears new
- The bike rack to the north of the school is old, rusted and in need of replacement.
- Some areas of the existing chain link fence post, rail and gate have been damaged and should be replaced. These areas generally occur at the south swingset.

- Concrete pavements (walks) are in fair condition, with many areas requiring replacement.
- Concrete curbs are generally in fair-to-good condition. Spot cracked curbs replacement is required.
- Existing asphalt parking lot areas are in fair-to-poor condition. Many areas of asphalt have failed and require replacement. All parking lot areas should be resurfaced and restriped after asphalt repairs have been made.

- Landscaping, where provided, is in fair condition.

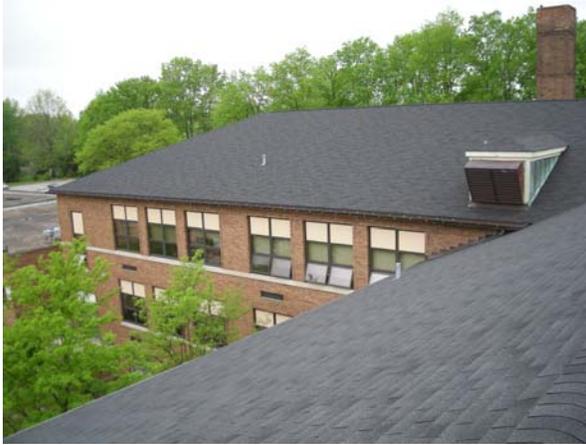
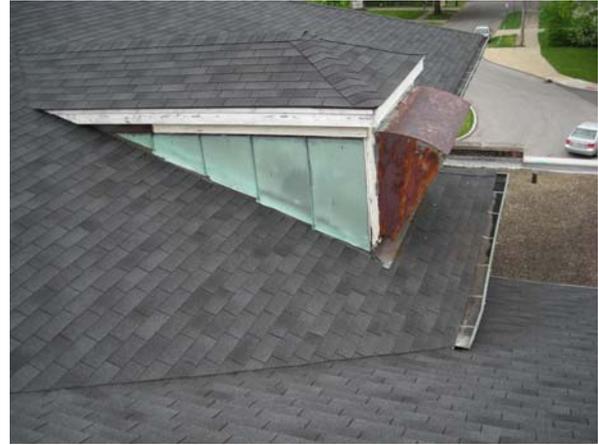
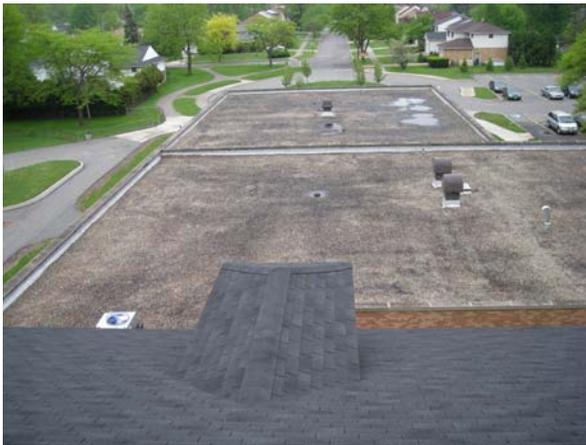
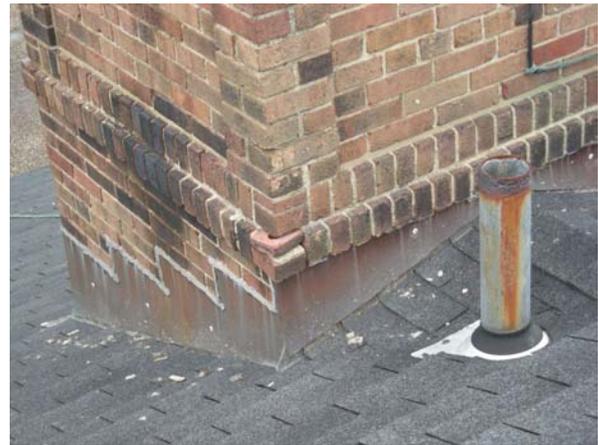
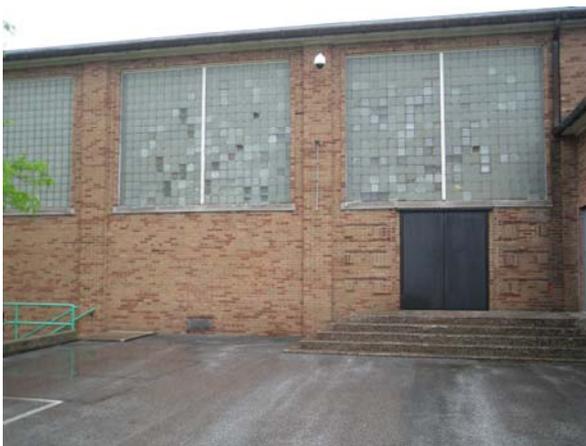
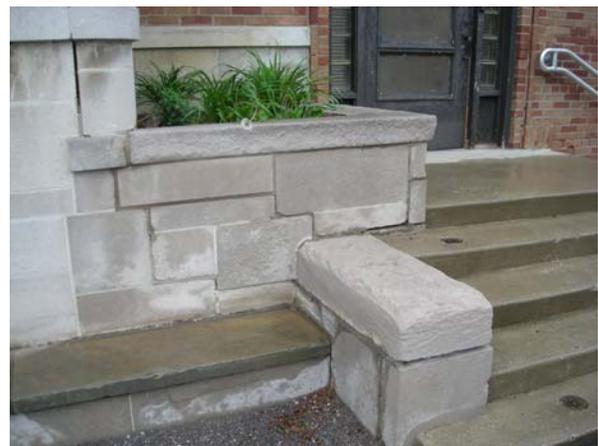
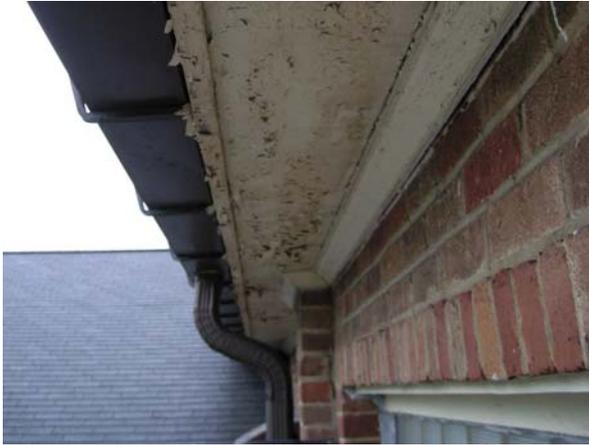
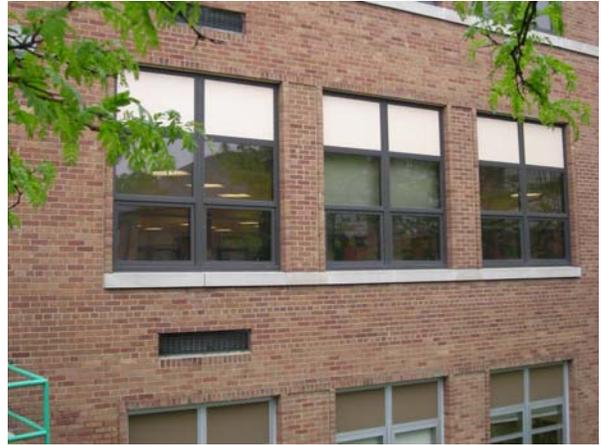
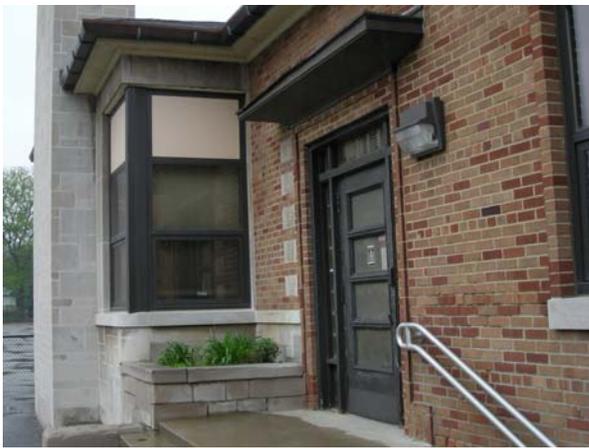
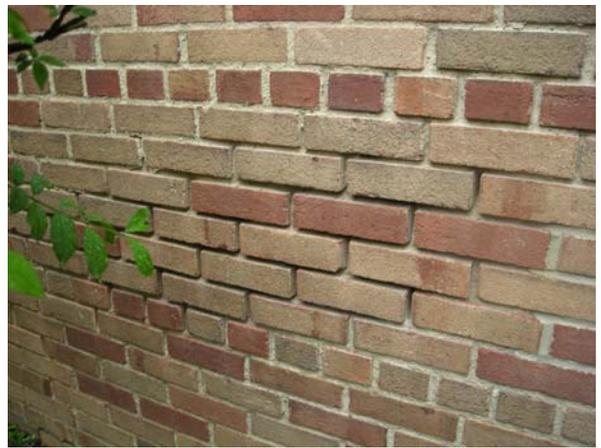
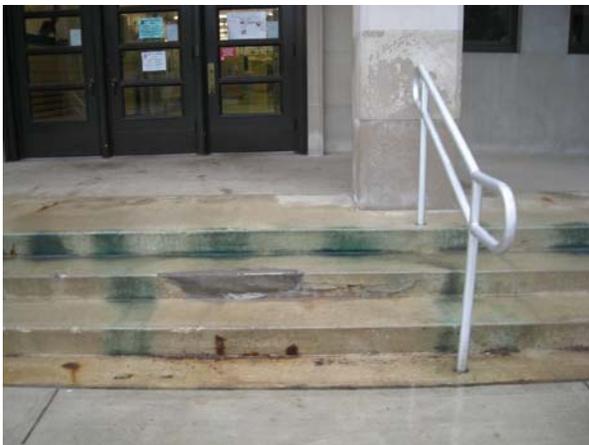
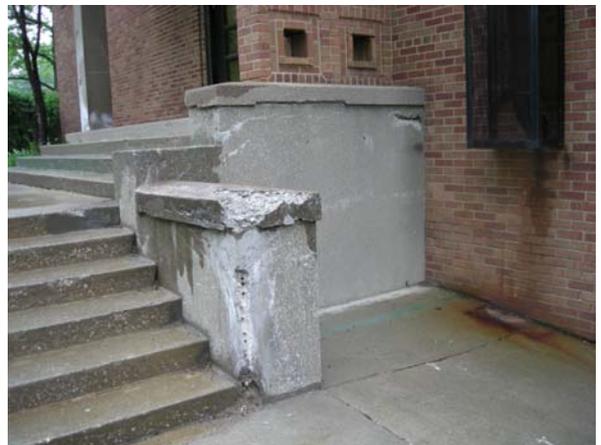
**D:Building Envelope**

- Exterior masonry typically consists of brick veneer with a concrete block backup. Limestone accent panels and limestone veneer surrounds the main entries of the original 1947 building. Some lintel cleaning/painting is required at previous window replacement. Lintel replacement is recommended at the 1954 & 1958 additions – lintels are expanding and displacing masonry. Spot stone repair and tuckpointing is required, primarily at the east elevation stair and chimney. Face Brick tuckpointing is required at all elevations, primarily above windows. Replacement of spalled face brick is required at the west elevation (office area). Some additional spot brick replacement is required.
- Glass Block masonry - see windows below.

- Exterior doors are generally in fair condition but are recommended for replacement within the next 5-6 years with FRP doors and aluminum frames. Some door replacement with FRP/aluminum frames has been initiated.
- Some original wood entry doors are recommended for renovation.

- The glass block “window walls” at the north and south walls of the gymnasium are in very poor condition and should be a priority replacement.
- Most windows at Gearity Elementary are newer thermally broken, anodized aluminum frame, insulated glass windows with insect screens. They are in good condition.

- The wood soffits at sloped roof overhangs and the wood roof edge trim at sloped roofs & dormers requires repair, cleaning and refinishing.

- The sloped roof areas are asphalt shingle covered. The slope roofing is in good condition. This roofing was installed in 1998.
- The copper standing seam roof above the main north entry is recommended for repair.
- The flat roof areas at Gearity Elementary are older (1988- early 1990’s) gravel surfaced built up roofing systems - some placed directly over concrete roof decks without insulation. This roofing is currently serving well but is recommended for replacement, within the next 5-6 years, due to age and lack of insulation.

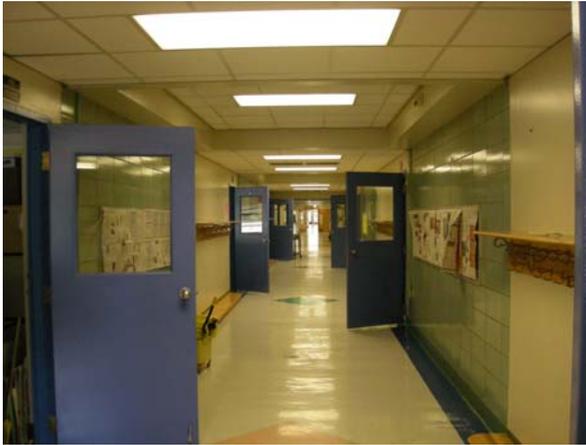
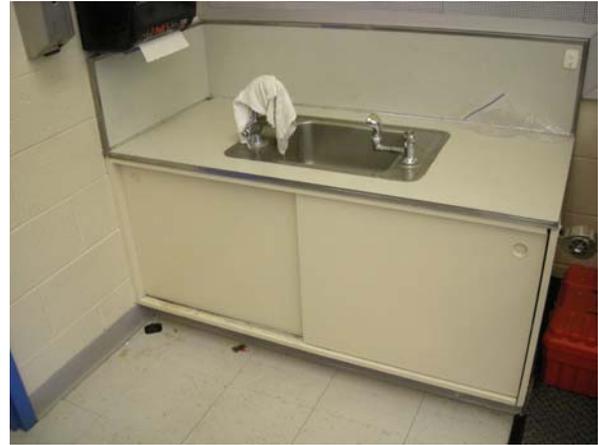
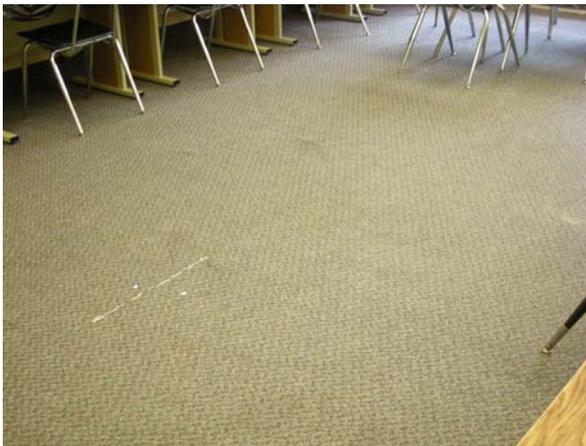
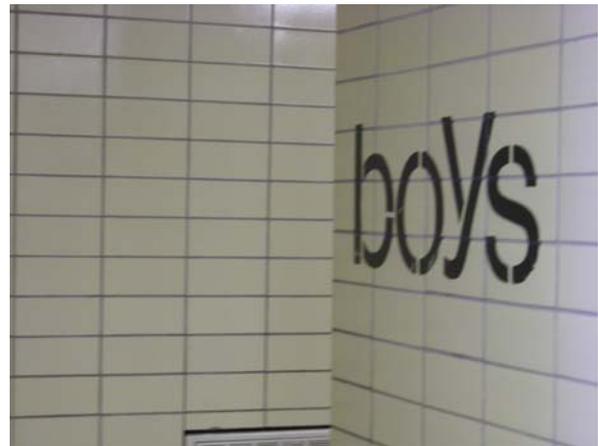
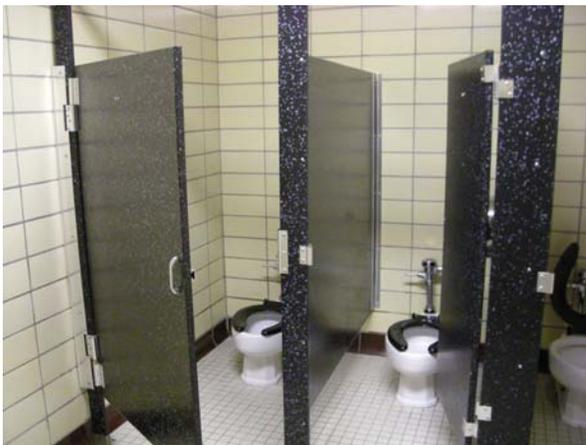
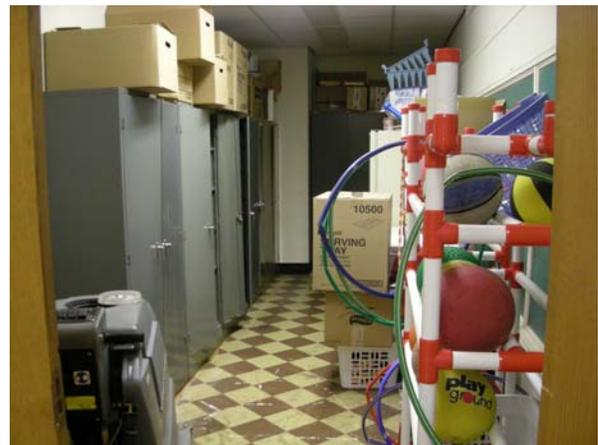
**E:Building Interior**

fair condition and should be refinished.

- Toilet accessories are in fair to good condition typically.

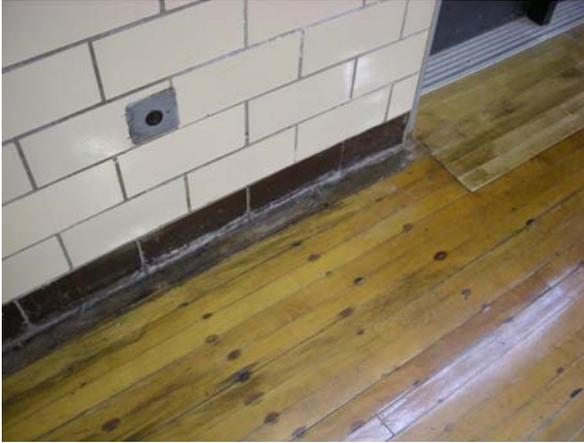
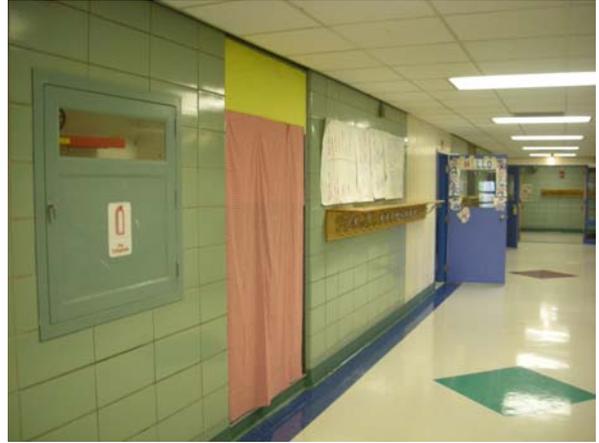
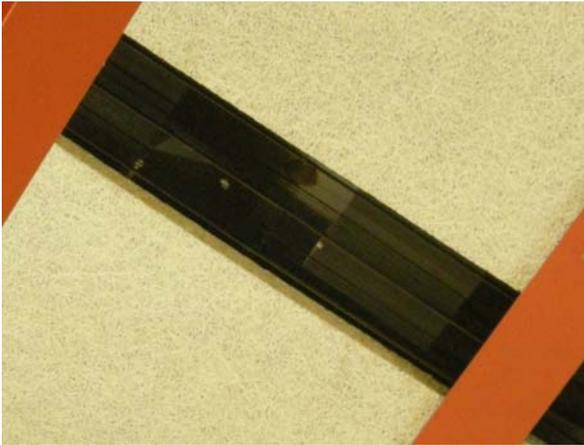
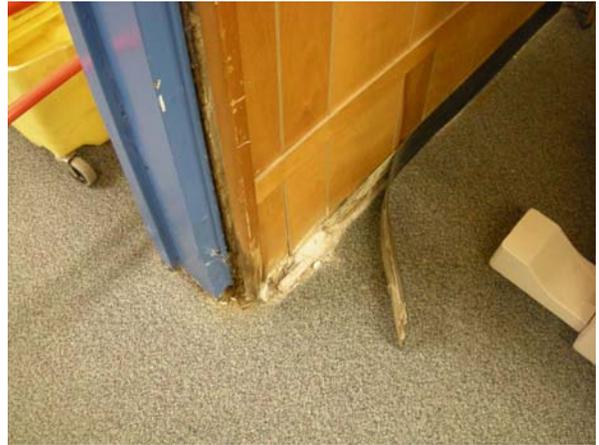
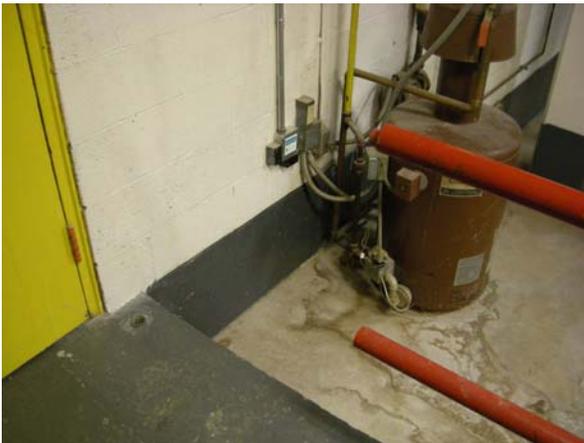
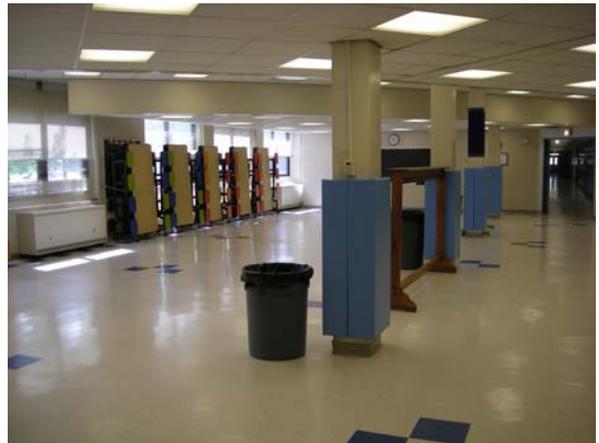
## **E: Building Interior**

- Handicapped toilet stalls do not exist within the building.
- Group sinks at all group toilets are inaccessible semi-circular wash fountains. These sinks were typically in poor to fair condition, with significant staining and rusting at metal bottoms.

- Drinking fountains observed at the school were not ADA compliant.
- Toilets and urinals are in good condition, old but showing no significant damage.
- Hardware at most doors consists of original knobs, which are not ADA compliant.

- Carpet in recently remodeled areas is in good condition, but showing early wear. Older carpet is still in usable condition, but may be nearing the end of its life. Carpet in the basement rooms typically needs replacement.
- VCT is generally in fair to good condition. It was replaced in 1998, and is ageing normally. A few areas, such as Art and Storage rooms require replacement.
- VAT (vinyl asbestos tile) was found in two small rooms. It should be removed according to regulations.
- Ceramic tile floors at the group toilet rooms are in good condition, with minor repairs needed.
- Terrazzo at the restrooms is in good condition, though some minor cracking was observed and discoloration occurs in some areas.
- Epoxy paint in basement areas (custodial office, toilet rooms, pump room, etc.) is in poor-to-

- Vinyl base is typically in fair-to-good condition. Typically, vinyl base should only be replaced when adjacent floor (carpet or VCT) is being replaced, but there are a few areas where it appears especially worn.
- Structural Glazed Facing Tile base at the group toilet rooms and in stairwells is in fair to good condition.

- Concrete block walls, apart from the problems described previously, are in typically good condition, with only minor, hairline cracking observed. An unusual amount of cracking was observed on the exterior wall of the south stair.
- SGFT walls in the Gymnasium are in good condition, but many have holes from removed equipment, and should be replaced. Walls in restrooms and stairwells are in good condition.
- Gypsum partition walls are typically in good condition. Some water damage was observed in the Kitchen.
- Partition walls in the Custodial areas should be replaced.
- The corridor wall of Room 003 shows severe water damage and deterioration. The paneling in this room is damaged and should be removed.

- Lay-in acoustical tile ceilings are generally in good-to-fair condition, with few areas requiring wholesale replacement. Selective tile and grid replacement is required. Many ceiling areas, while level and sound, had yellowed/discolored grid - an aesthetic concern which does not require immediate replacement.
- Many areas of concealed spline ceiling need complete replacement. All other areas require significant spot replacement.
- Plaster ceiling occur in restroom and utility spaces, and are in typically good condition.
- The ceiling of the gymnasium appears to be black expanded mesh and Tectum panels suspended below the original 12x12 adhered acoustic tile ceiling. These original tiles are falling onto the mesh. Both ceilings should be removed, and a proper new ceiling installed.

- Most doors appear to be original wood construction, and function properly. Many wood doors have been repeatedly painted, and will require ongoing maintenance. Hollow metal doors in the basement are in poor-to-fair condition, with many requiring repair or replacement.
- Most door frames appear to be original construction, and function properly. Both hollow metal and wood frames exist.
- Door hardware is typically knob type, and is not ADA-compliant.

- Most toilet partitions are original metal partitions, and should be replaced.
