2007 District Wide Facilities Evaluation  
Building Assessment Report

# Cleveland Heights High School

13263 Cedar Road, Cleveland Heights, Ohio

June 18, 2007

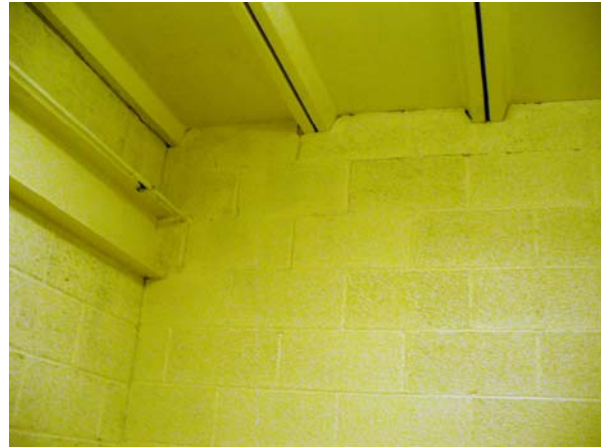
Mezzanine Restroom

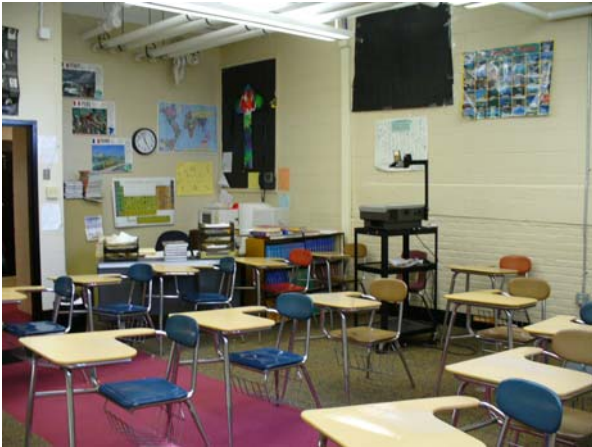
Typical Classroom

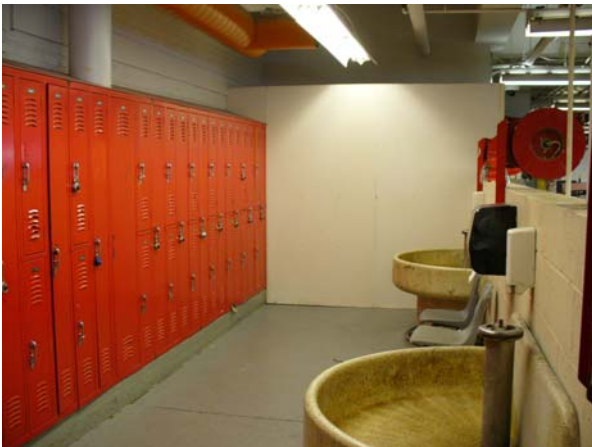
Automotive Tech Changing Area

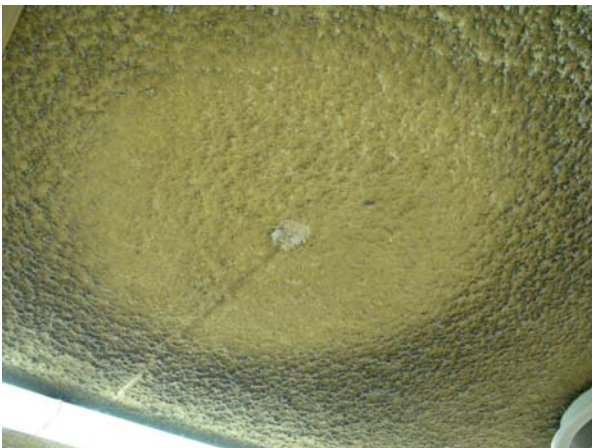
Acoustic Ceilings in Science Wing

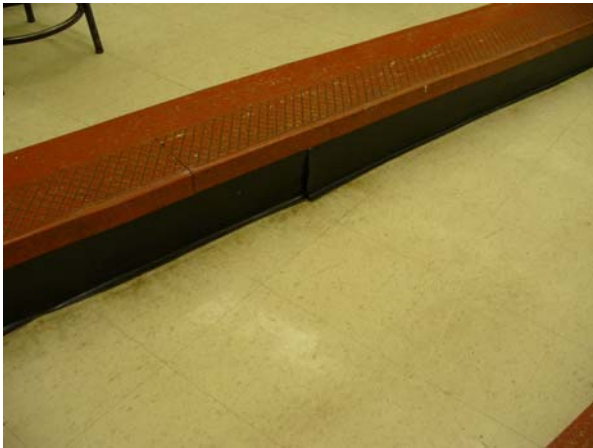
Vinyl Risers in Band Room

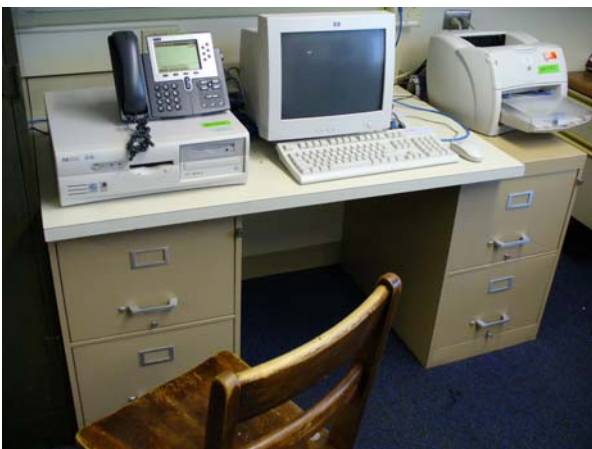
Improvised Office Desk

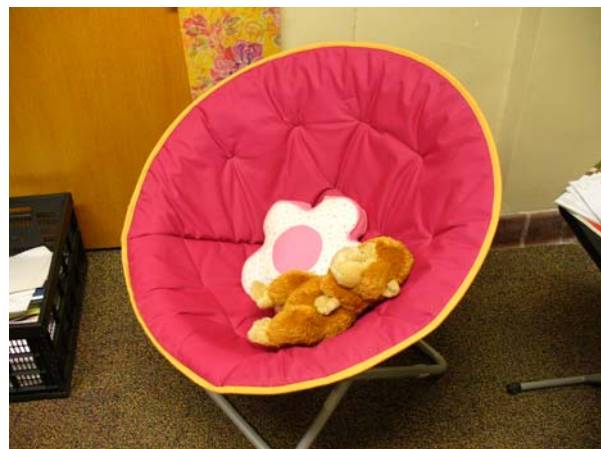
Staff-Supplied Seating

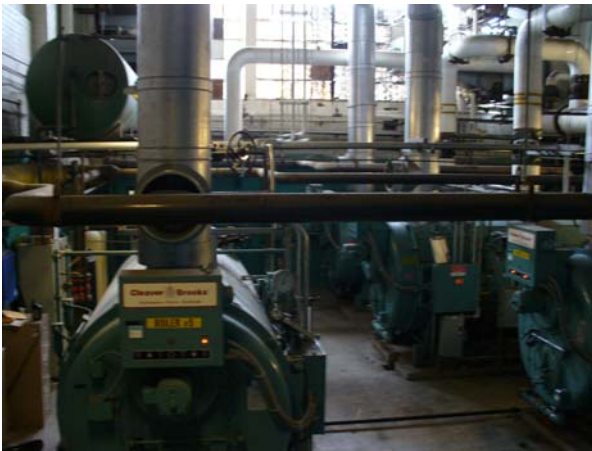
Boiler Room

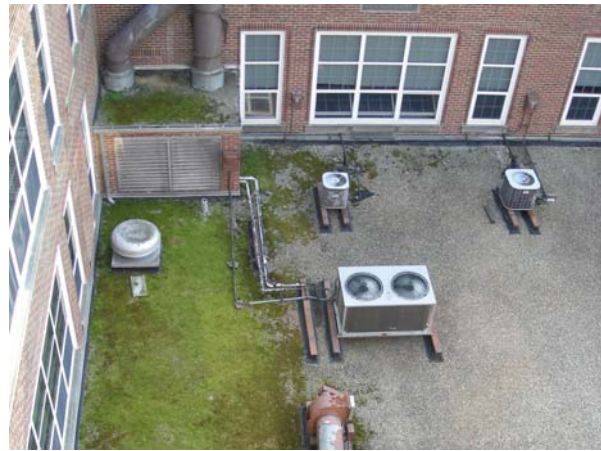
Rooftop Units

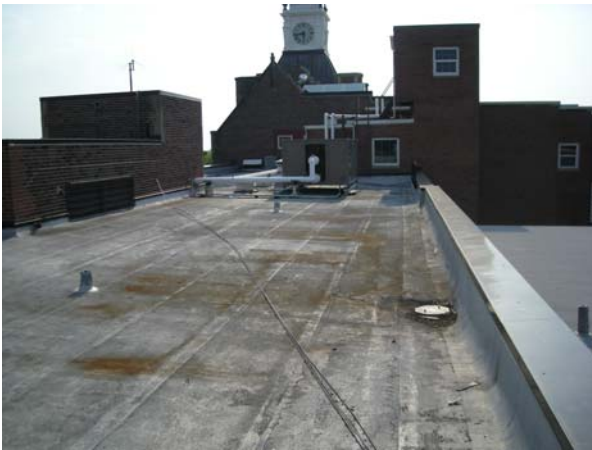
Rooftop Unit

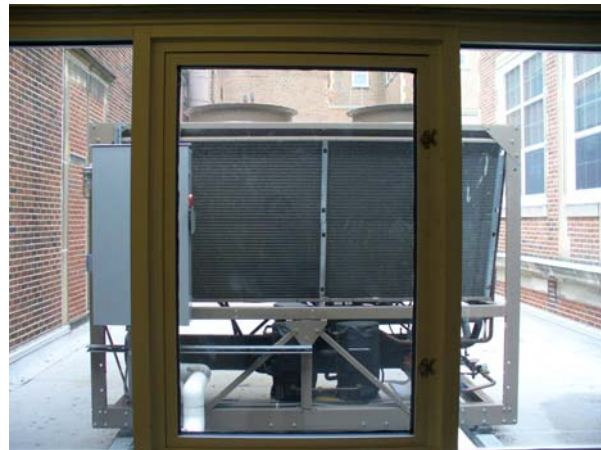
Rooftop Unit

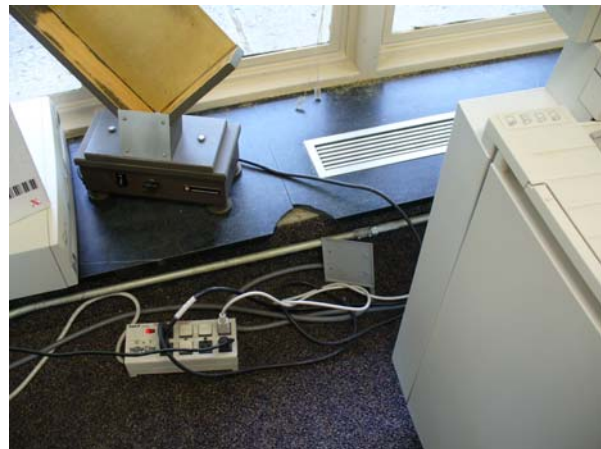
Unit Ventilator
